Clarence River Crossing

Construction / Pre-Operation Compliance Report

Report 6 April 2019 - October 2019

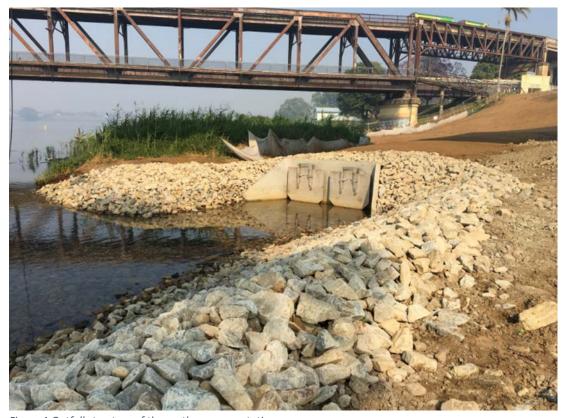
- Installation of internal pump systems
- Inlet and outlet piping systems
- Installation of the electrical works and pump control units

${\it Figure~1~Outfall~structure~of~the~northern~pump~station}$

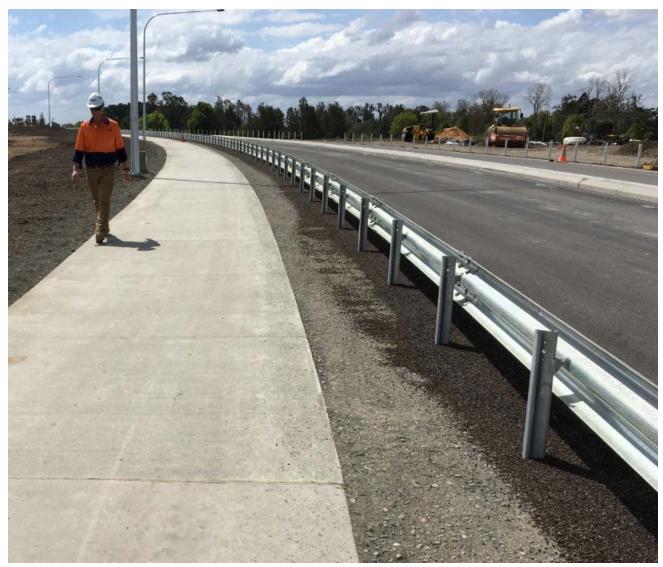
Figure 3 fill 1 finalised verge, steel barrier, street lighting and asphalt

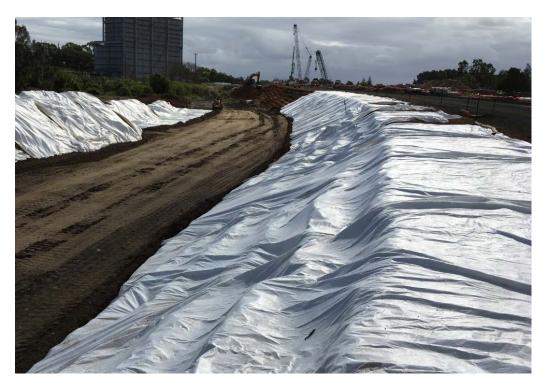
When asbestos is encountered onsite works stop and contaminated land specialists are engaged to safely remove the materials. The process for safely removing the material is to isolate the work area with no other workers in the area. The area is wet down and material is safely removed into a lined truck by an asbestos removalist. Air monitoring is in place to confirm asbestos fragments are not lost during the process.

Figure 4 Asbestos contaminated material being encapsulated in a batter widening for future infrastructure

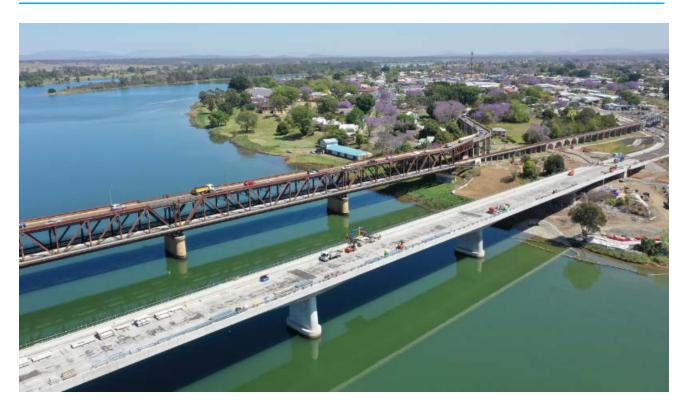
Figure 7 Marine works progress

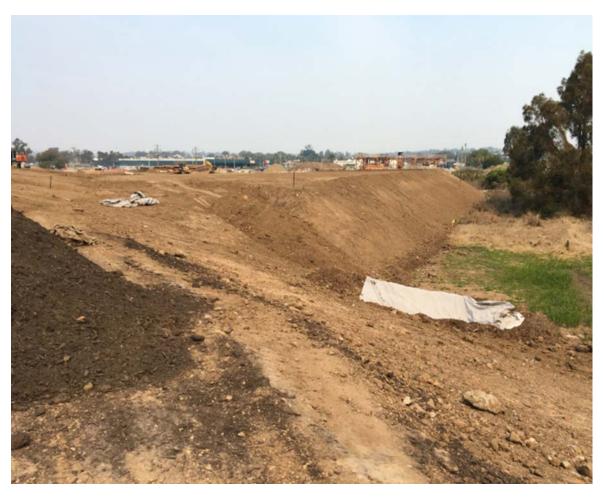
Figure 8 beneficial reuse of surplus material in south Grafton to improve land use

- Correct cigarette butt disposal campaign. Additional signage was installed on the bridge deck
- Return and earn program for plastic bottles promoted on the project with separate bins, signage and education programs
- Battery recycling facilities installed at the project offices
- The beneficial reuse of 17,000m³ of spoil and concrete to improve a flood prone parcel of land in South Grafton
- The encapsulation of ACM in South Grafton which will allow for future infrastructure when required.

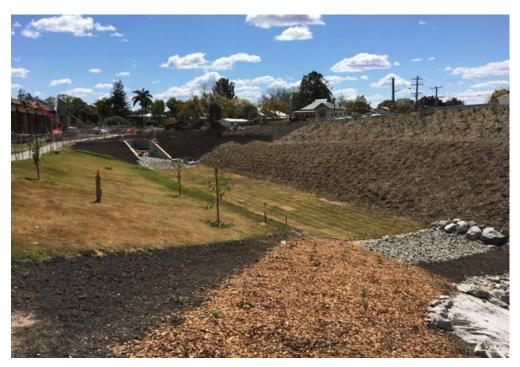
Final design features including pavements, kerb and gutter, footpaths and landscaping have now been completed in the southern and northern bridge access areas into Grafton, Pound Street and Clarence Street. This stage of construction ensures the soil is locked away and the runoff from the project is clean.

Figure 9 Completion of landscaping and final drainage features

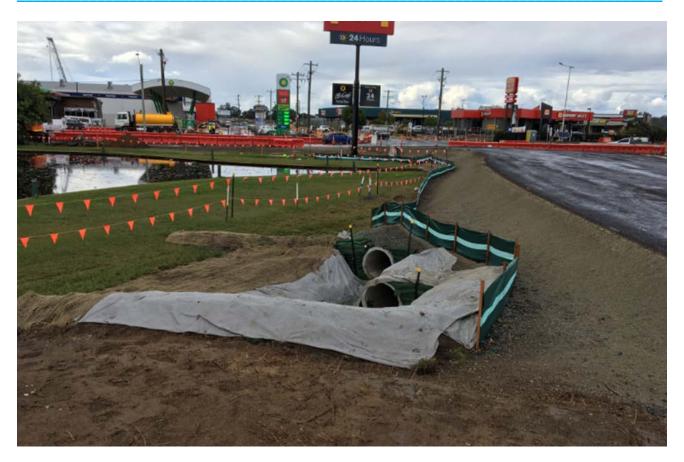
Figure 10 best practice erosion and sediment controls installed for temporary pavement and drainage works

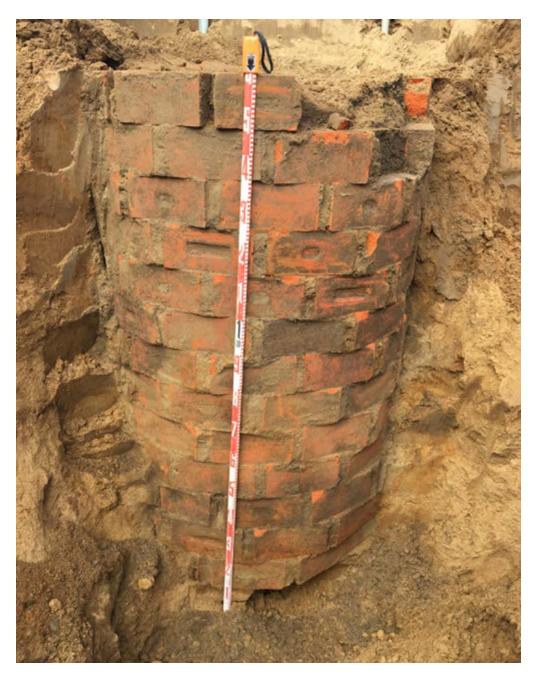
Figure 12 A cistern was located whilst excavating to install the pump station gravity main in Grafton

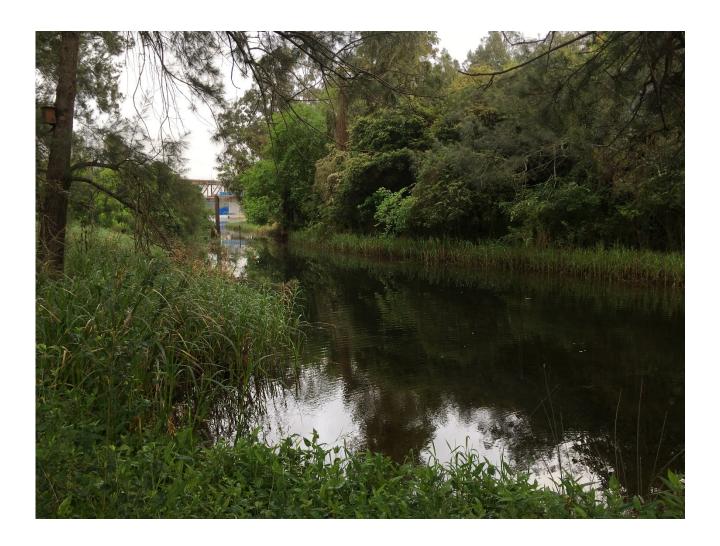
B-1: Surface water quality monitoring completed during the reporting period
