Construction Flora and Fauna Management Plan

Additional Crossing of the Clarence River at Grafton Project

SEPTEMBER 2016

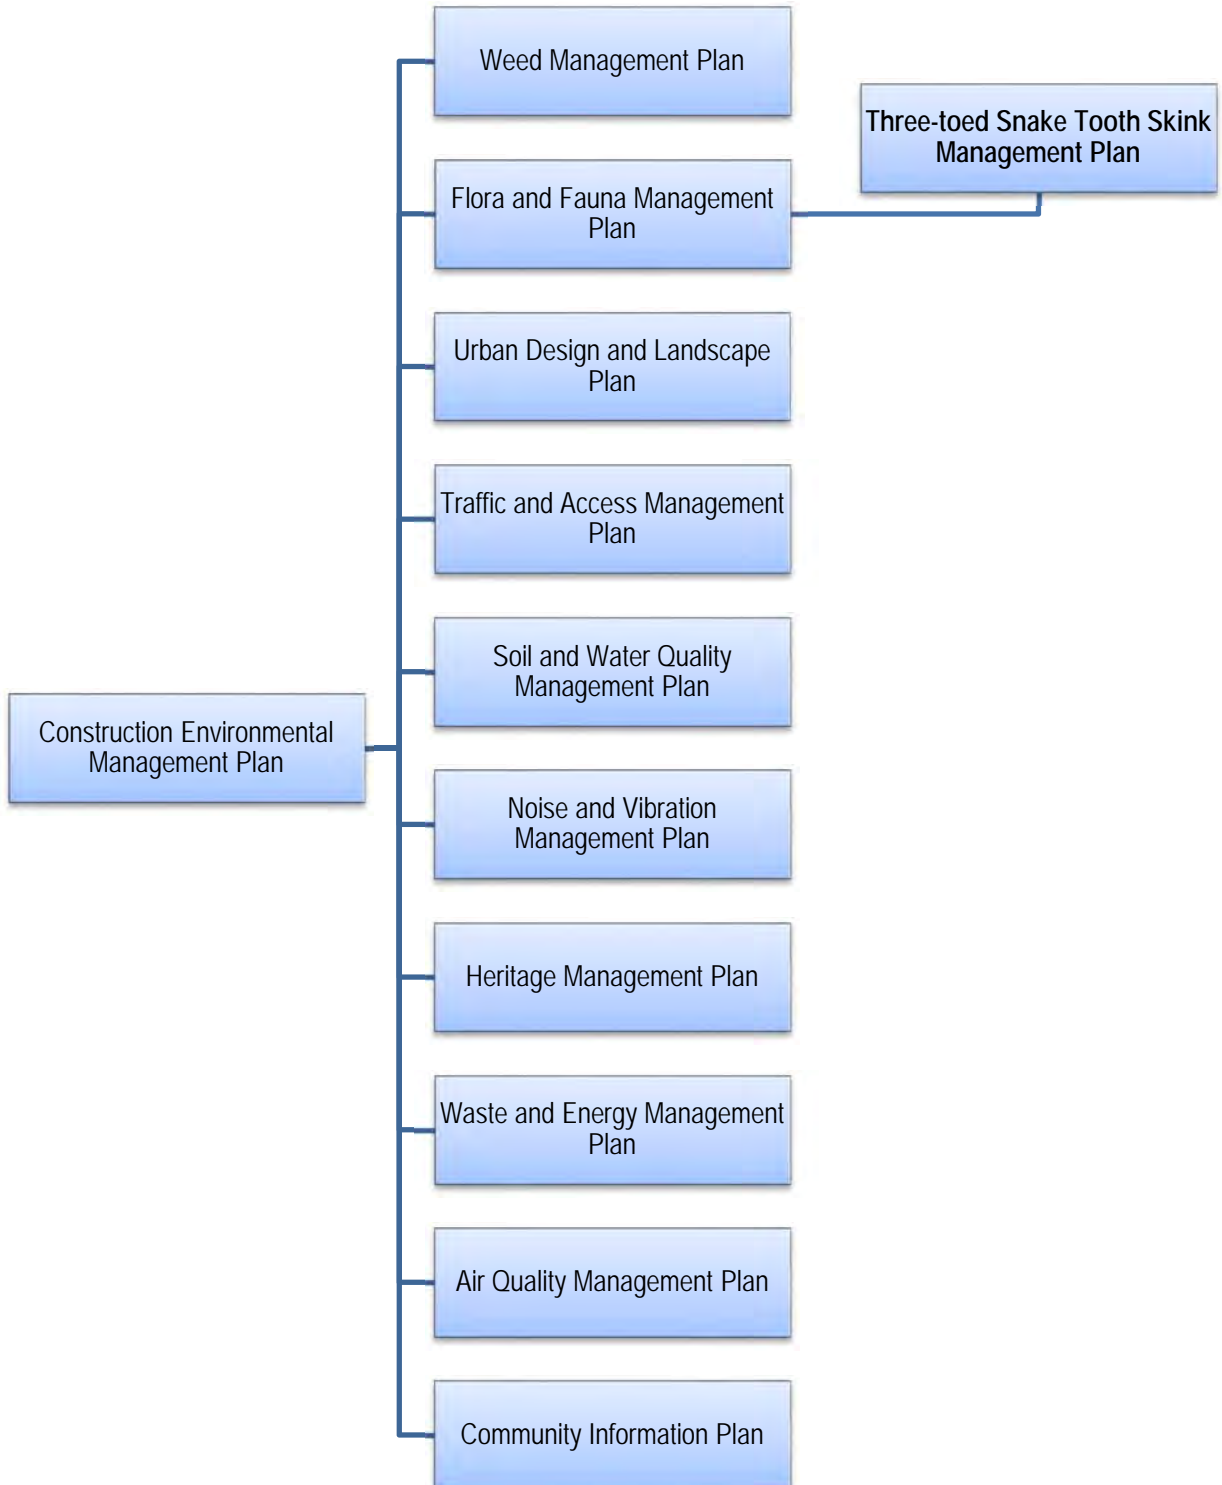
Figure 1-1. Construction Environmental Management Plan framework.

The Construction Environmental Management Plan (CEMP) framework is outlined below in Figure 1-1.

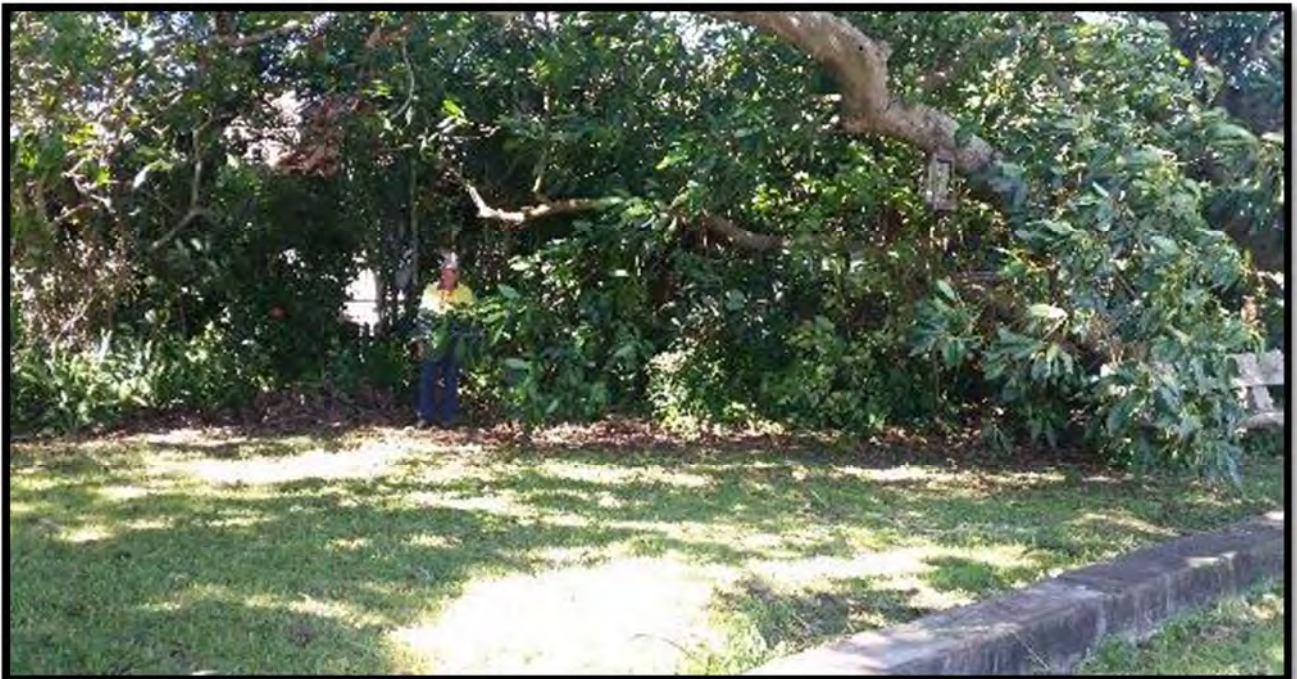
Plate 8-2. Capture location (R. Jago positioned) at APO 8 beneath a mature Avocado Tree. Note levee block wall in foreground.
