# **Additional crossing of the Clarence River at Grafton**

Route Options Development Report  
Technical Paper – Geotechnical Assessment  
for Route Options

**Main Road 83 Summerland Way -  
Additional Crossing of the  
Clarence River at Grafton**

Geotechnical Assessment for Route  
Options

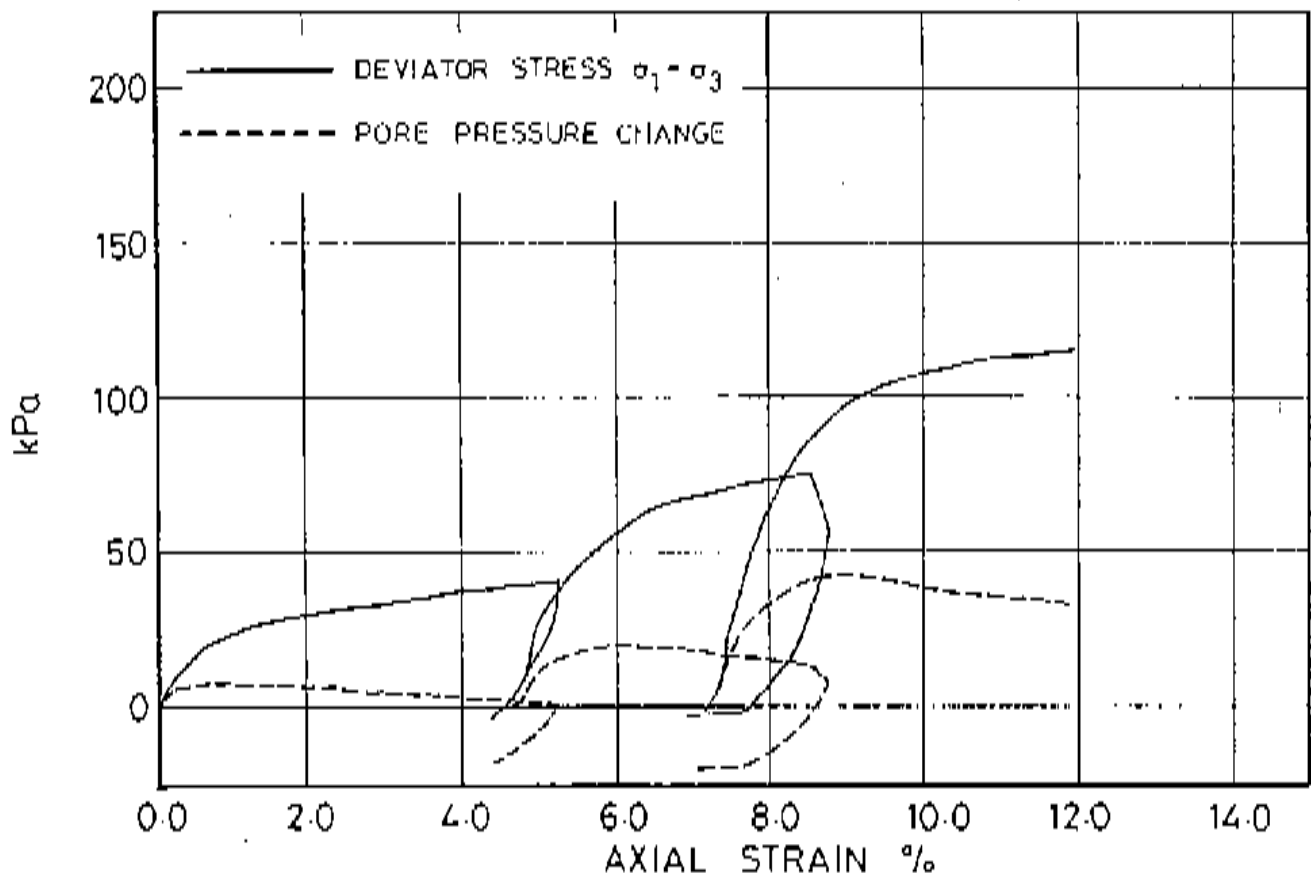
CAMERON MCNAMARA PTY. LTD.  
SOUTH GRAFTON LEVEE - GEOTECHNICAL INVESTIGATION  
C.U. TRIAXIAL TEST RESULT - SAMPLE BH SG3/UD1

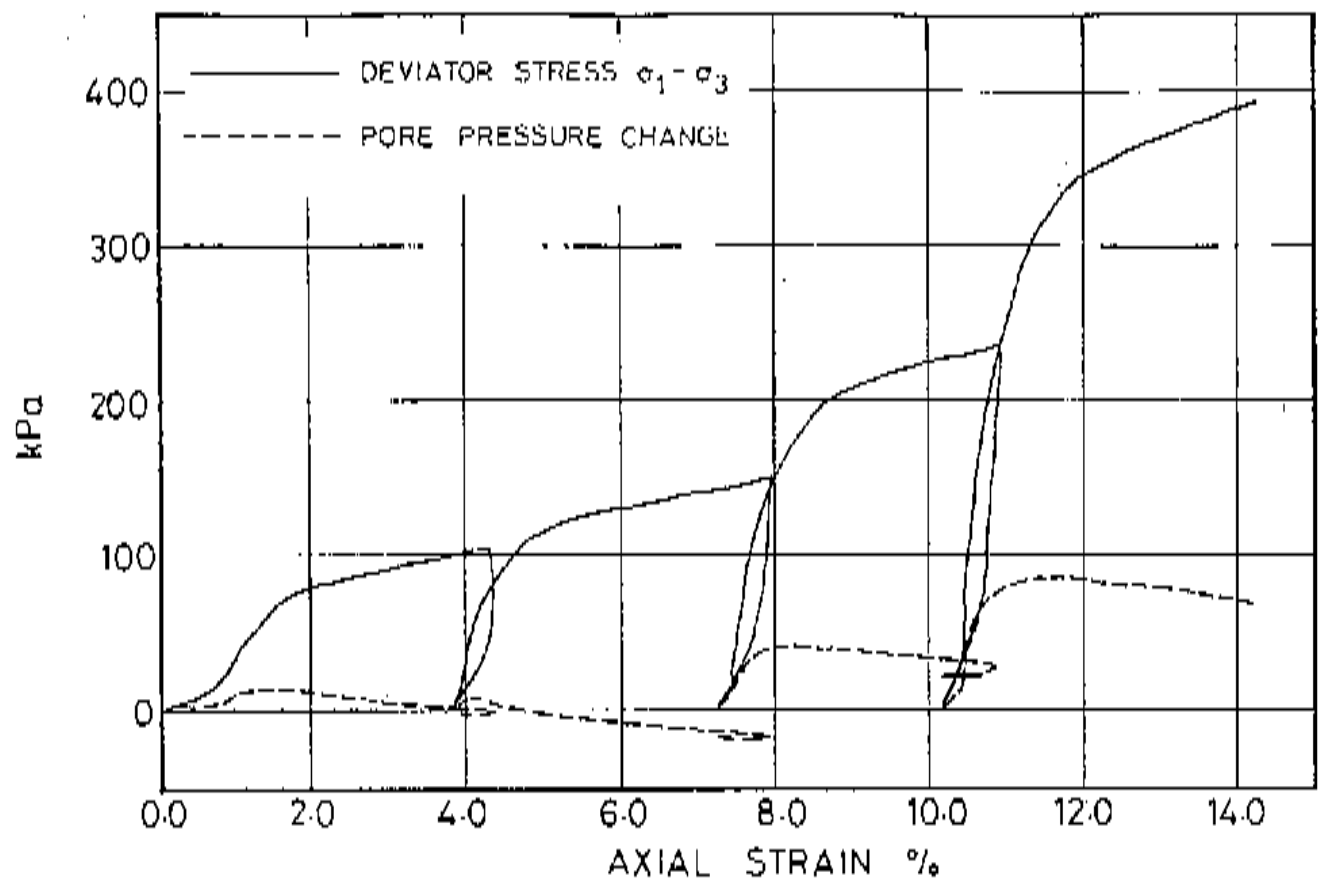
CAMERON McNAMARA PTY. LTD.  
 SOUTH GRAFTON LEVEE - GEOTECHNICAL INVESTIGATION  
 C.U. TRIAXIAL TEST RESULT - SAMPLE BH SG5/UD2

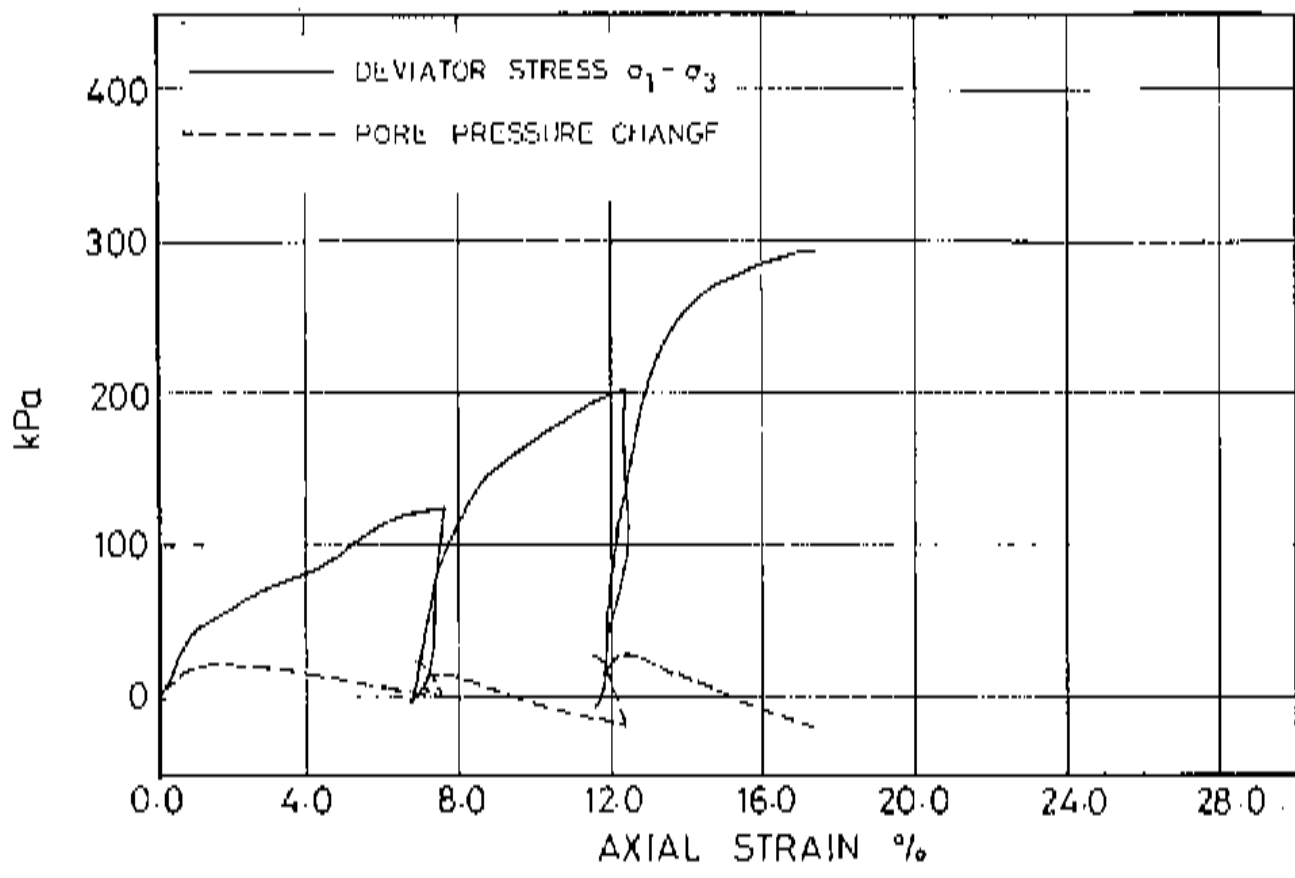
CAMERON MCNAMARA PTY. LTD.  
 SOUTH GRAFTON LEVEE - GEOTECHNICAL INVESTIGATION  
 C.U. TRIAXIAL TEST RESULT - SAMPLE BH SG7/UD2

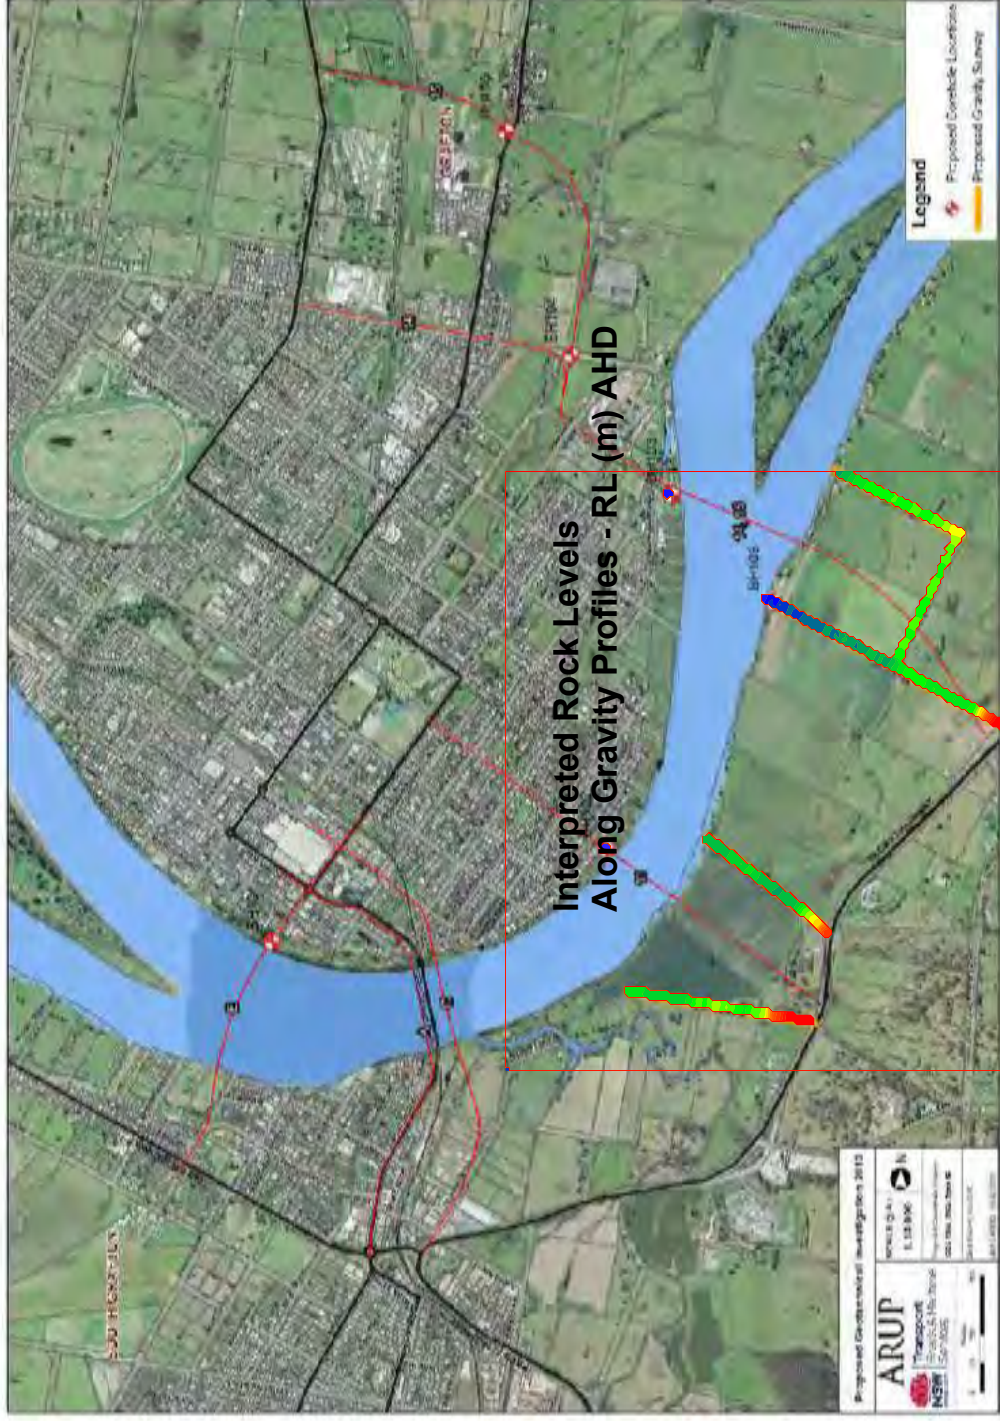
**Figure 3**

**ARUP / ROADS & MARITIME SERVICES  
SUMMERLAND  
GRAVITY SURVEY  
INTERPRETED ROCK LEVELS  
(AERIAL PHOTO SITE PLAN)**
