# Clarence River Crossing

## Construction Compliance Report

*Report 2*

*18 April 2017 - 17 October 2017*

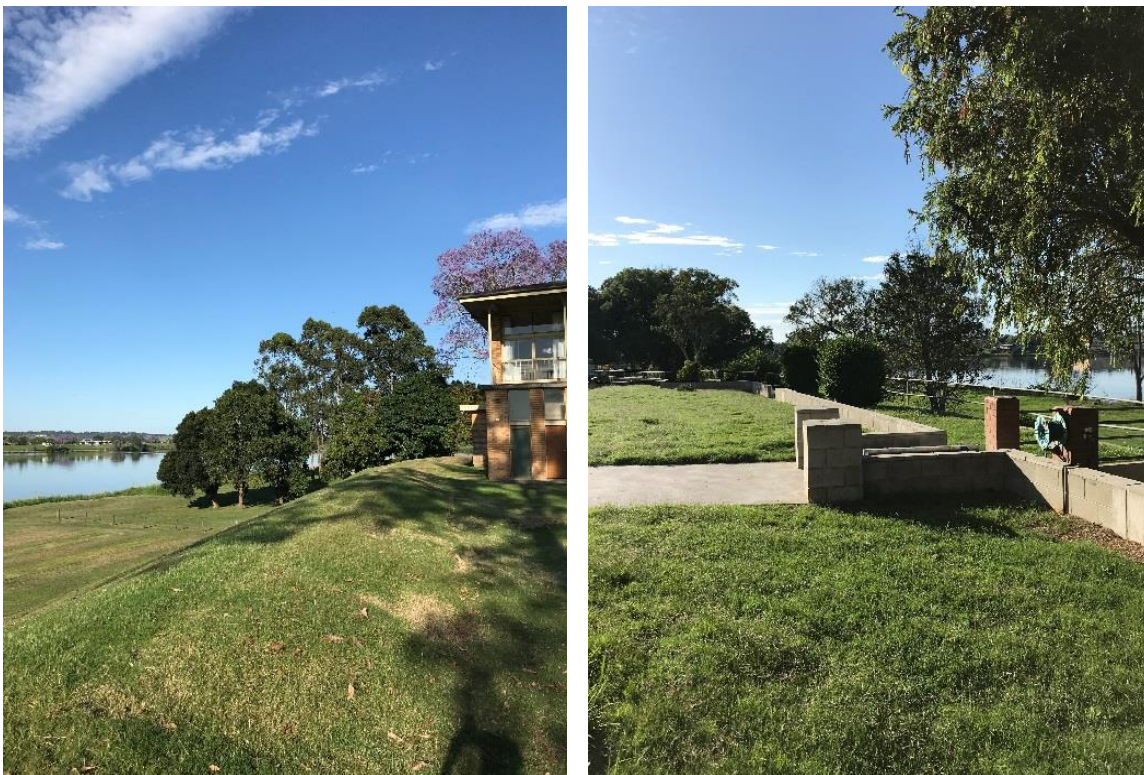
As a part of the project upgrades to the Grafton levee wall were required to be constructed, those works were completed in July 2017. Maintenance and minor defects repairs will be ongoing.

Figure 1 Completed levee works in Grafton at (a) NG04 and (b) LPO111

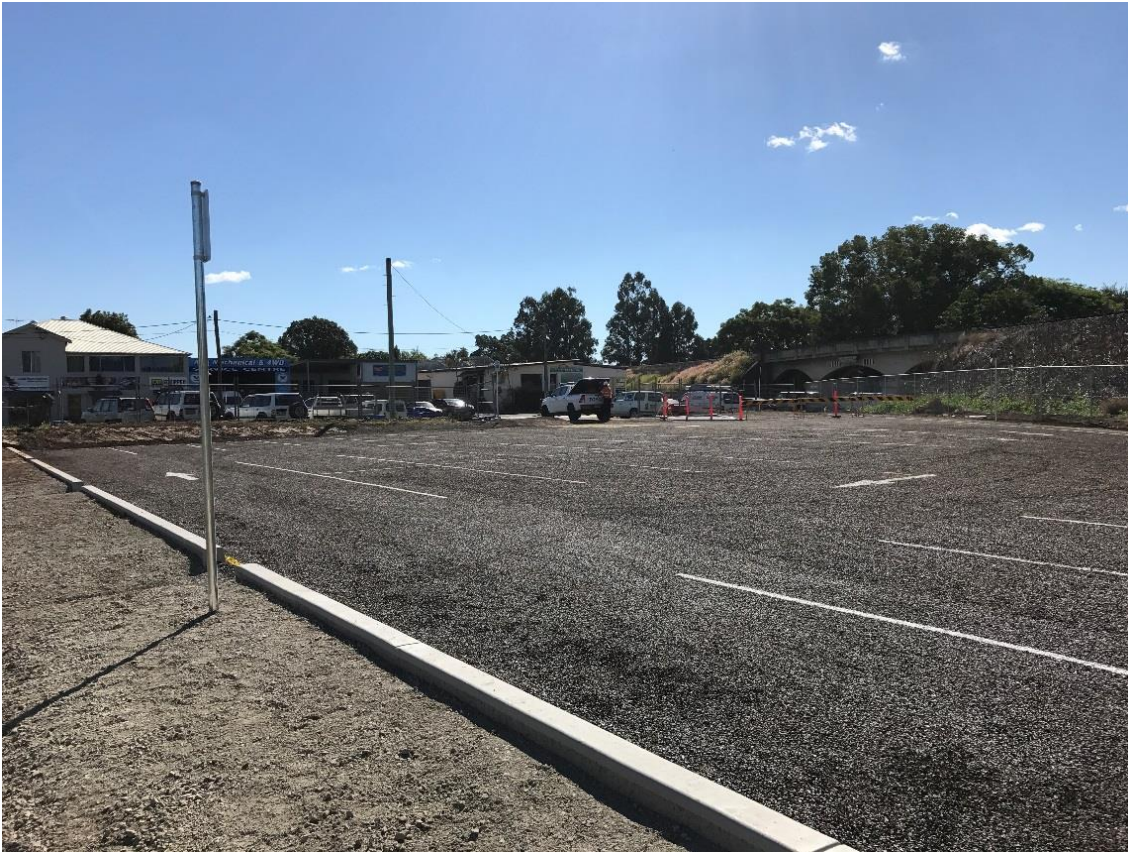
In Grafton, construction of the Clarence and Pound Street car park was completed and opened to the public in May 2017.

*Figure 2 Completed construction of the Clarence and Pound Street car park*

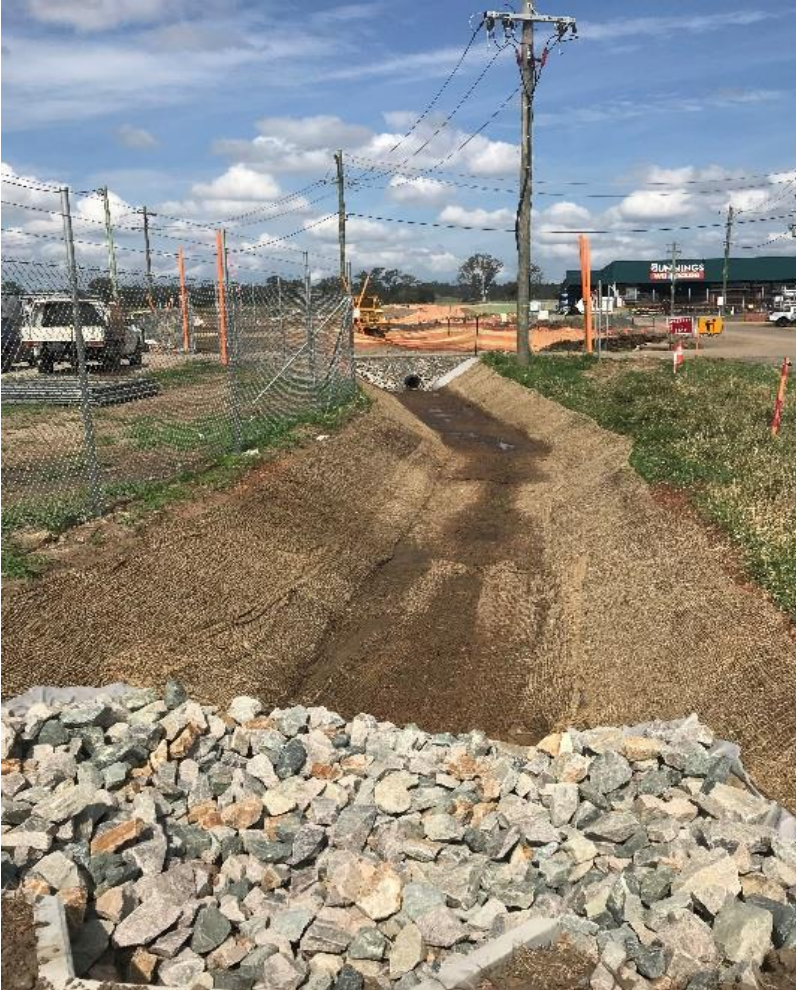
- Drains lined with jute mesh and ready for hydroseeding at Iolanthe Street and Through Street
- Installation of culverts and headwalls on Through Street
- Construction of the concrete base slab for the box culvert in fill 2

*Figure 3 jute mesh lined drains completed to final design at Iolanthe/ Through Street*

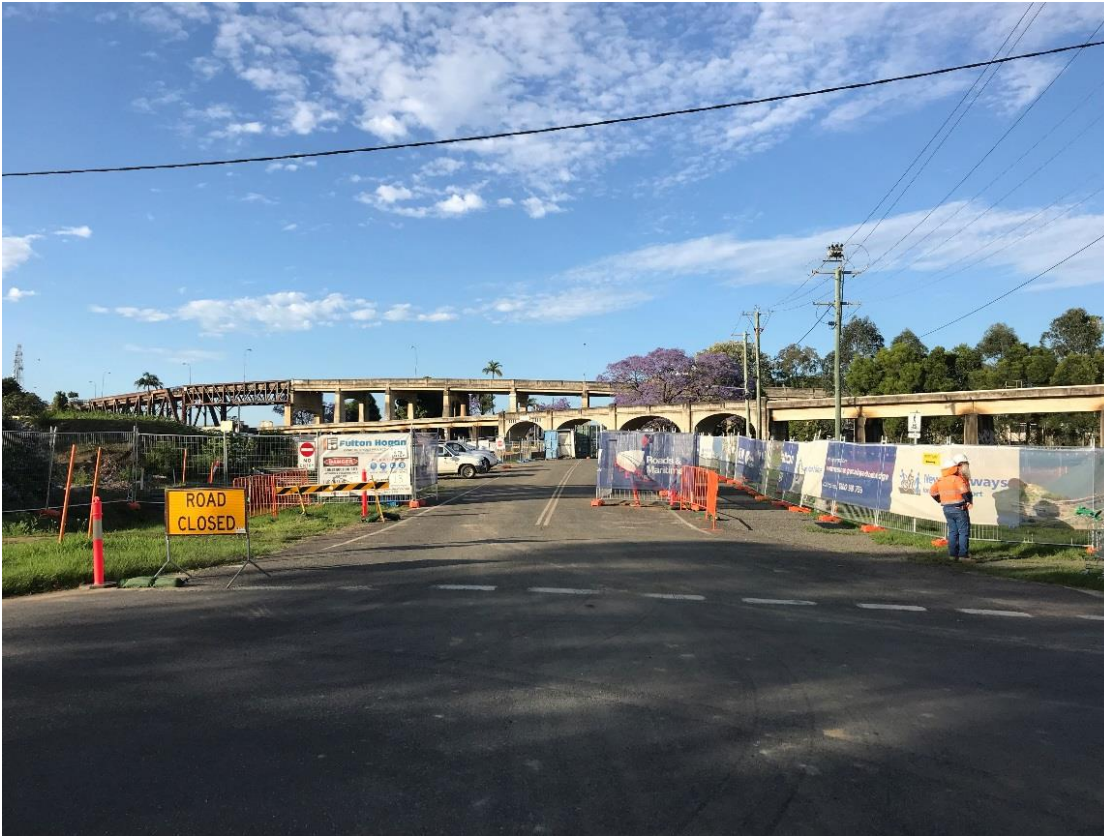
Figure 4 Permanent closure of Kent Street

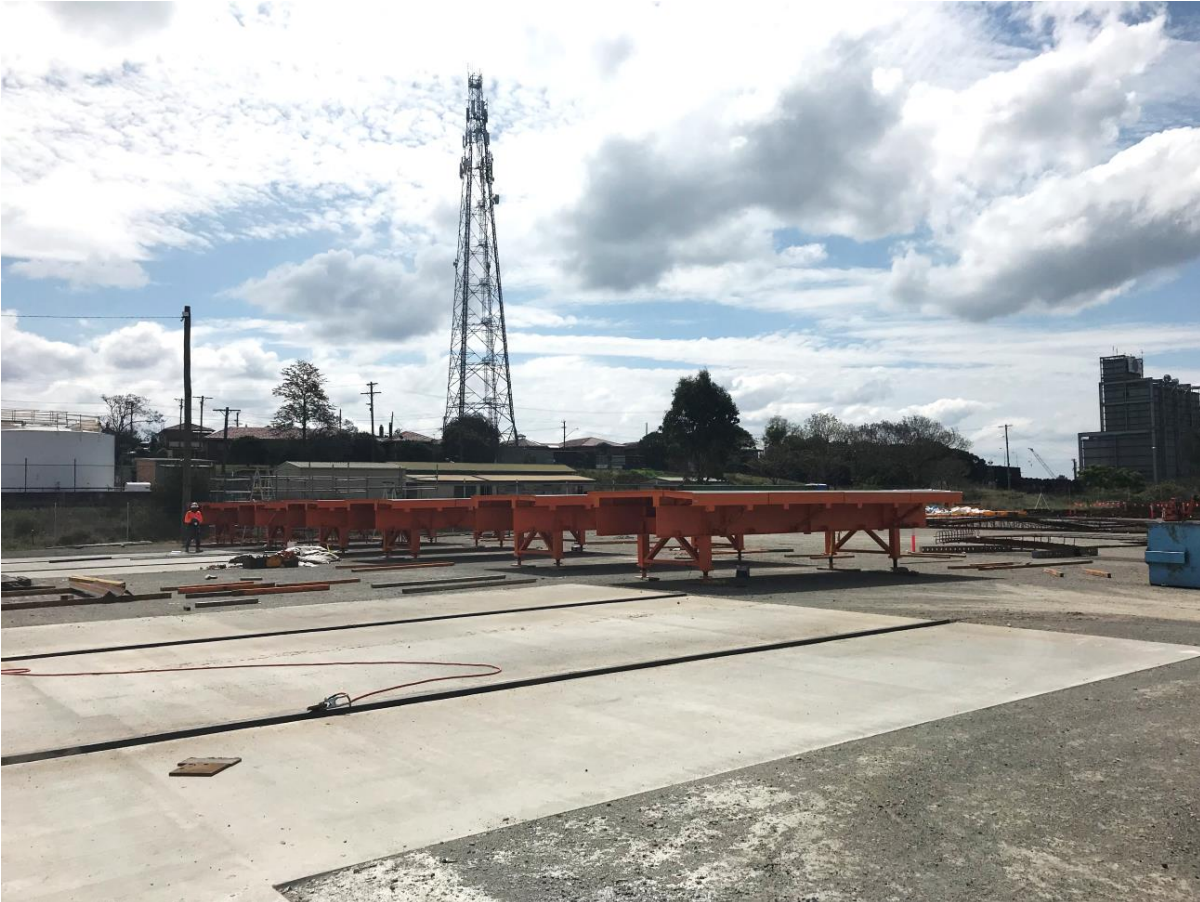
- Foundation layer and clean rock capping layer completed
- Concrete slabs poured for moulds
- Permanent fencing installation completed
- Progressive erosion and sediment controls
- Construction of all 5 pier skirts completed
- Arrival of the exterior mould tables onsite
- The reo cage for the first segment successfully constructed

*Figure 5 Mould segments in the process of construction onsite*

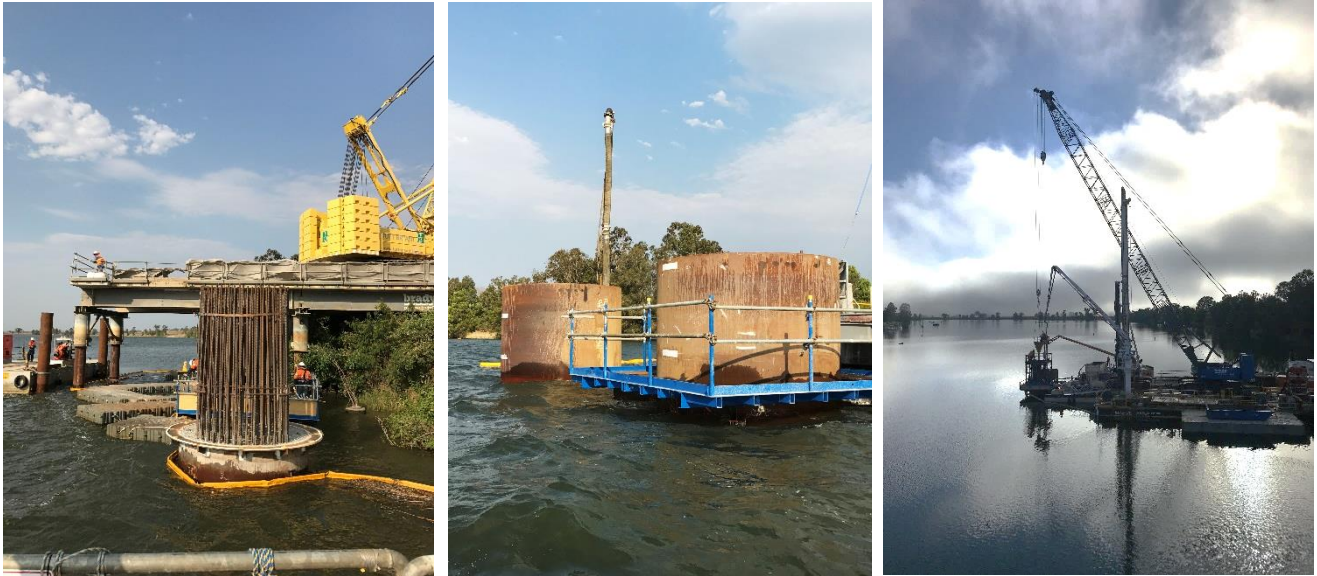
Both piles at pier 2 and one pile at pier 3 were successfully poured during the reporting period. All water was managed onsite and sent to the sediment basin at fill 1.

Figure 6 (a) completed pours at Pier 2 in preparation for pier skirt installation; (b) installed casings for pier 3 and; (c) concrete pump at pier 3

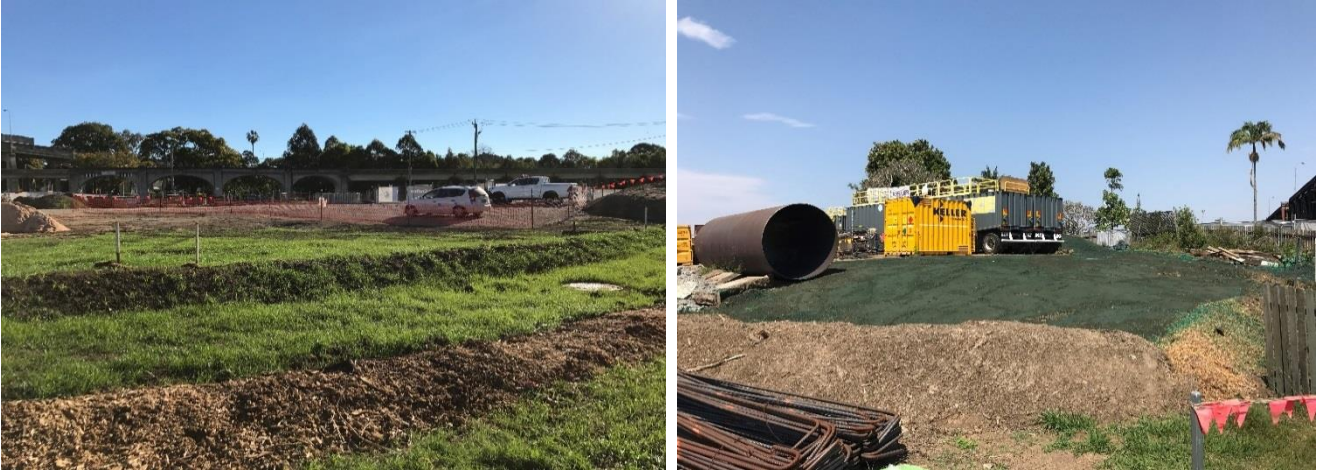
The Grafton section of the project is an urban construction area. This section of the project has limited space and a high complexity of works. In Grafton, the key focus was to minimise the amount of water entering site and reduce the sediment mobilisation. Key controls were seeding disturbed areas and earth mounds, mulch bunds around the works perimeter, polymer stabilisation on exposed dirt and stockpiles, and installing stormwater pit controls.

Figure 7 Controls in Grafton (a) mulch bund and seeded earth mounds and; (b) exposed areas banded and polymer applied

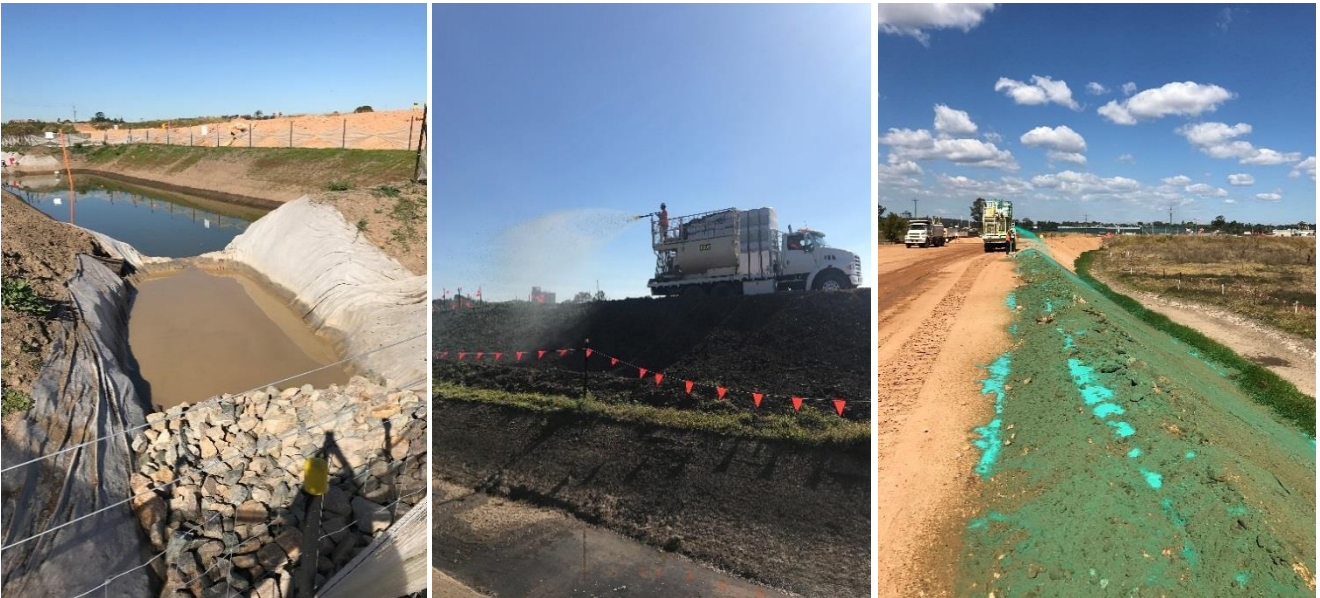
In South Grafton, controls remain focused on diverting water away from the Clarence River. As earthworks have progressed design drainage has been installed and areas landscaped to reduce disturbance footprint and maintain a high standard of site water control. The focus of the project is to control sediment at the source by applying hydromulching and polymer.

Figure 8 Controls in South Grafton (a) sump removing sediment prior to entering sediment basin; (b) hydroseeding of topsoiled batters and; (c) polymer application on exposed batters

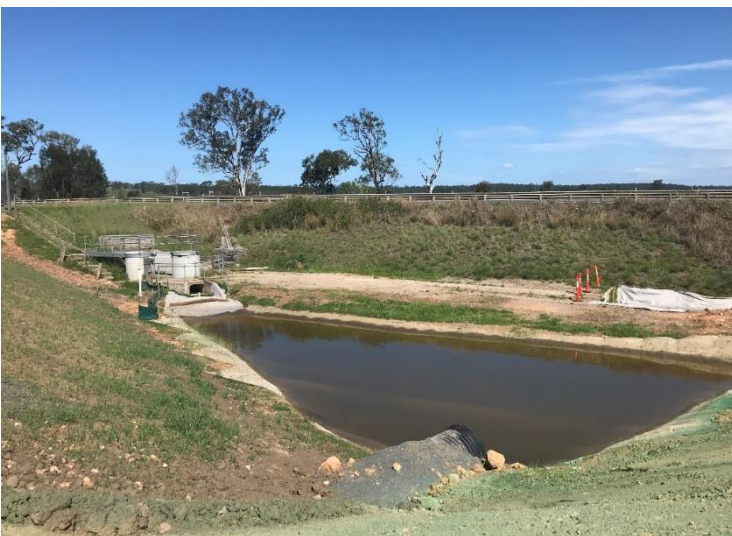
Figure 9 Grass strike from hydroseeding and polymer controls on batters surrounding clean water basin at Fill 2

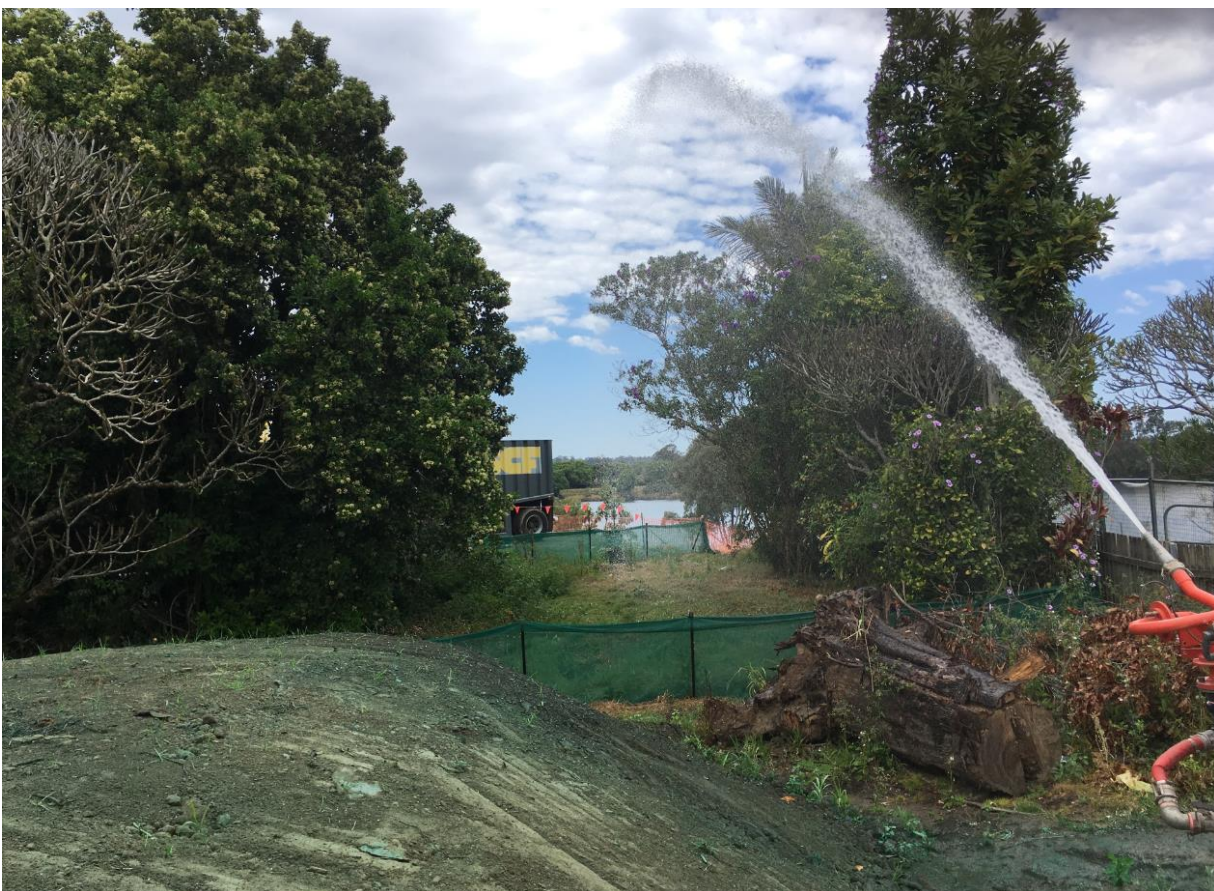
*Figure 10 Watering down of skink habitat during dry months throughout the reporting period*

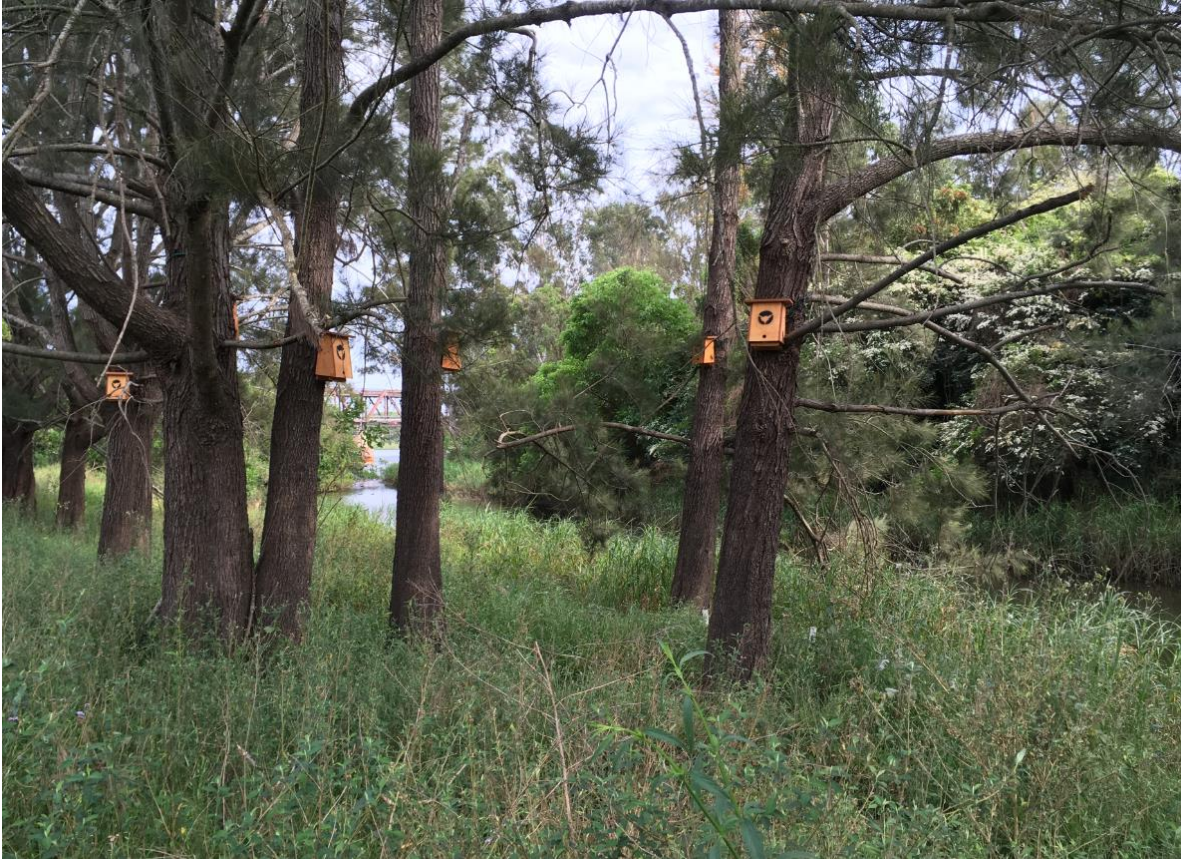
Nine additional nest boxes were installed in excellent habitat close to Alipou Creek during the reporting period. Autumn and summer monitoring of nest boxes both took place during the reporting period.

Figure 11 Additional nest boxes installed along Alipou Creek

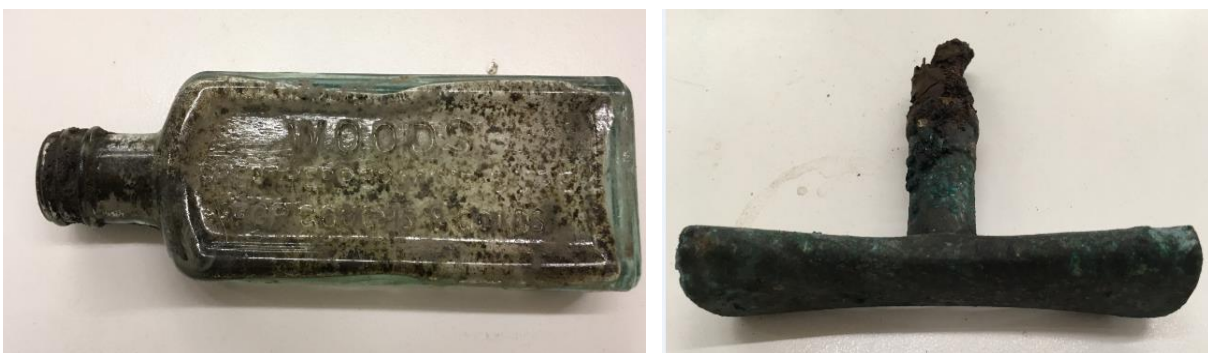
Figure 12 Heritage items found between Abutment A and Pier 1 during excavation works. Object (a) Woods Peppermint cough cure bottle from the early 1900's and object (b) an old copper train handle

Some of these structural forms were salvaged and cleaned to be donated to the local historical society. Excavation works between Abutment A and Pier 1 also found some scattered rubbish items including copper handles, a glass bottle and ceramic items.

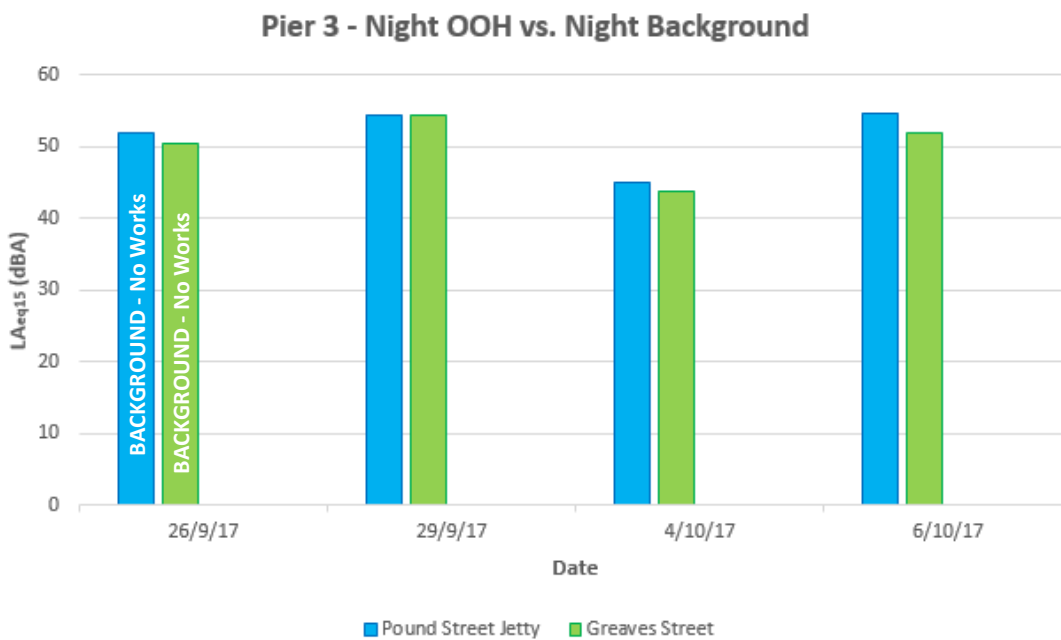
Attended noise monitoring was undertaken to assess the modelled out of hours and evaluate calculated noise levels. Figure 13 below shows a comparison between a background noise assessment where no works were taking place against the monitored out of hours works during construction. Results confirmed the model indicating the difference to be negligible.

Figure 13 OOH works assessment vs. background noise levels for works at Pier 3

All out of hour's works were consistent with the CEMP management plans and were completed without complaint or incident.

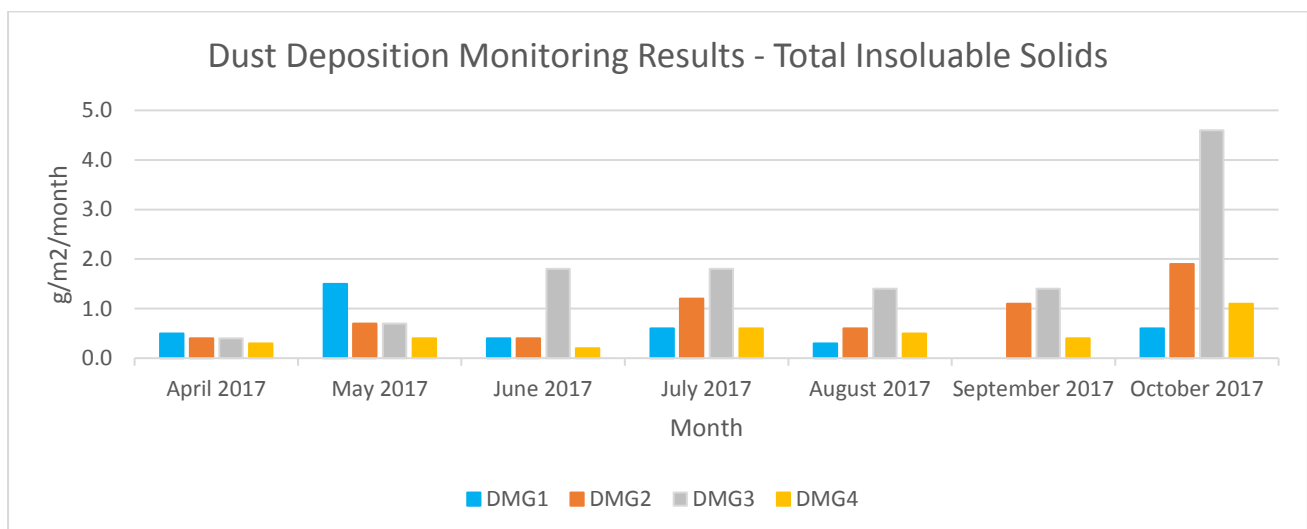
Air monitoring results for the reporting period are shown in figure 14 below.

Figure 14 Air monitoring results for the reporting period. All results are reported in g/m<sup>2</sup>/month

Dust suppression on the project during the reporting period included the increased use of water carts, shade cloth, webbing around basin perimeters, and pre-wetting of materials prior to cartage. Seeding, hydromulching and polymer application to stockpiles, batters and earth mounds was implemented where possible.
