# Appendix H

## Non-Aboriginal Heritage Assessment (Local)

Pacific Highway Intersection Improvements in Wahroonga / Warrawee /  
Turrumurra  
Statement of Heritage Impact for Locally Significant Heritage Items within  
Ku-ring-gai Local Government Area

For Roads and Maritime Services

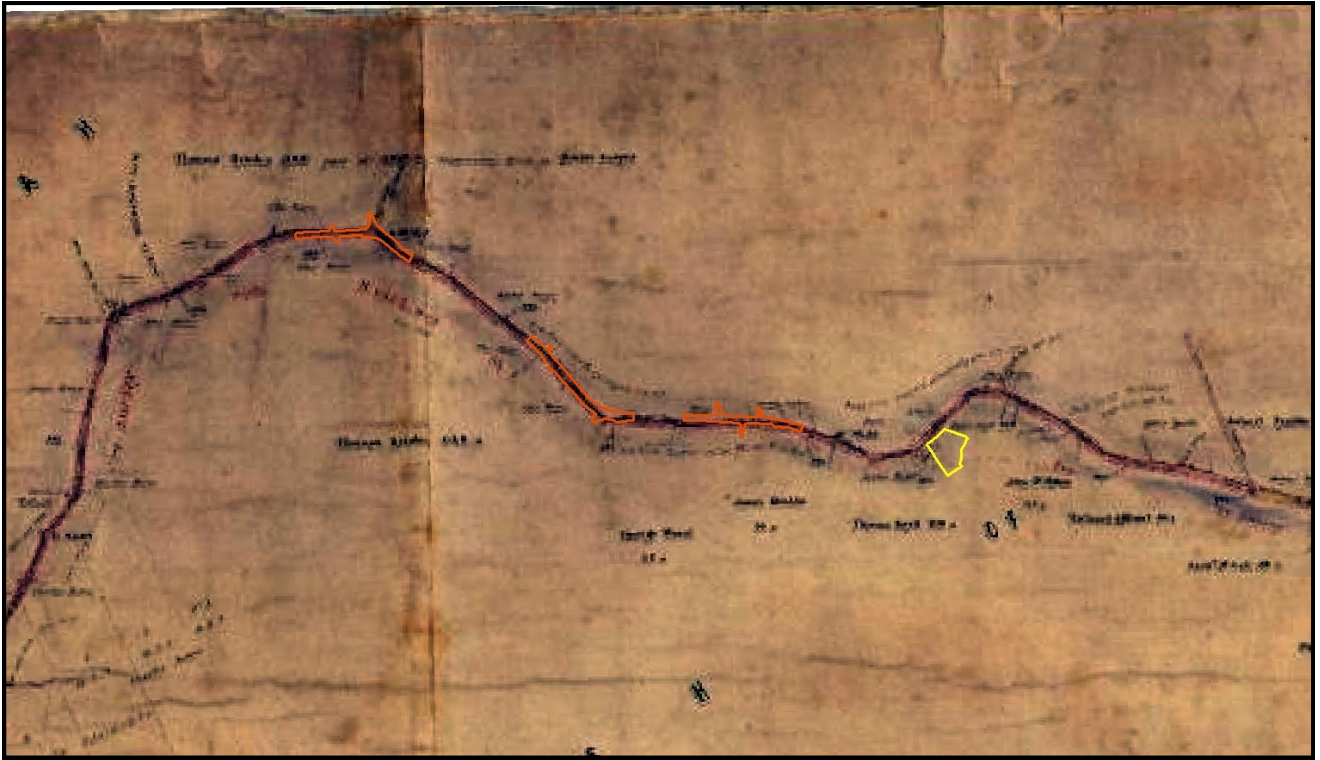
**Figure 7** An 1862 survey of the St Leonards to Pennant Hills Road, with the proposal area highlighted; several structures are present on the plan, but only one may be located within the proposal area (Source: NSW Land Registry Services, Crown plan R290.1603)

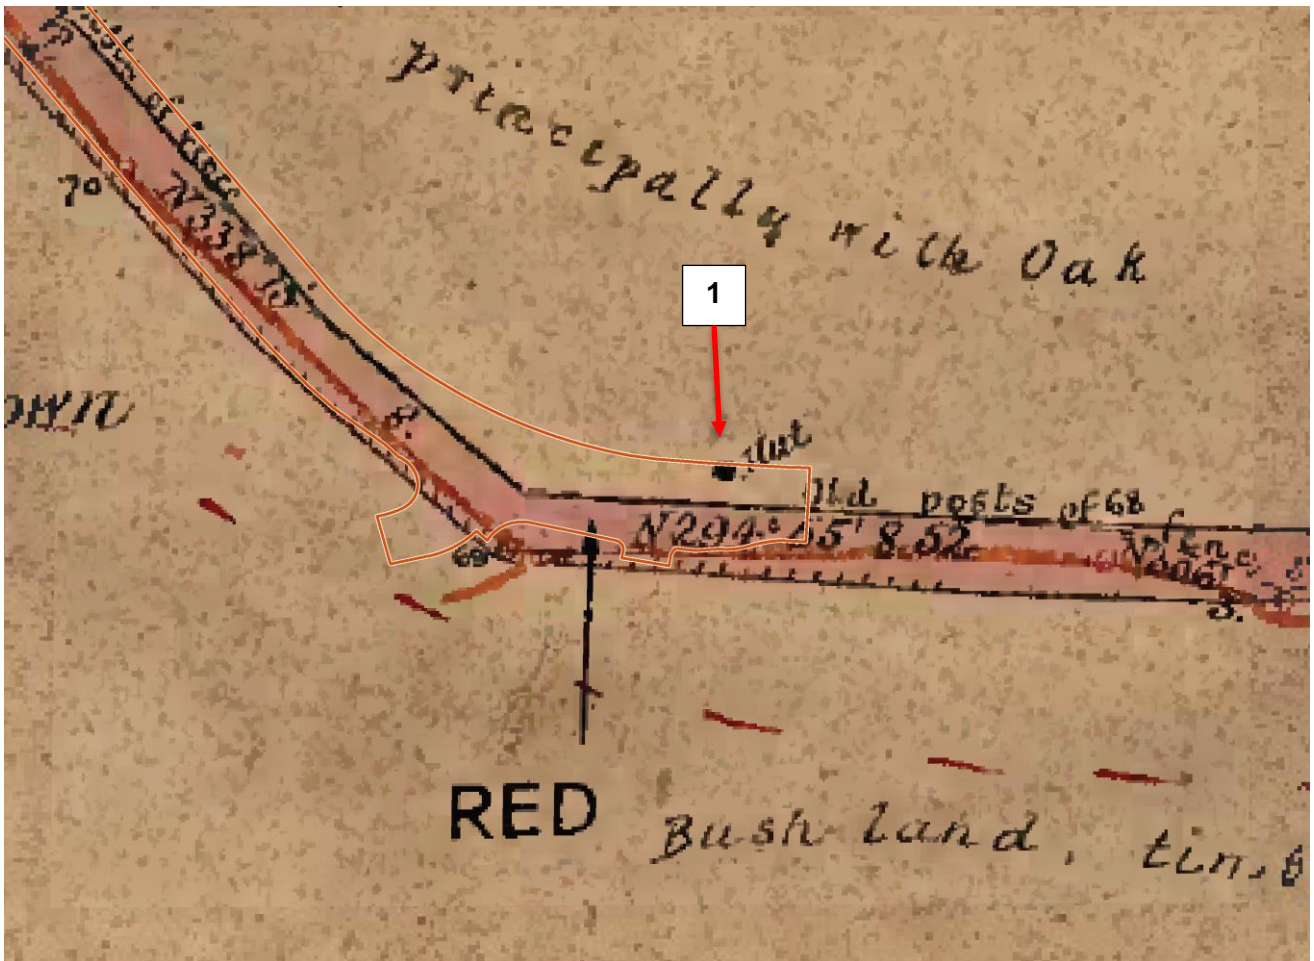
**Figure 8** Detail from an 1862 survey of the St Leonards to Pennant Hills Road, showing a hut [1] near the junction of Fox Valley Road and Lane Cove Road; it appears this hut [1] may be partially within the proposal area at Fox Valley Road (Intersection 2) (Source: NSW Land Registry Services, Crown plan R290.1603)

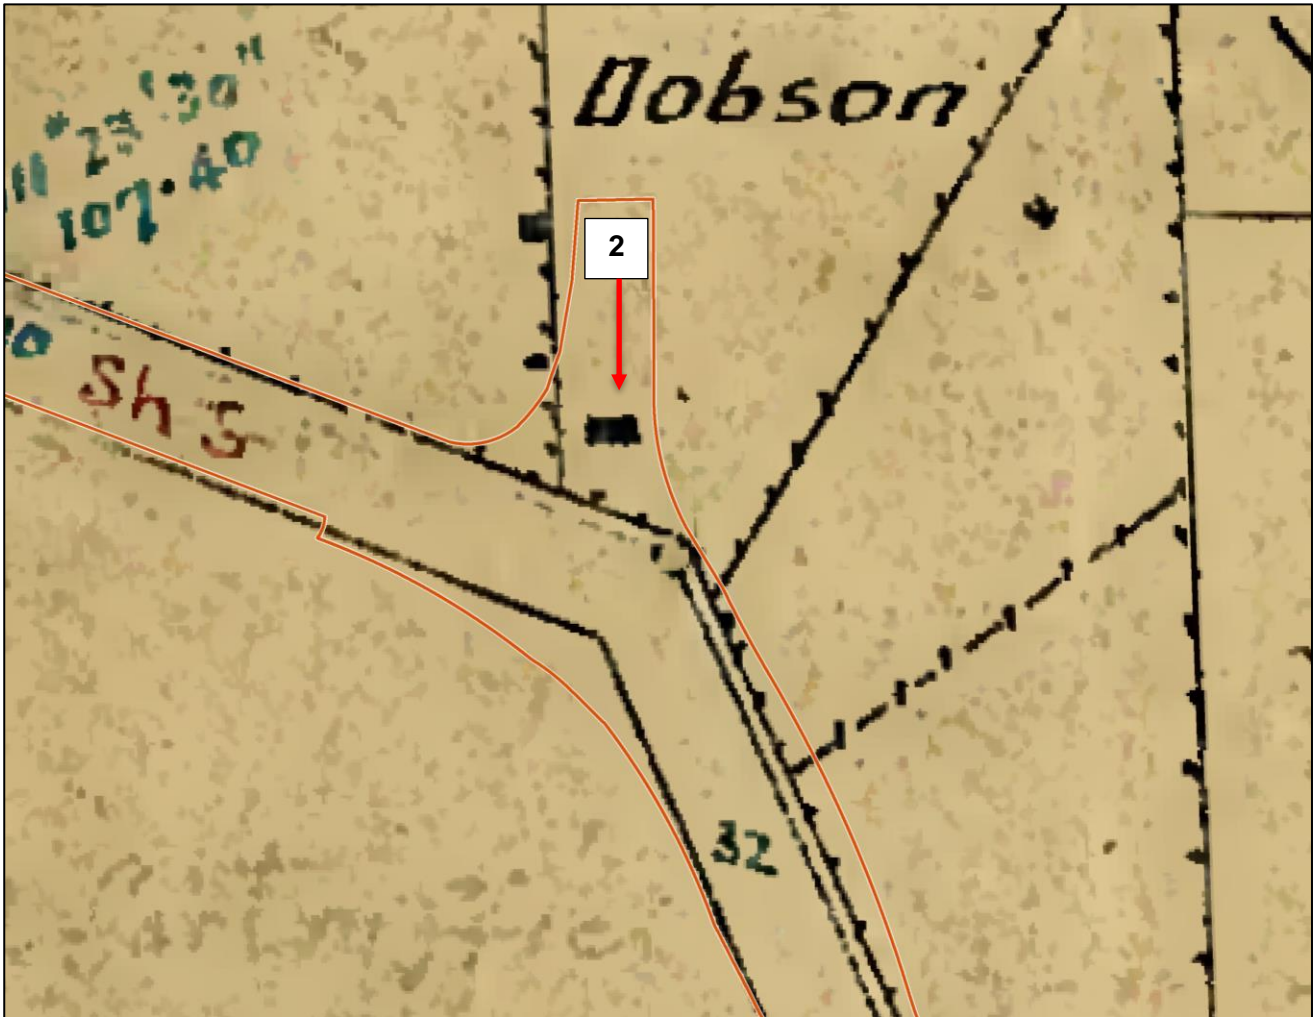
**Figure 10** Detail from an 1888-1889 survey for the roads within the parishes of Gordon and South Colah, showing a structure [2] recorded within the current alignment of Redleaf Avenue (Source: NSW Land Registry Services, Crown plan R3824.1603)

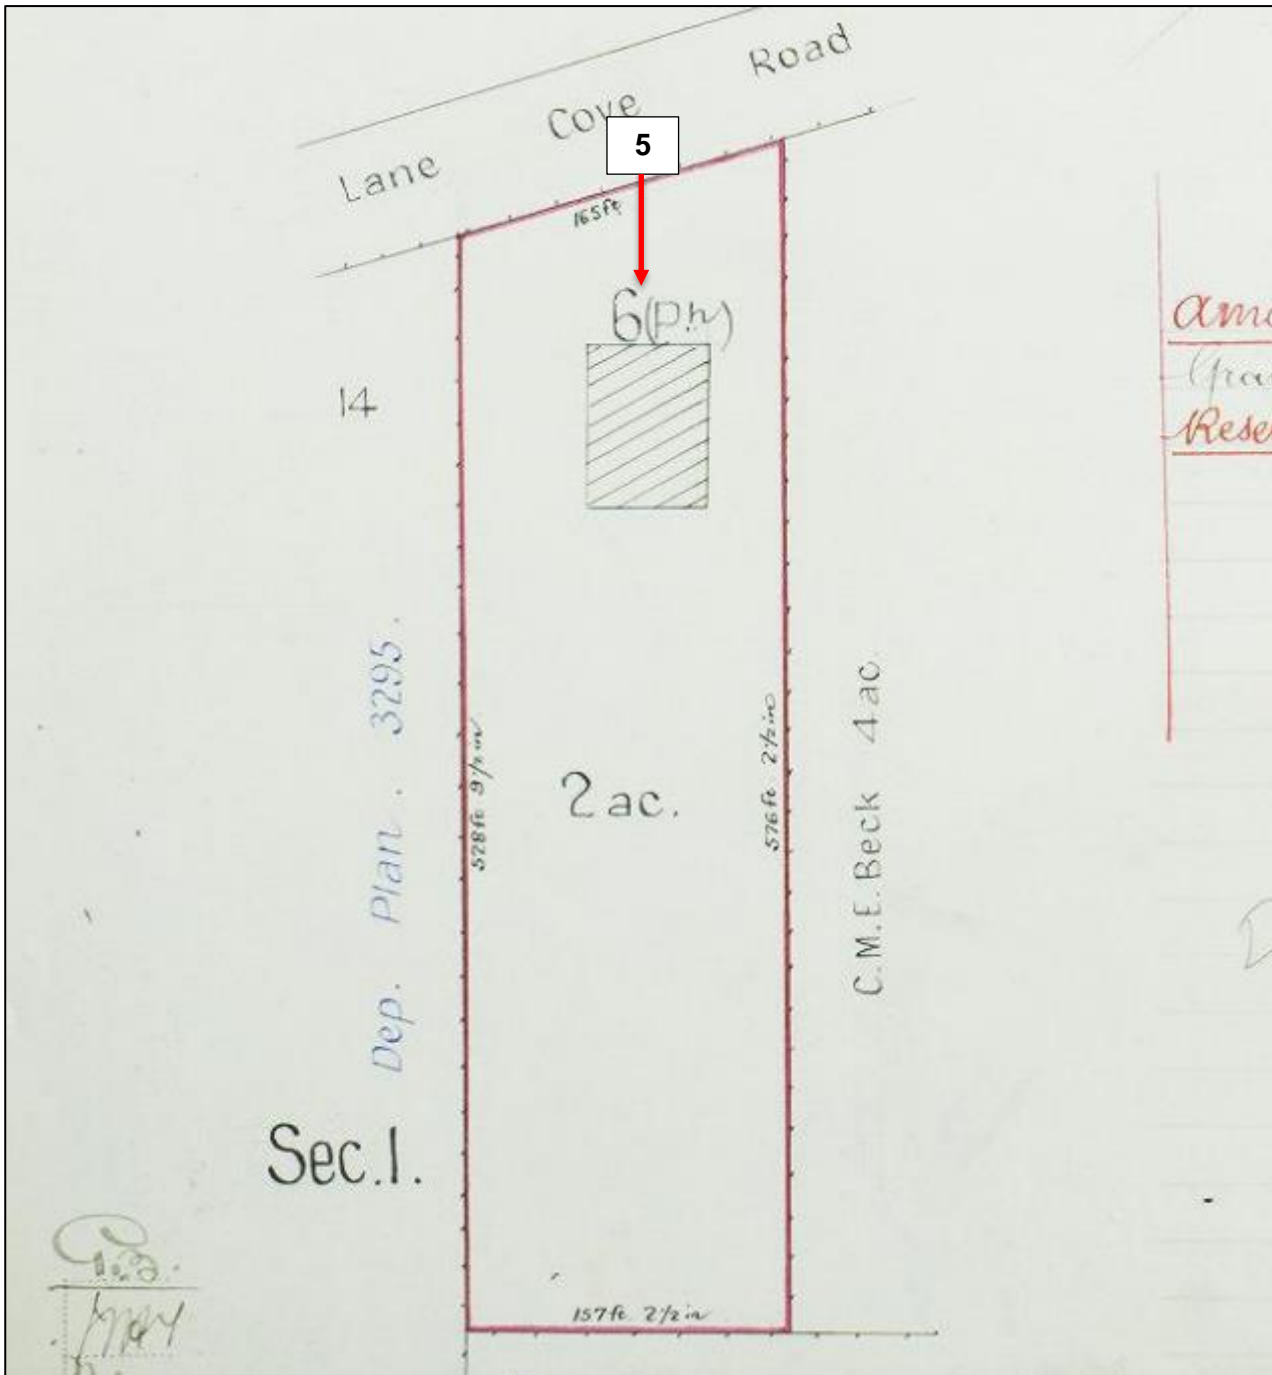
**Figure 13 A Certificate of Title plan dating to 1893 records a structure [5] in the vicinity of Lane Cove Road (Source: NSW Land Registry Services, Certificate of Title Volume 1470 Folio 116)**

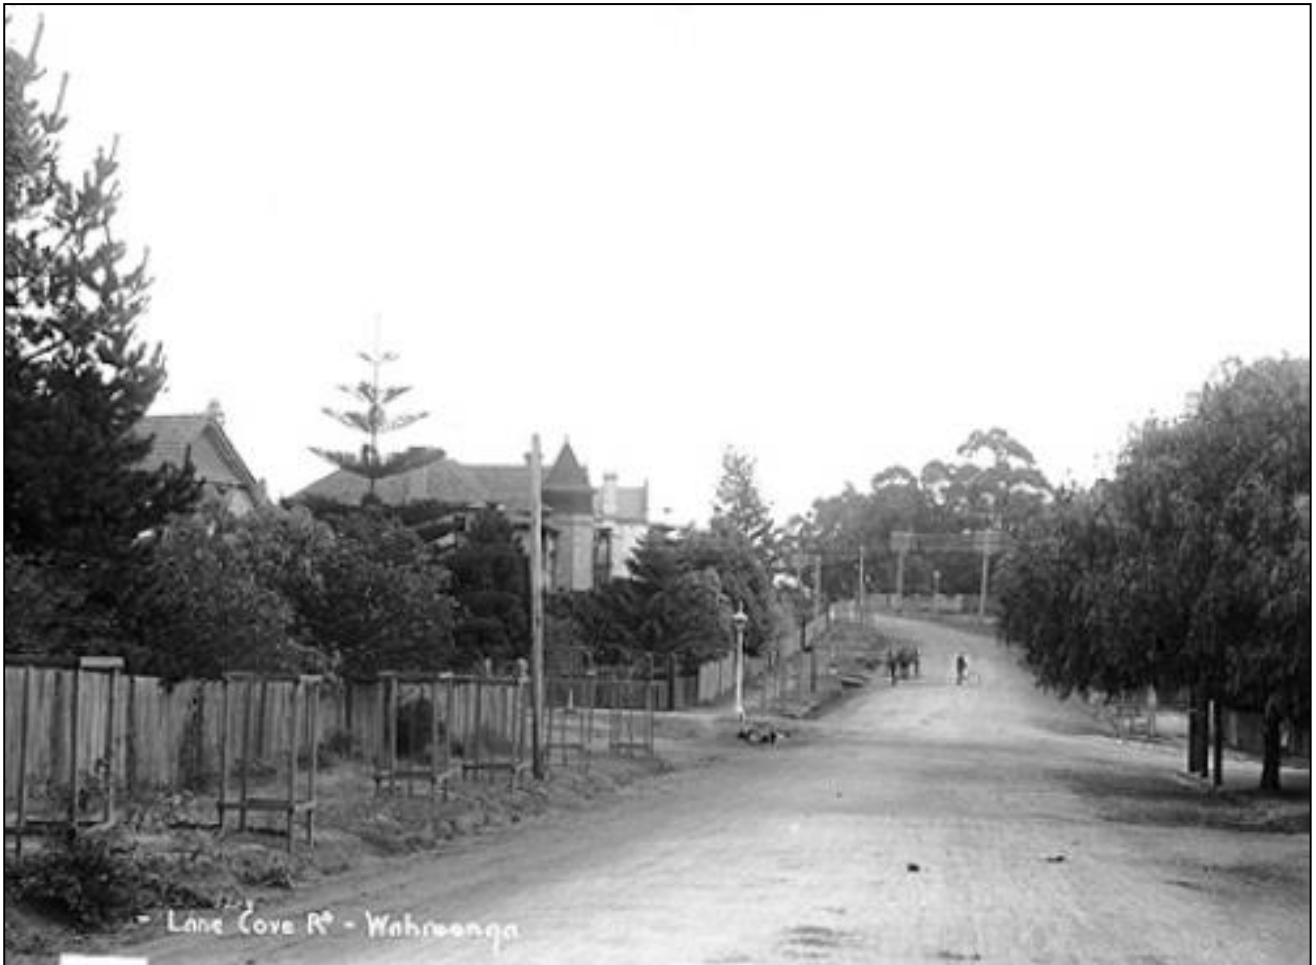
**Plate 1 Typical view of Lane Cove Road through Wahroonga, Warrawee and Turramurra, 1908 (Source: NSW State Archives)**

A series of photographs taken in 1908 show the condition of Lane Cove Road in Wahroonga, Turramurra and Warrawee. The road appears to be a dirt surface at this time, with some possible instances of kerbing but also soft verges. Kerbside plantings are also present, as are electricity poles and wires, and street lamps (Plate 1).

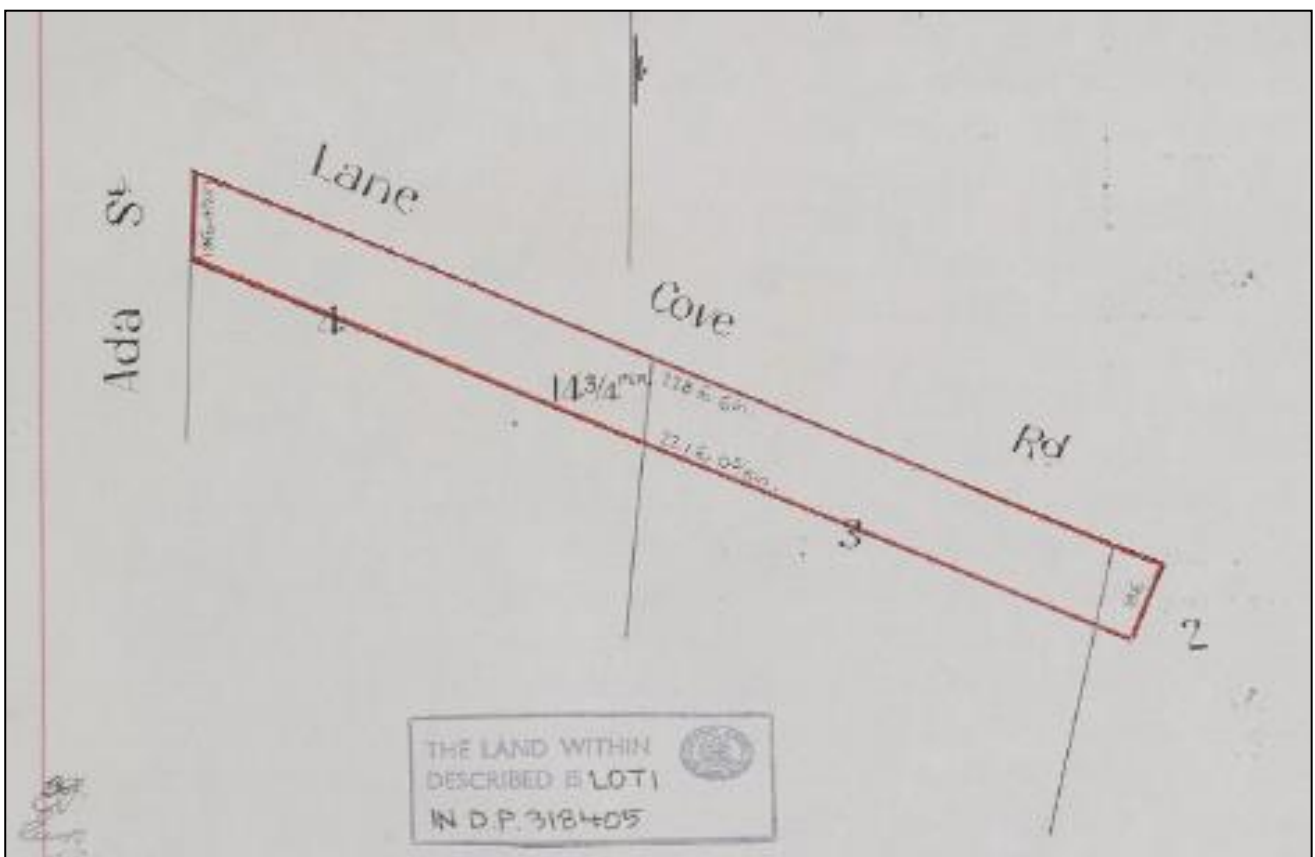
**Figure 20 Plan of area resumed in 1928-1929 from Estha [15] for the widening of Lane Cove Road for the Pacific Highway (Source: NSW Land Registry Services, Certificate of Title Volume 4062 Folio 192)**

period 1901-1920 (Figure 20). In 1938, land was acquired by the Commissioner of Roads from the Hillview property. Several other resumptions were also made for non-heritage properties, including within the current 1666-1670 Pacific Highway Wahroonga in 1929 (Figure 21). As a result of proposed resumptions to Hillview, the front stone wall [16] was disassembled in 1936 and reconstructed closer to the house itself. The position of the new wall can be seen on a 1955 subdivision plan which also shows the Hillview Garages [14], noted as being of brick construction. The plan does not record the three structures [9] [10] [11] which were present on the 1913 Certificate of Title, suggesting they had been demolished prior to 1955 (Figure 23).

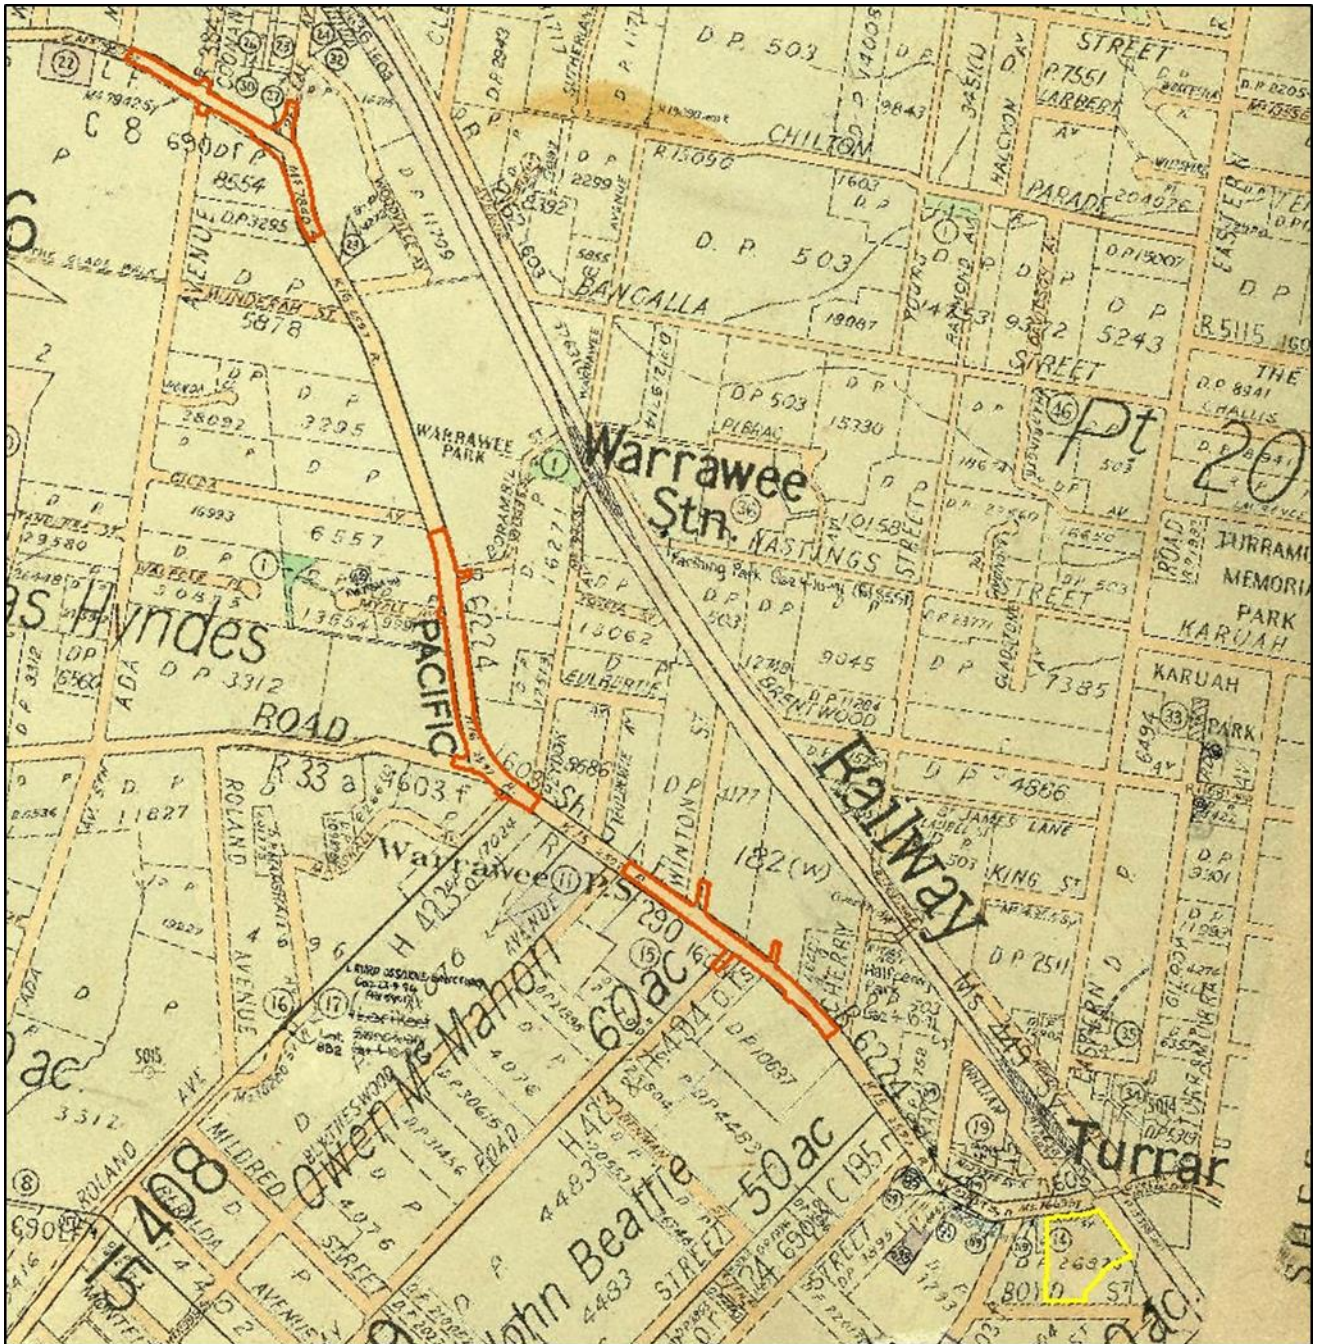
**Figure 28 Extract from a 1966 map of Gordon Parish, with the proposal area highlighted (Source: NSW Land Registry Services)**

Further changes were made to the alignment of the Pacific Highway in the mid-1960s. A regional charting map for the parish of Gordon dating to 1966 provides an indication of some of the road resumptions which have taken place within and adjacent to the northern part of the proposal area in Warrawee (Figure 28).

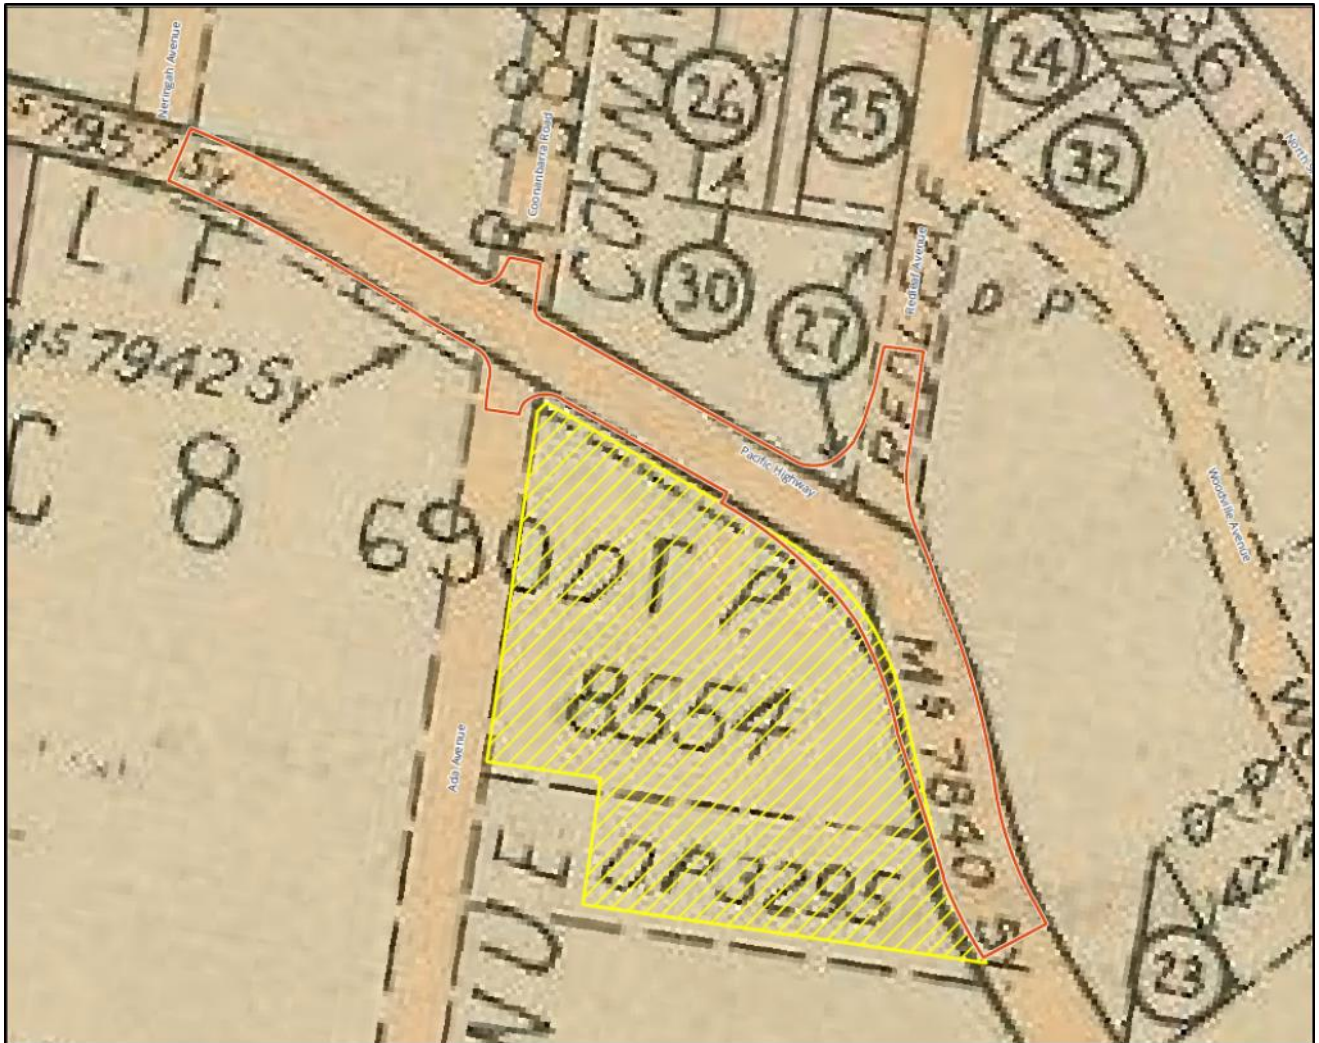
**Figure 29** Detail from a 1966 map of Gordon Parish, showing areas of road resumptions from the Estha [15] property (Source: NSW Land Registry Services)

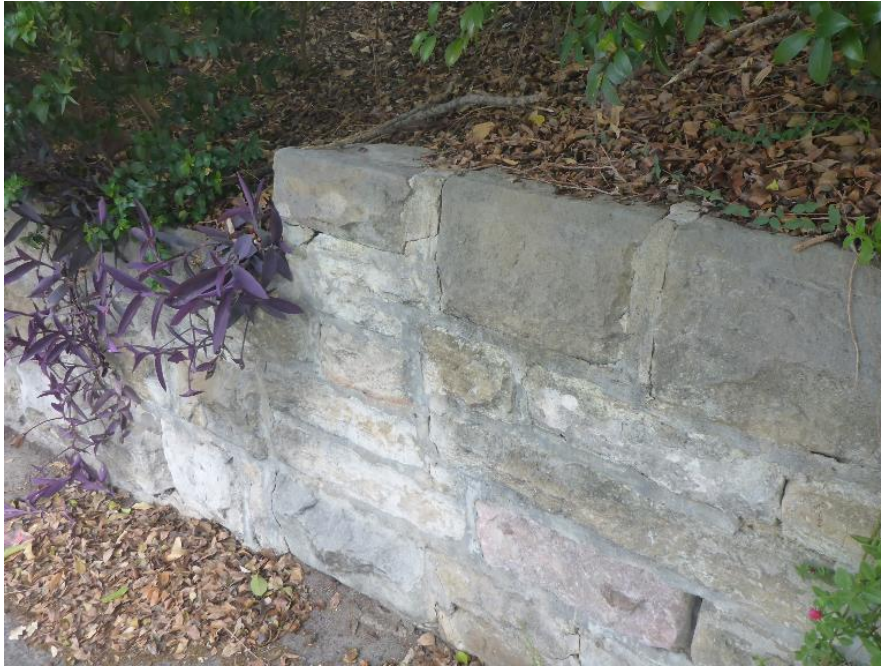
**Plate 8** Detail of stone boundary wall [24] to Estha [15]

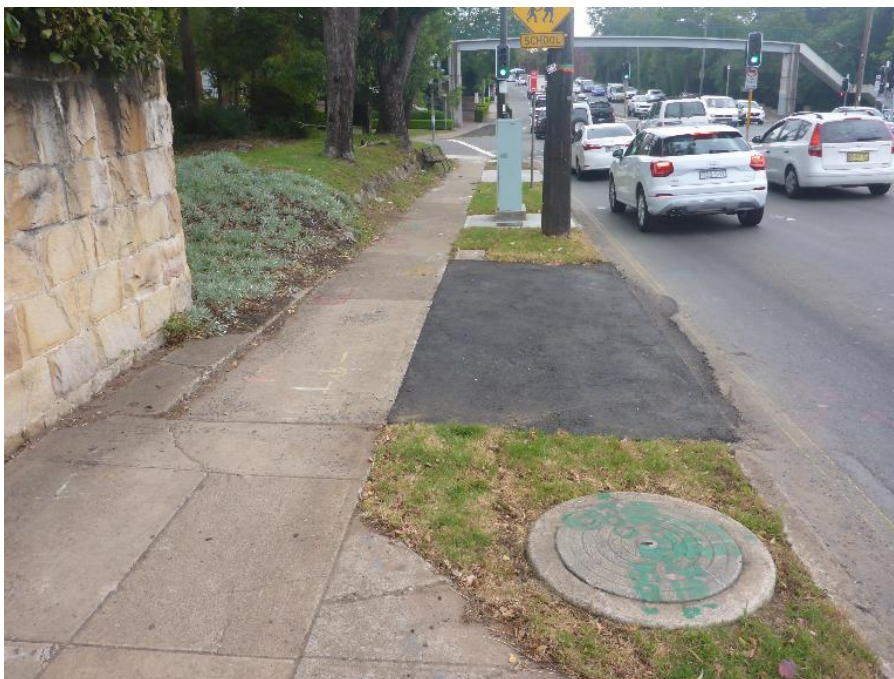
**Plate 9** Evidence of sub-surface works within the road reserve in the vicinity of the stone boundary wall of Estha [15], facing north-west

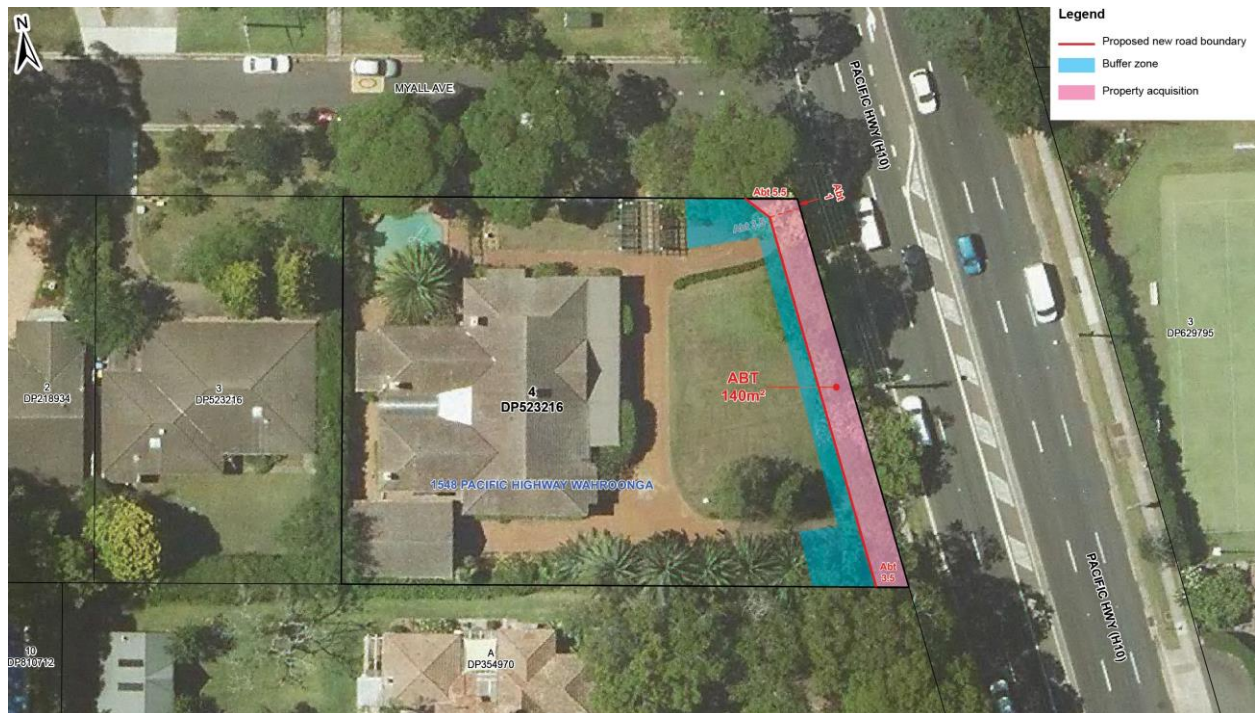
**Figure 31 Area of Kyeamba site impacted by the proposed works for Pacific Highway at Fox Valley Road, Wahroonga/Warrawee**

- The proposed land acquisition totals 140 m<sup>2</sup> on the eastern boundary
- An additional northbound lane and pedestrian path construction would impact the sandstone wall and the planting. The road widening and land acquisition is 140 m<sup>2</sup> with excavation up to 5.5m along the eastern boundary.
- The removal of the retaining wall, including the timber arbor and the trees and vegetation, would open up views directly to the Pacific Highway and remove all screening between the house and the road corridor.
- The remaining garden and driveway directly behind the proposed acquisition zone forms a buffer to the proposed works and will need to accommodate new retaining wall, shrubs and vegetation. The nature and extent of reinstatement of these works will need to be discussed with the owners and RMS.

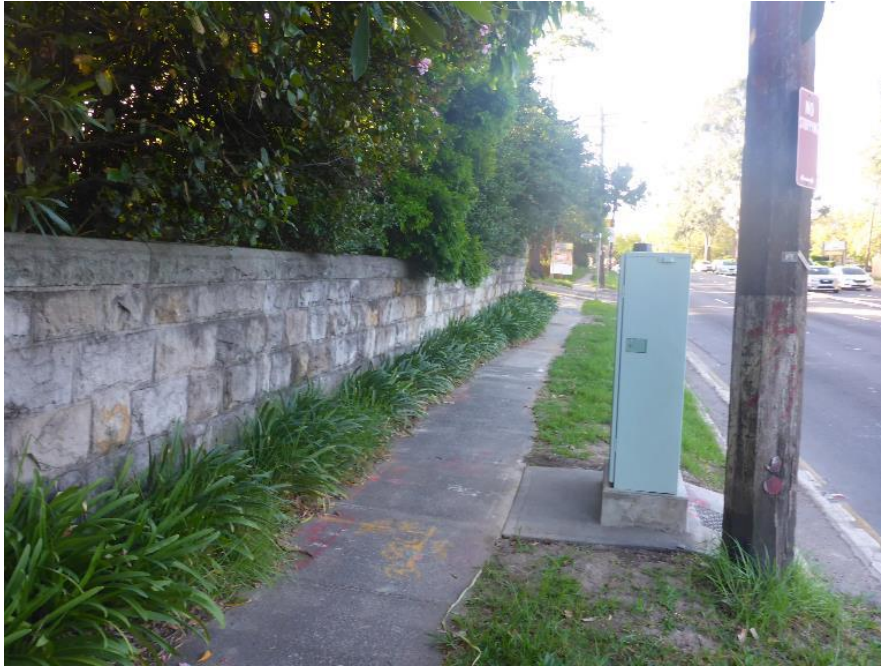
**Plate 10** View of stone boundary wall of heritage listed Kyeamba dwelling [17] adjacent to Yaamba [29] and road reserve area with evidence of sub-surface infrastructure works, facing north-west

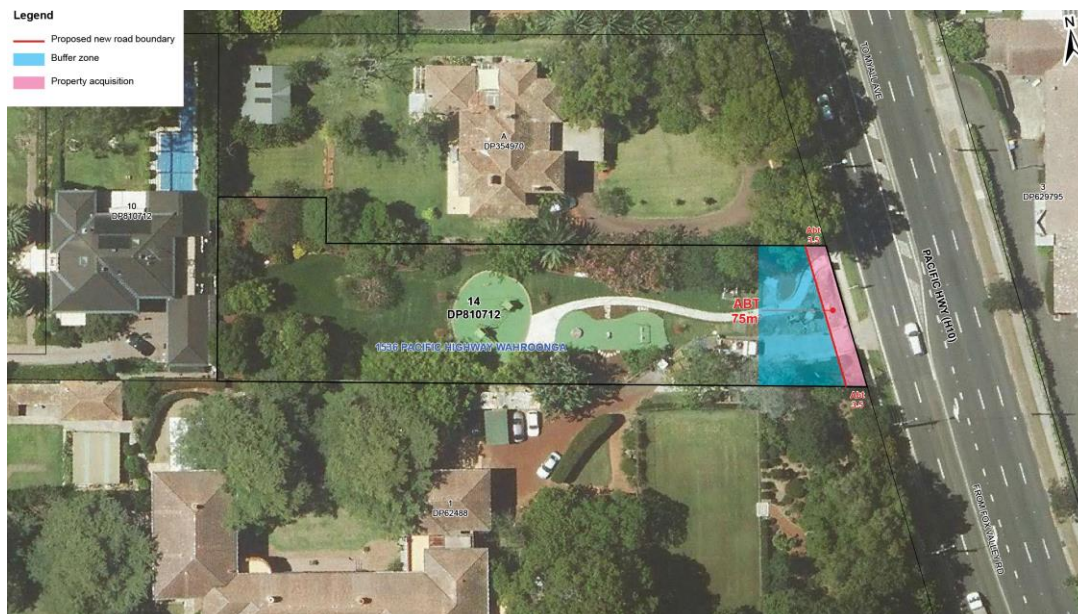
**Figure 33 Area of Curtilage Park site impacted by the proposed works for Pacific Highway at Fox Valley Road, Wahroonga/Warrabee**

- The proposed land acquisition is 75 sqm<sup>2</sup> on the eastern boundary
- The extent of encroachment is about 3.5m into the boundary with the Pacific Highway.
- The impact of construction is the removal and relocation of the eastern boundary brick retaining wall (and associated ramp structure) as well as the removal of a garden bed with a range of shrub and ground cover plantings. The planting bed and ramp would require rebuilding and the plants either transplanted or replanted.

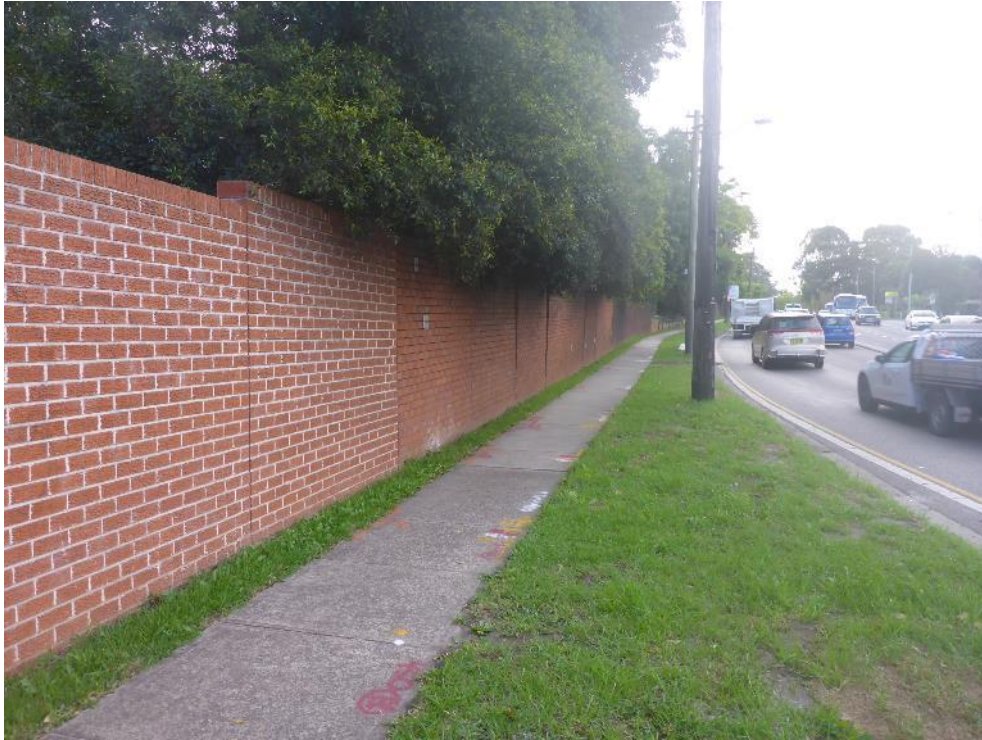
**Plate 19** Brick boundary wall of Mahratta [12] and adjacent road reserve, facing north-west

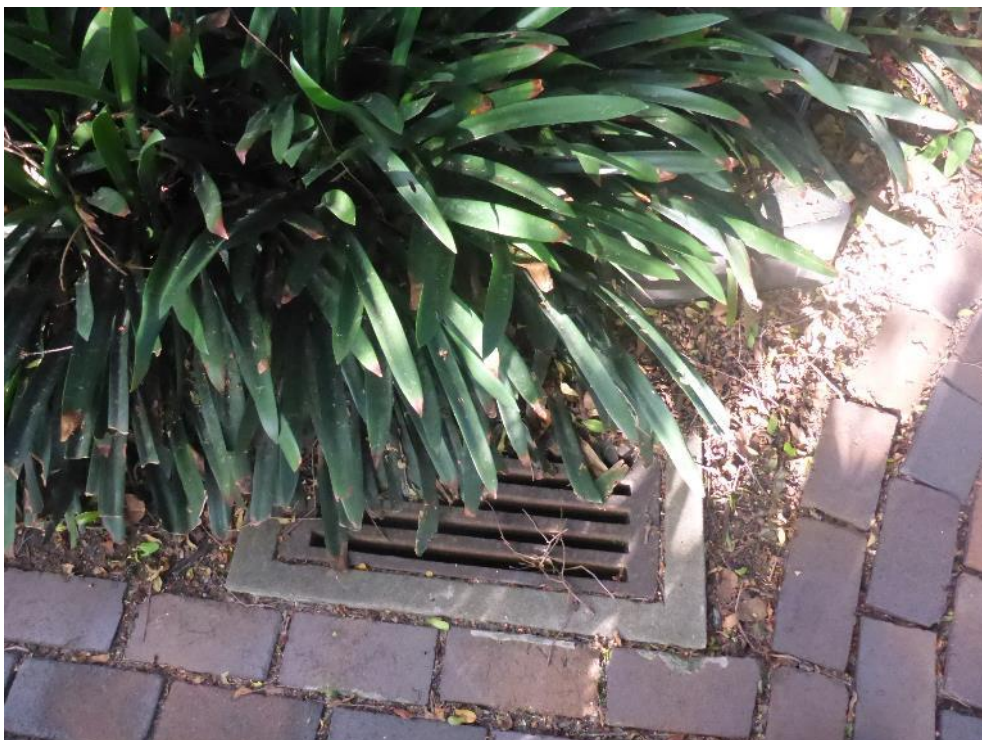
**Plate 20** Evidence of sub-surface drainage infrastructure within the Mahratta [12] grounds

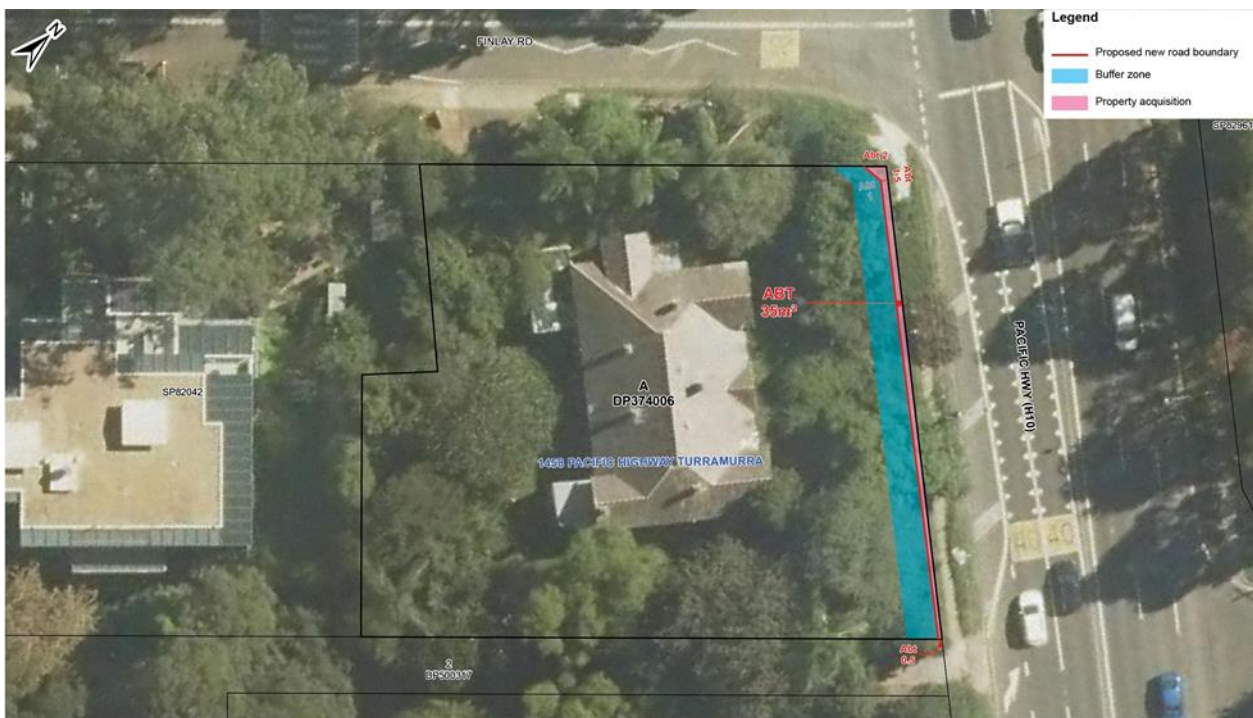
**Figure 35 Area of Dwelling House site impacted by the proposed works of Pacific Highway at Finlay Road, Warrawee/Turramurra**

- The proposed land acquisition totals 35m<sup>2</sup> along the eastern boundary.
- The site works would impact the site with construction of the new footpath and road carriageway resulting in an encroachment of 0.5m tapering to 2m.

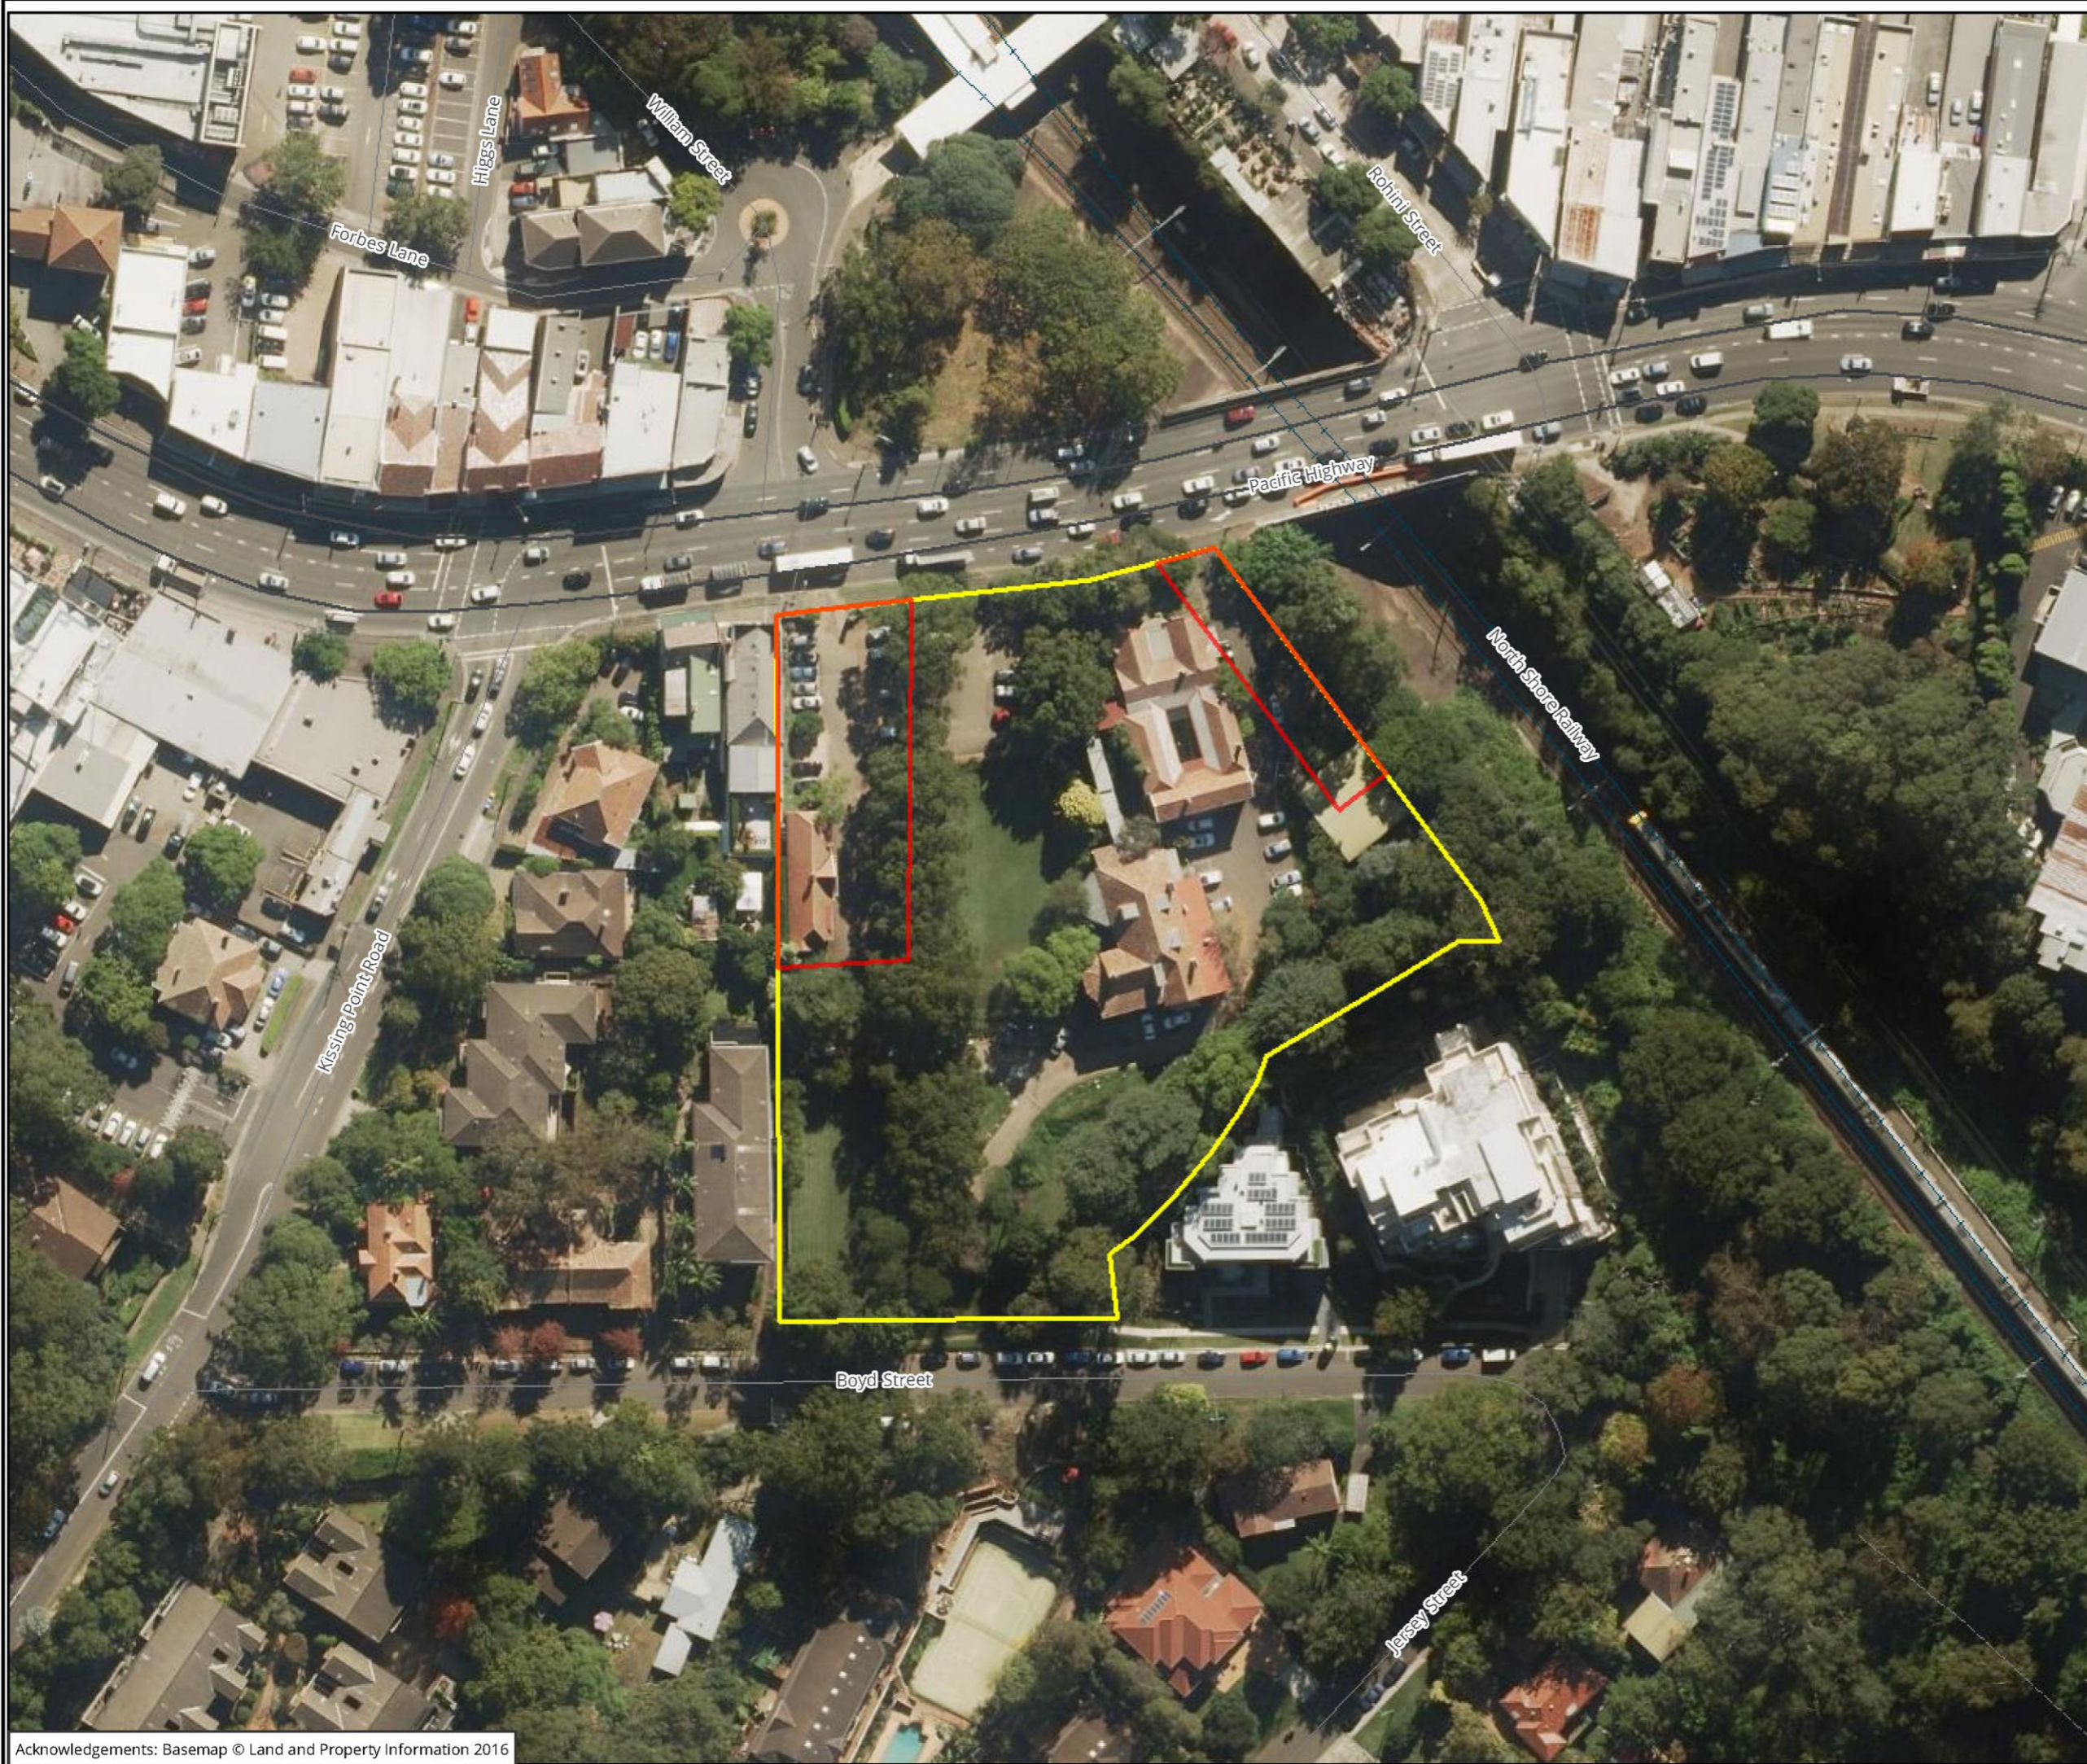
- Legend**
- Compound area
  - Areas where no ground disturbance or excavation is permitted without a s140 excavation permit

**Figure 38** Areas where no ground disturbance or excavation is permitted without a S140 excavation permit

Ground disturbance or excavation in areas of moderate archaeological potential would only be permitted with a s139 excavation exception or s140 excavation permit (as relevant) (see Figure 38). Should the temporary relocation and reinstatement of the northern boundary wall of the Hillview complex be required and also involve disturbance or excavation in the area of moderate archaeological potential, a s139 excavation exception or s140 excavation permit (as relevant) will be required to undertake these works. Depending on the scale of works, archaeological monitoring or excavation may be required to identify and assess the significance of any archaeological material encountered during these works.
