# Appendix H

## Non-Aboriginal Heritage Assessment (Local)

Pacific Highway Intersection Improvements in Wahroonga / Warrawee /  
Turrumurra  
Statement of Heritage Impact for Locally Significant Heritage Items within  
Ku-ring-gai Local Government Area

For Roads and Maritime Services

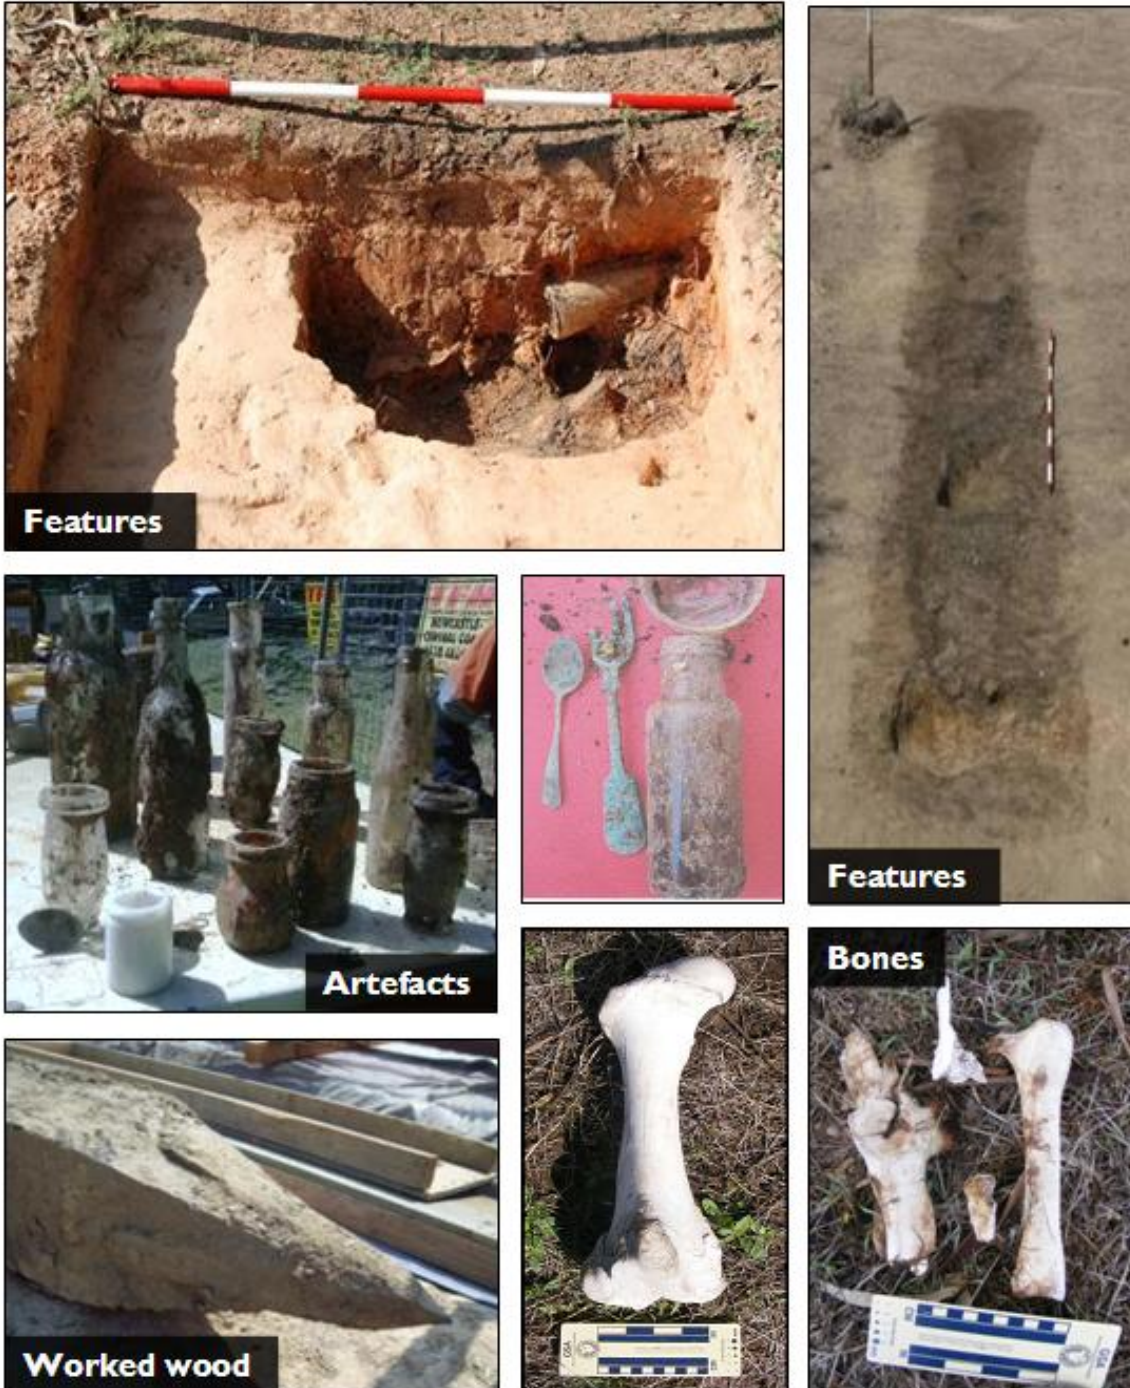
**Top left hand picture continuing clockwise:** Stock camp remnants (Hume Highway Bypass at Tarcutta); Linear archaeological feature with post holes (Hume Highway Duplication), Animal bones (Hume Highway Bypass at Woomargama); Cut wooden stake; Glass jars, bottles, spoon and fork recovered from refuse pit associated with a Newcastle Hotel (Pacific Highway, Adamstown Heights, Newcastle area).

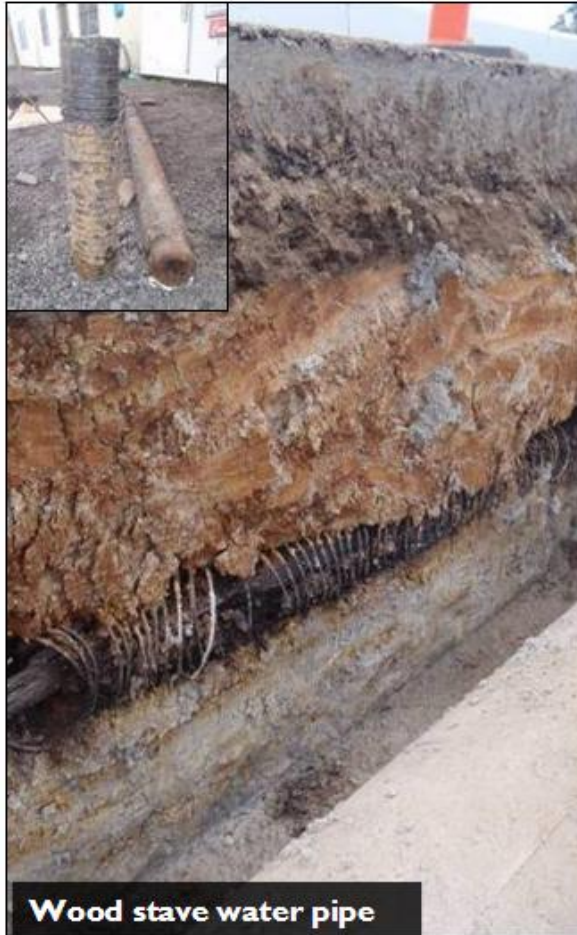
**Wood stave water pipe**

**Top left hand picture continuing clockwise:** Woodstave water pipe with tar and wire sealing (Horsley Drive); Tram tracks (Sydney); Brick lined cistern (Clyde); Retaining wall (Great Western Highway, Leura).

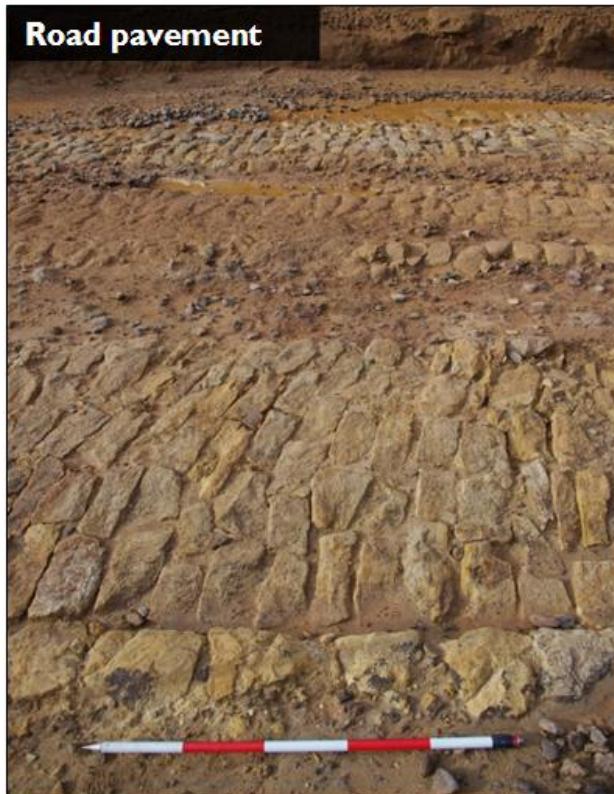
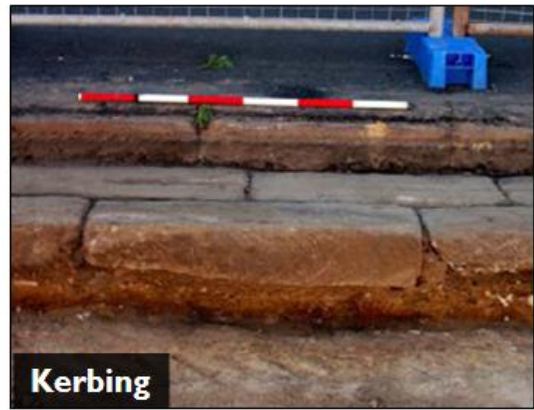
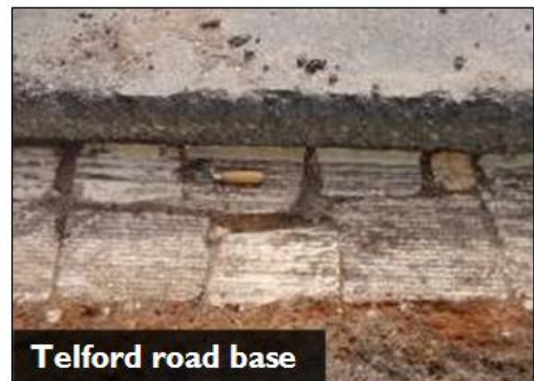
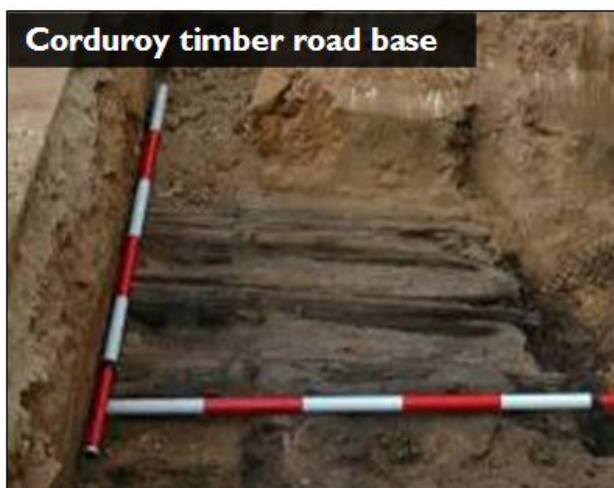
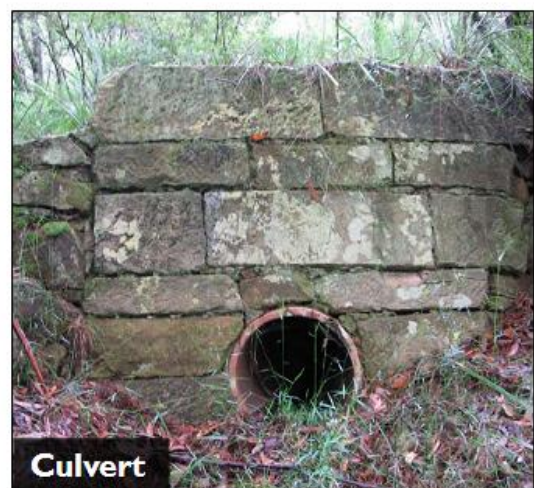
**Top left hand picture continuing clockwise:** Road pavement (Great Western Highway, Lawson); Sandstone kerbing and guttering (Parramatta Road, Mays Hill); Telford road (sandstone road base, Great Western Highway, Leura); Ceramic conduit and sandstone culvert headwall (Blue Mountains, NSW); Corduroy road (timber road base, Entrance Road, Wamberai).

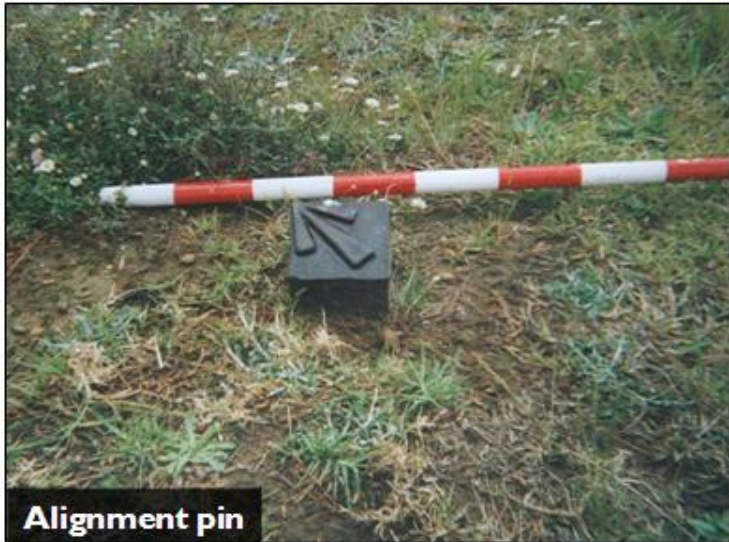
**Alignment pin**

**Top left hand corner continuing clockwise:** Alignment Pin (Great Western Highway, Wentworth Falls); Survey tree (MR7, Albury); Survey tree (Kidman Way, Darlington Point, Murrumbidgee); Survey tree (Cobb Highway, Deniliquin); Milestone (Great Western Highway, Kingswood, Penrith); Alignment Stone (near Guntawong Road, Riverstone). Please note survey marks may have additional statutory protection under the *Surveying and Spatial Information Act 2002*.

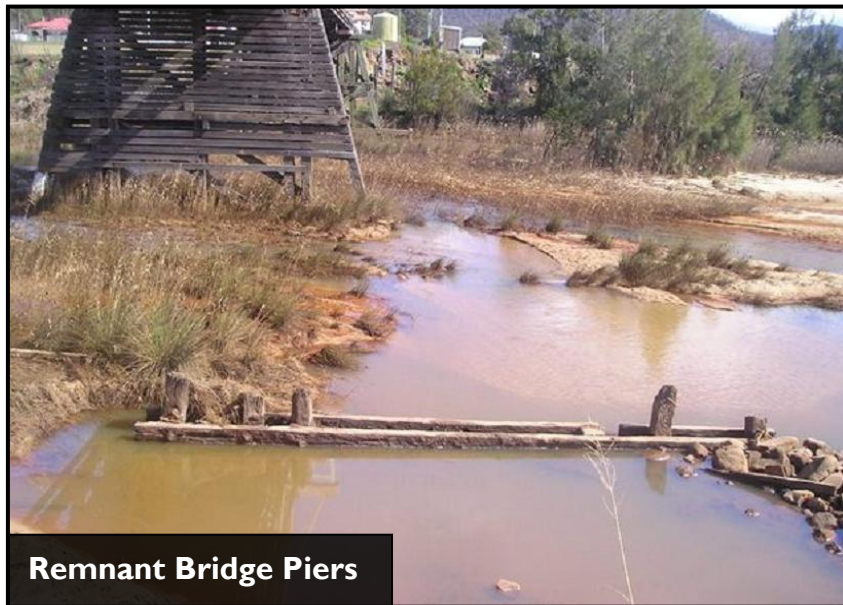
**Remnant Bridge Piers**

**Top left hand corner continuing clockwise:** Remnant bridge piers (Putty Road, Bulga); Wooden boundary fence (Campbelltown Road, Denham Court); Dairy shed (Ballina); Golden Arrow Mine Shaft.

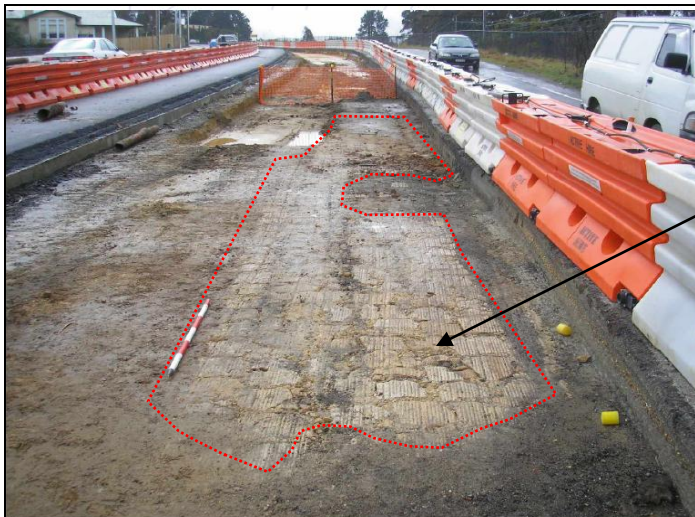
**Figure 1:** Telford road uncovered on the Great Western Highway (Leura) in 2008.

It is important to take a general photograph (Figure 1) to convey the location and setting of the item. This will add much value to the subsequent detailed photographs also required (Figure 2).

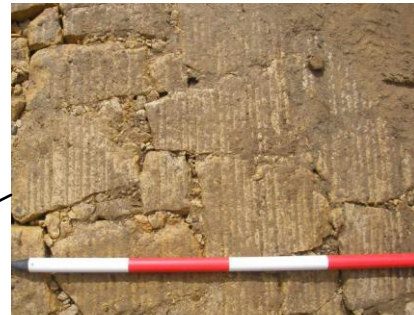
**Figure 2:** Close up detail of the sandstone surface showing material type, formation and construction detail. This is essential for establishing date of the feature.

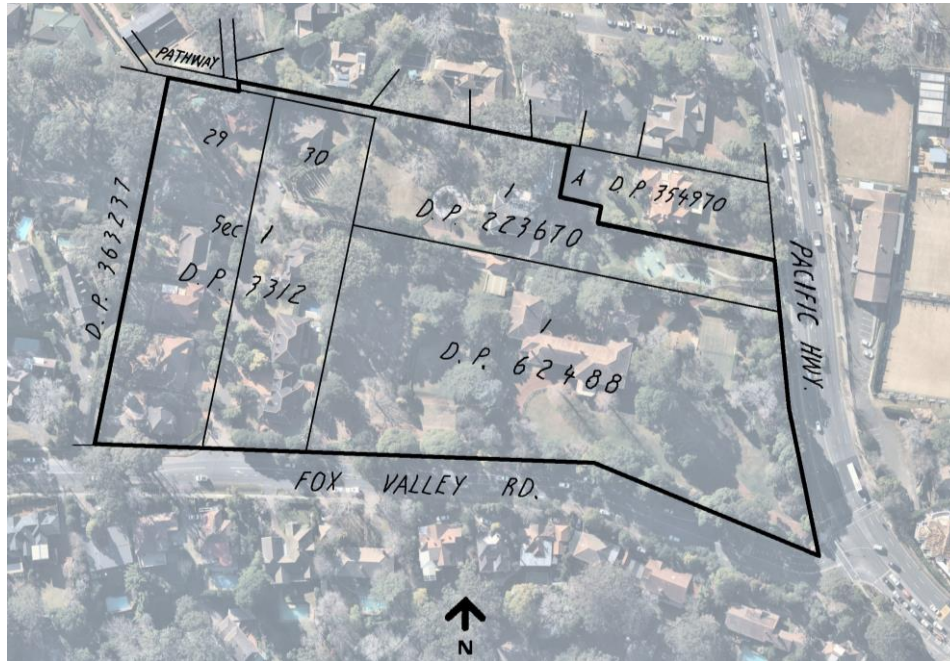
Figure 1 Outline of the Mahratta Heritage Site

The heritage item ('Mahratta') curtilage covers an area of approximately 3.52 hectares, comprising of the Mahratta site at 1526 Pacific Highway, Curtilage Park at 1540 Pacific Highway and all properties (1-13) on Field Place (refer Figure 1).

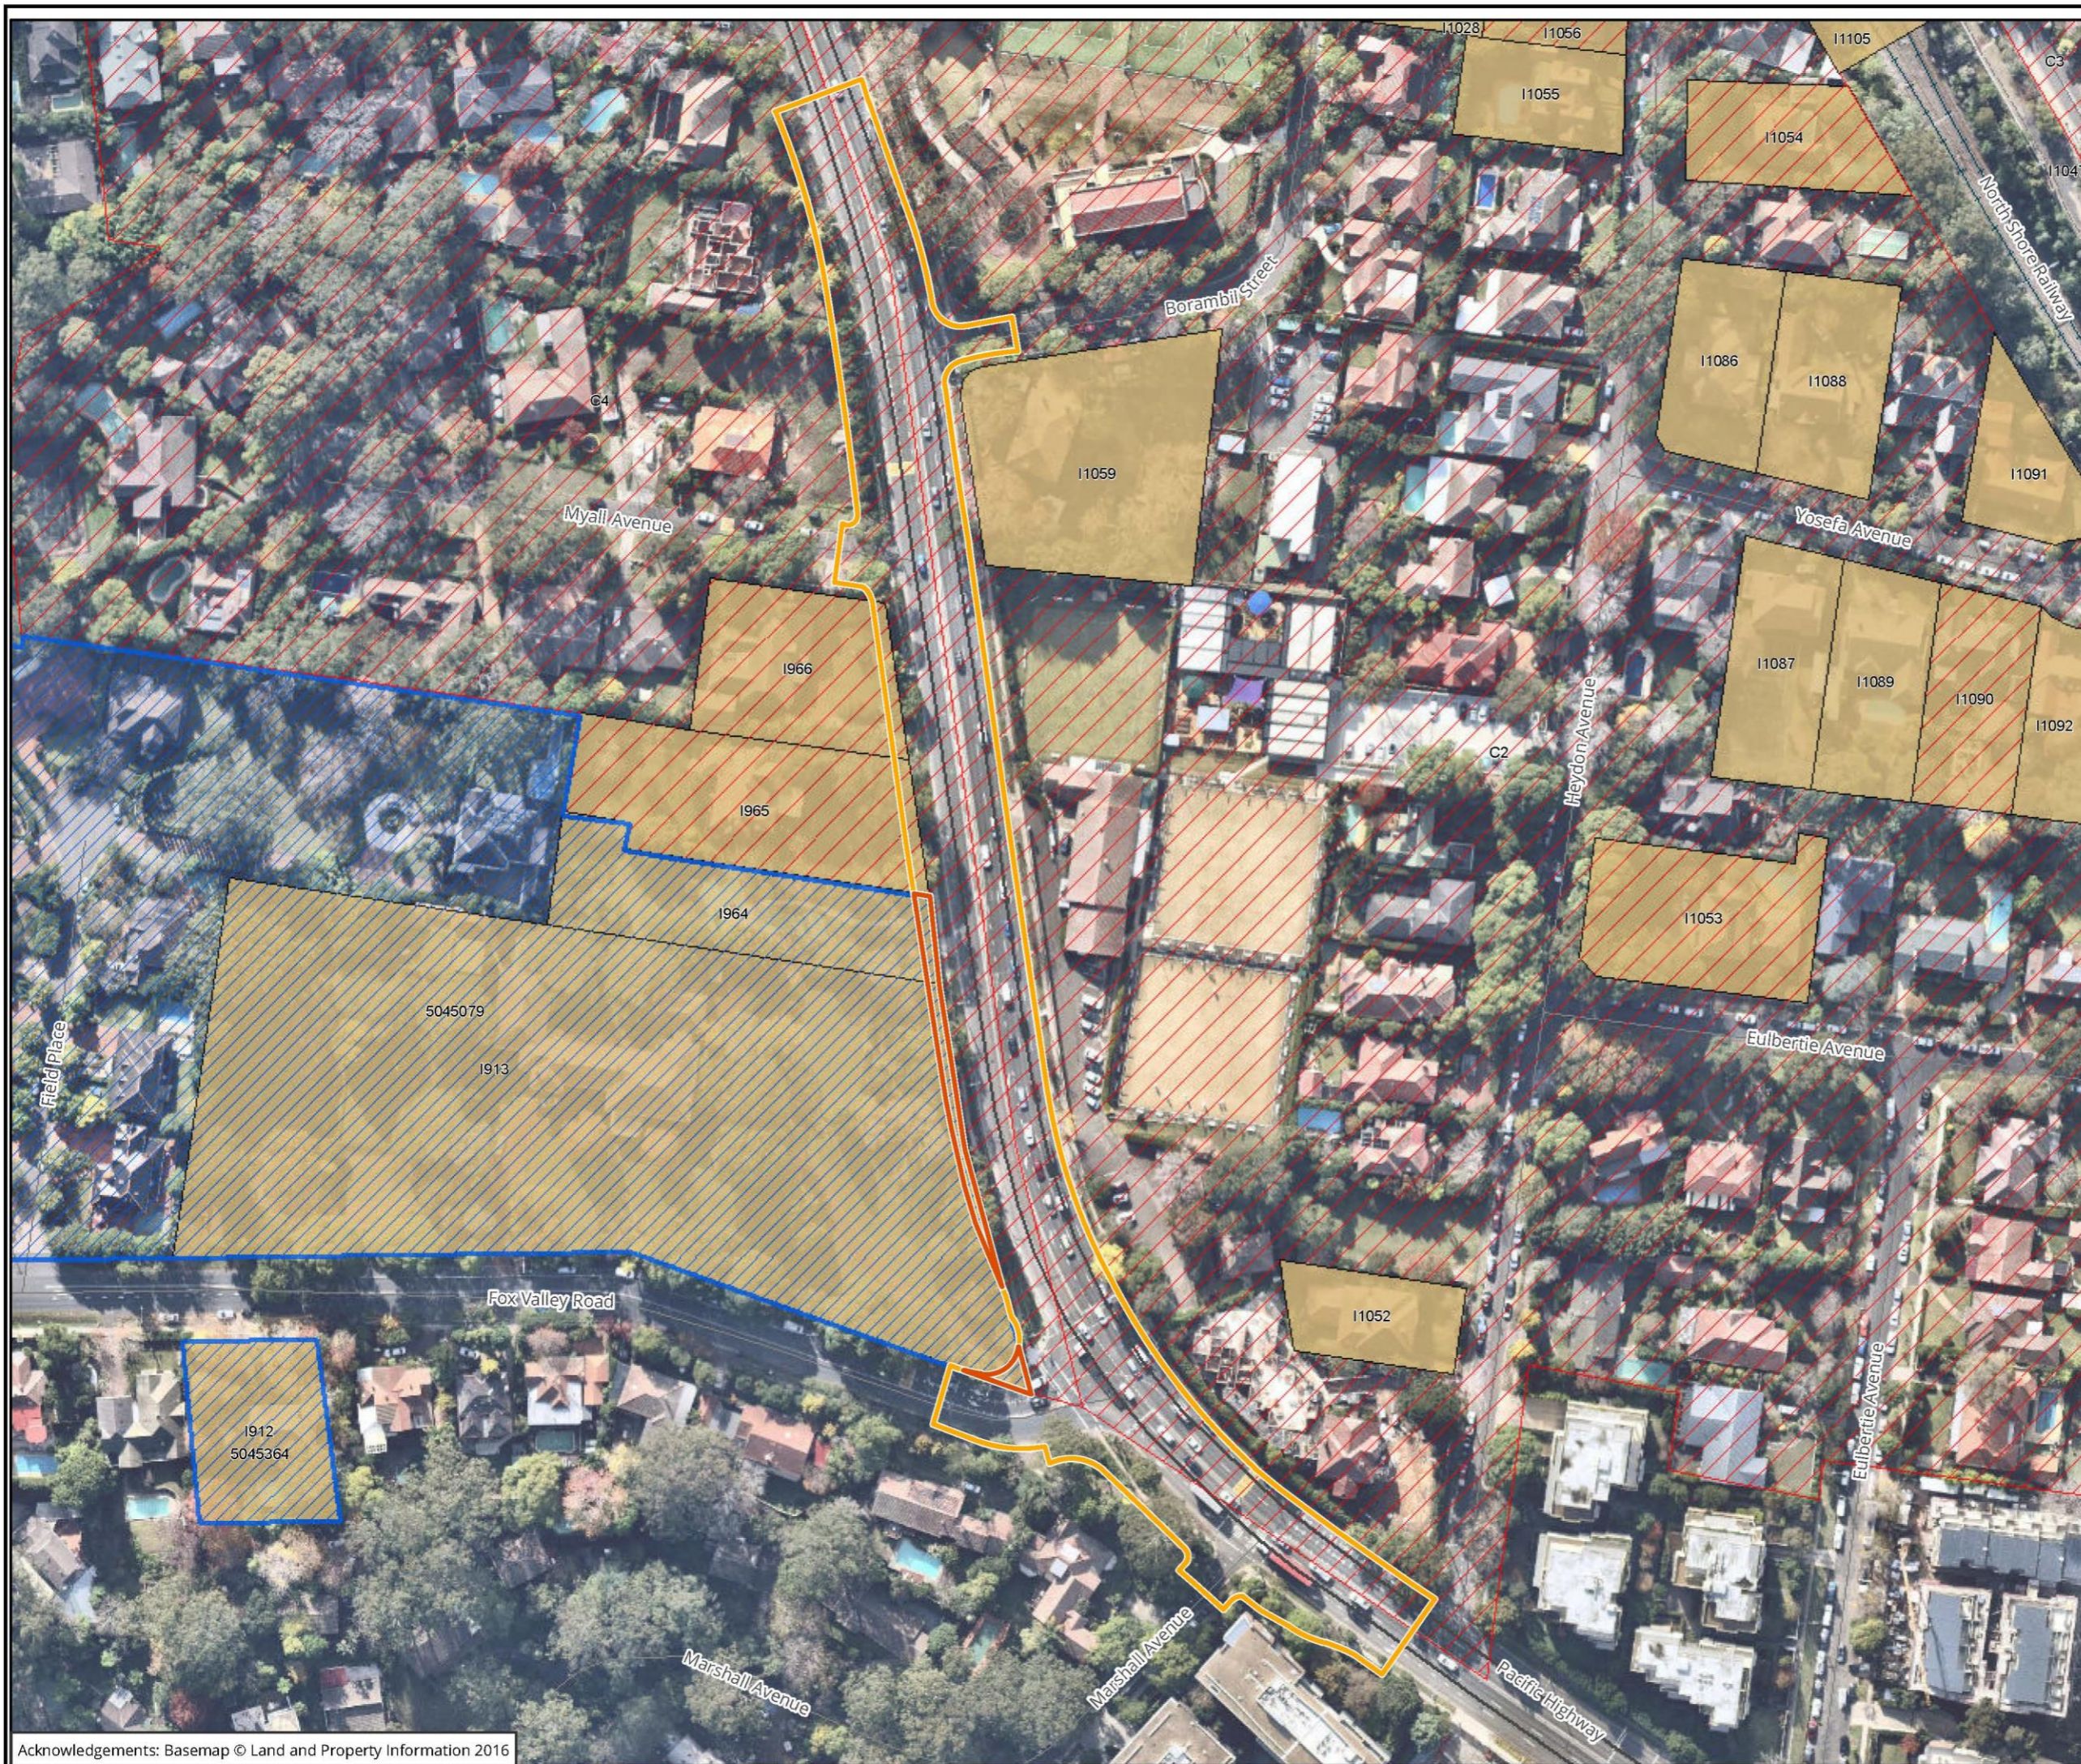
**Figure 5** Location of the heritage items within the proposal location and in the vicinity

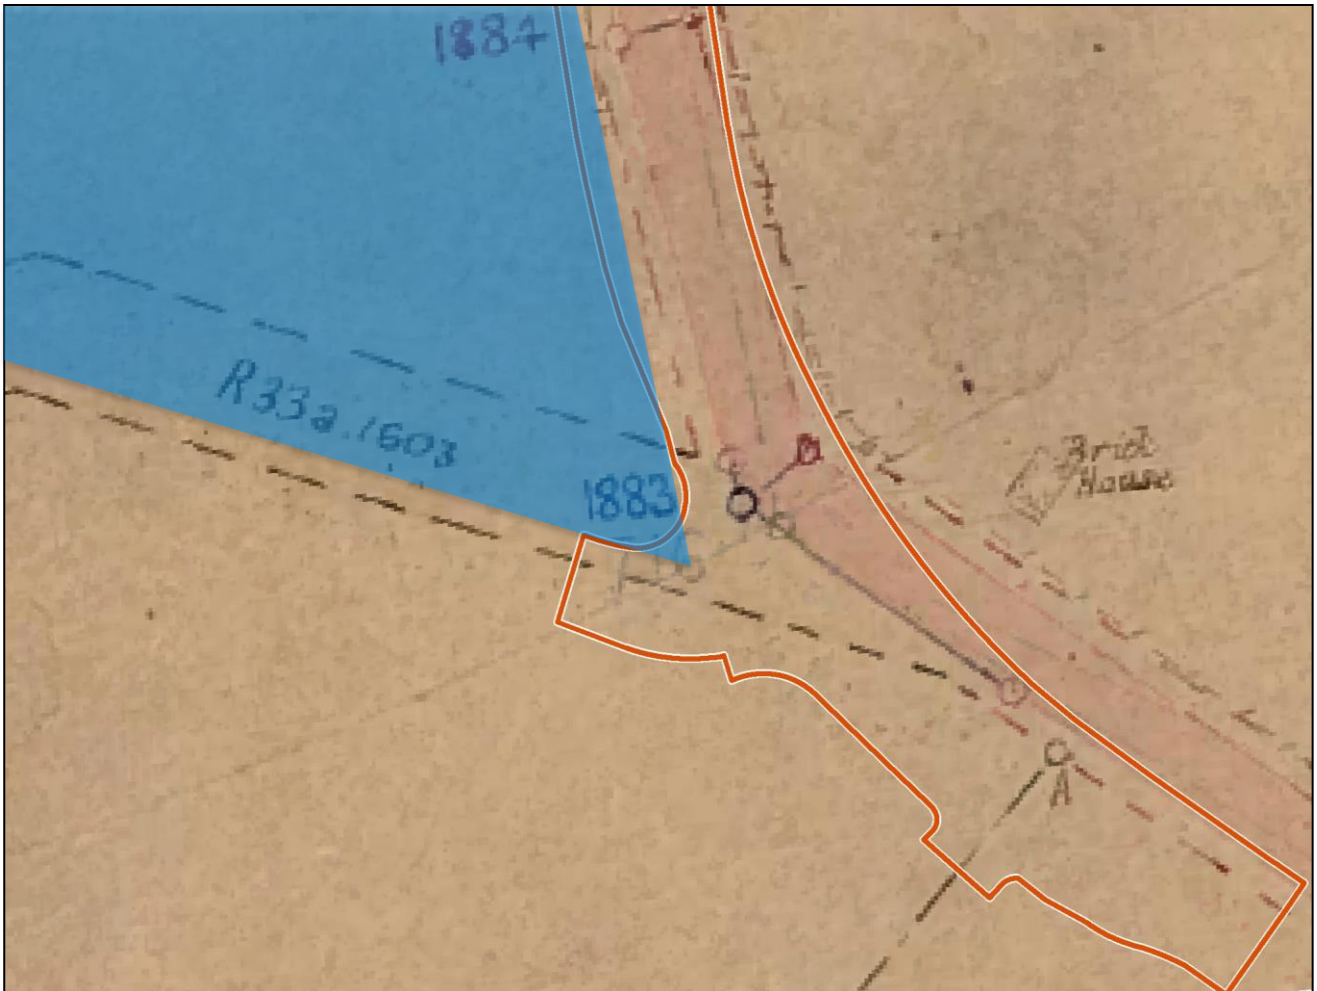
**Figure 8** Detail from an 1881/1899 survey for the Lane Cove Road, showing a brick house opposite Fox Valley Road (Source: NSW Department of Lands, Crown plan R6224.1603)

An 1881 Crown plan for the Lane Cove Road revised in 1899, records several structures of brick and weatherboard in the vicinity of the study area, while fence lines are also present (Figure 8).

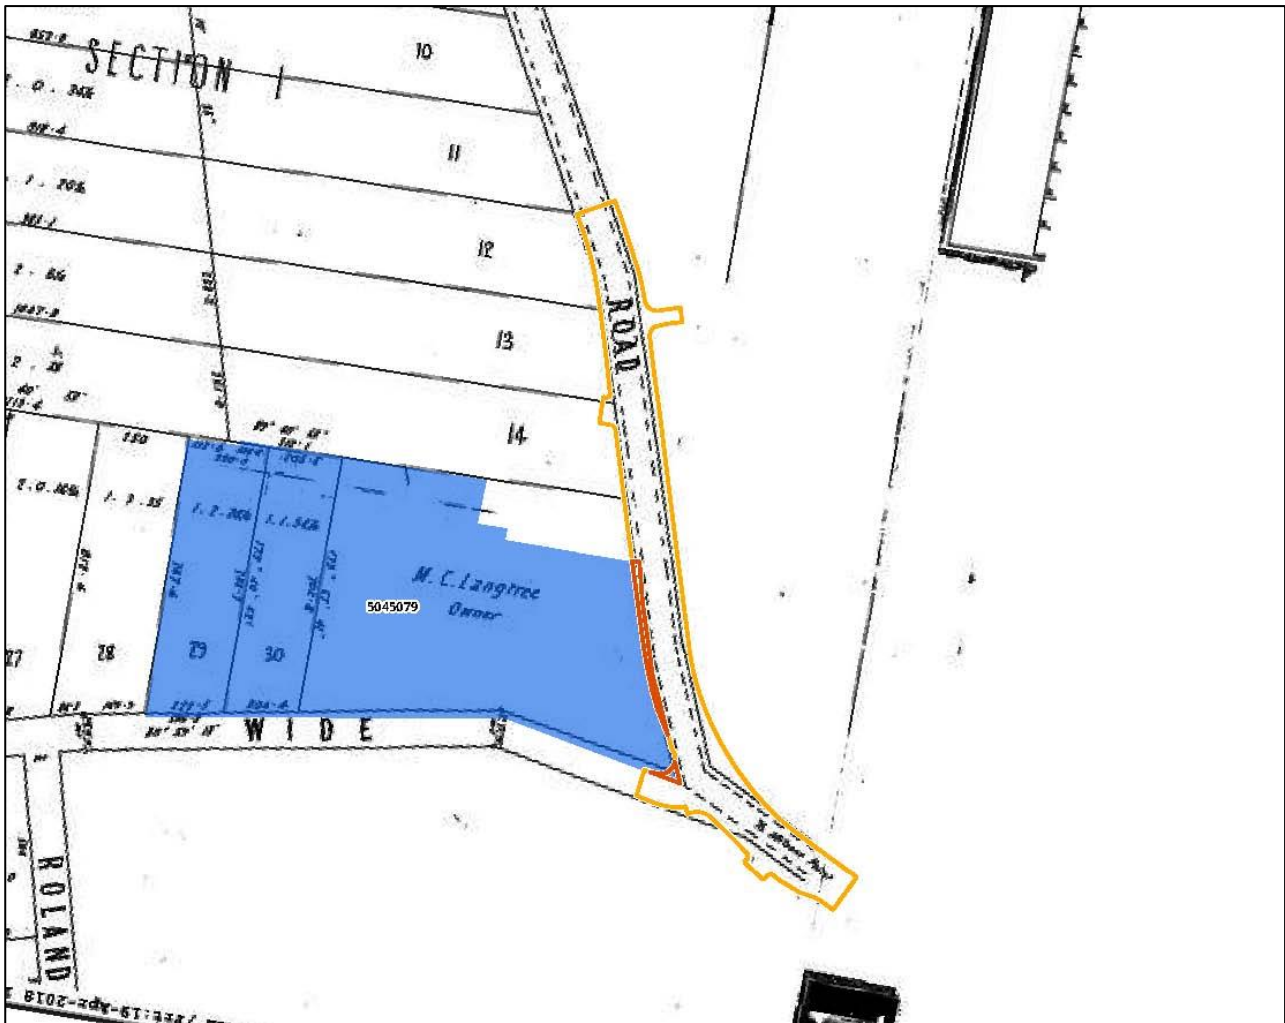
**Figure 10 Extract from an 1893 subdivision plan of Hyndes' grant south of Lane Cove Road, with the proposal area highlighted (Source: NSW Department of Lands, DP 3312)**

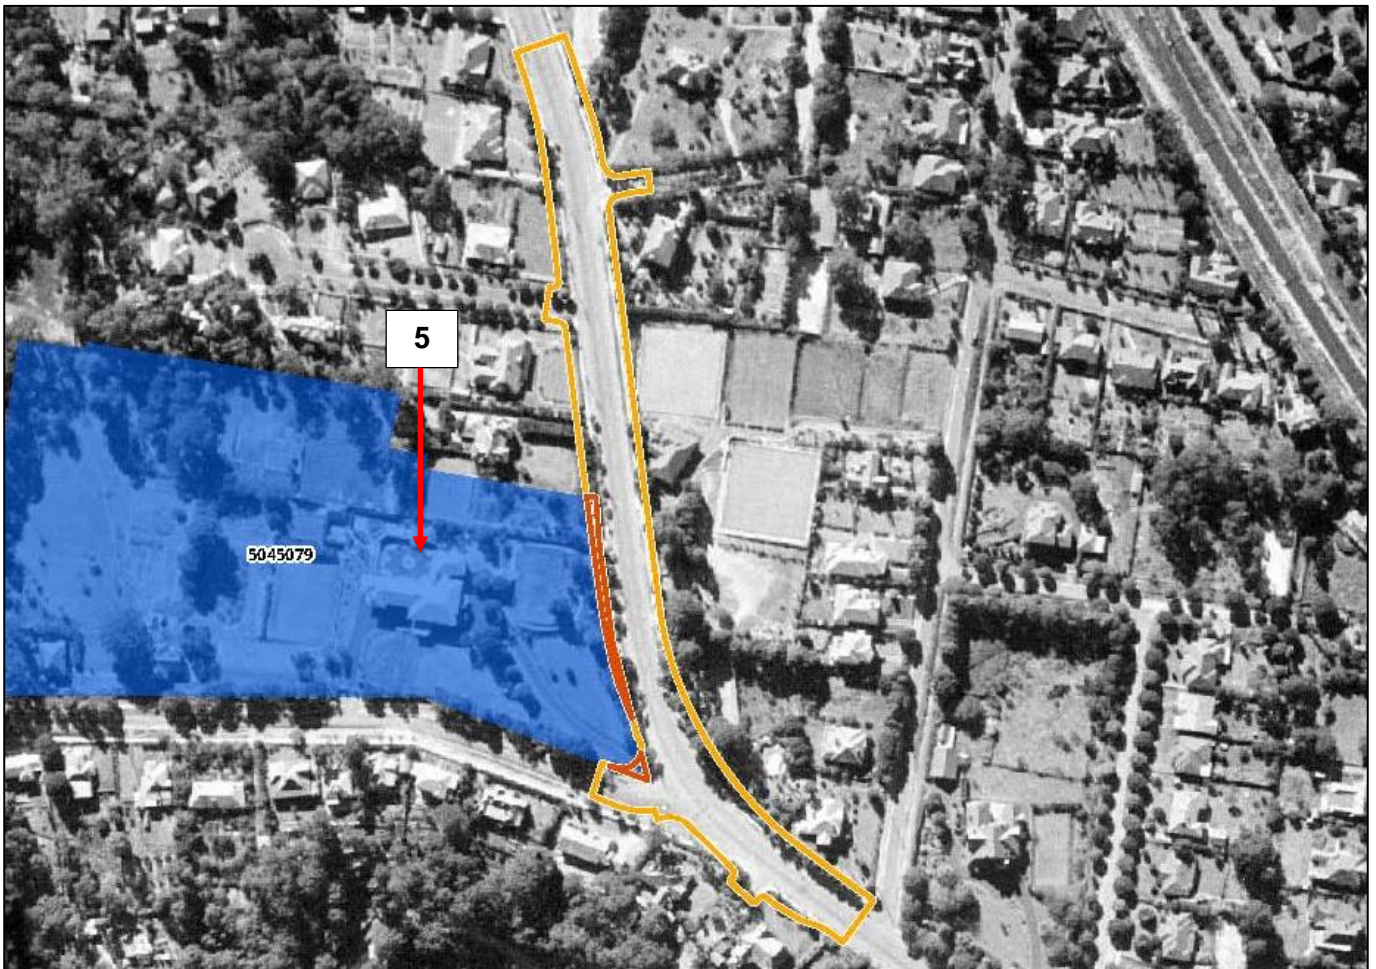
**Plate 2** Detail from a 1943 aerial photograph of the second part of the proposal area, featuring the Mahratta [5] property (Source: SIX Maps)

Agnew worked with Sorensen on additional planting design and visited his nursery in the Blue Mountains<sup>33</sup>. The property as it appeared in 1943 can be seen in Plate 2 and Plate 3.

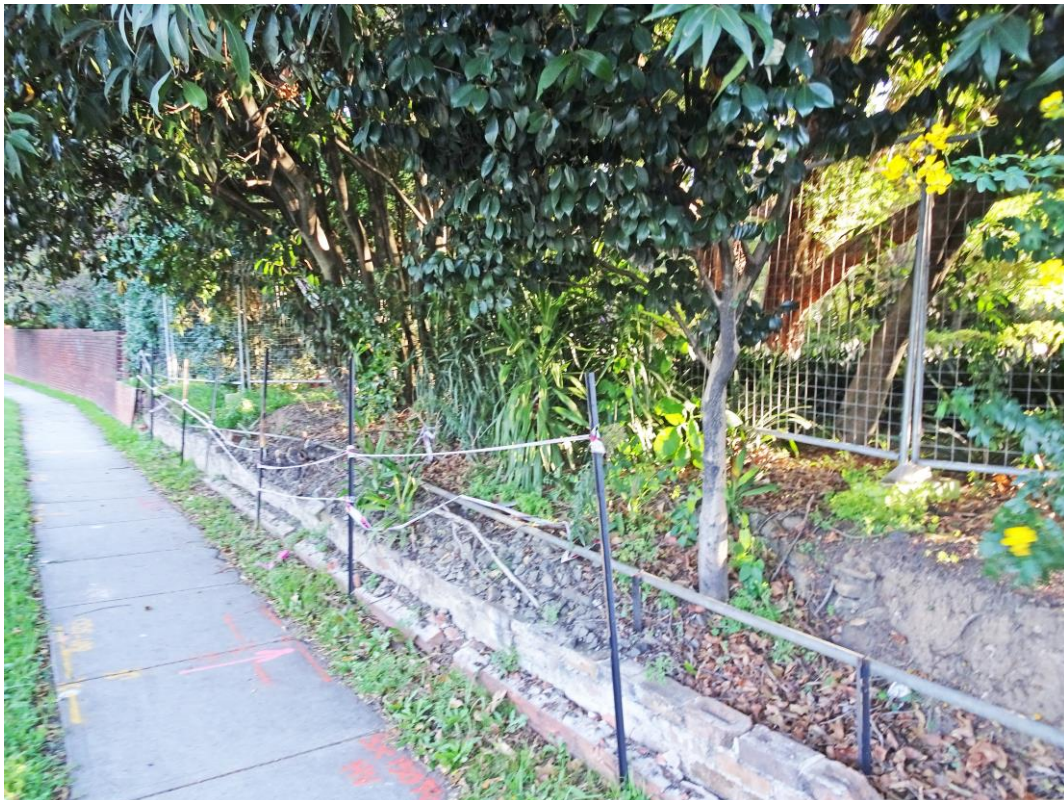
**Plate 6 Section of removed wall on the Pacific Highway boundary**

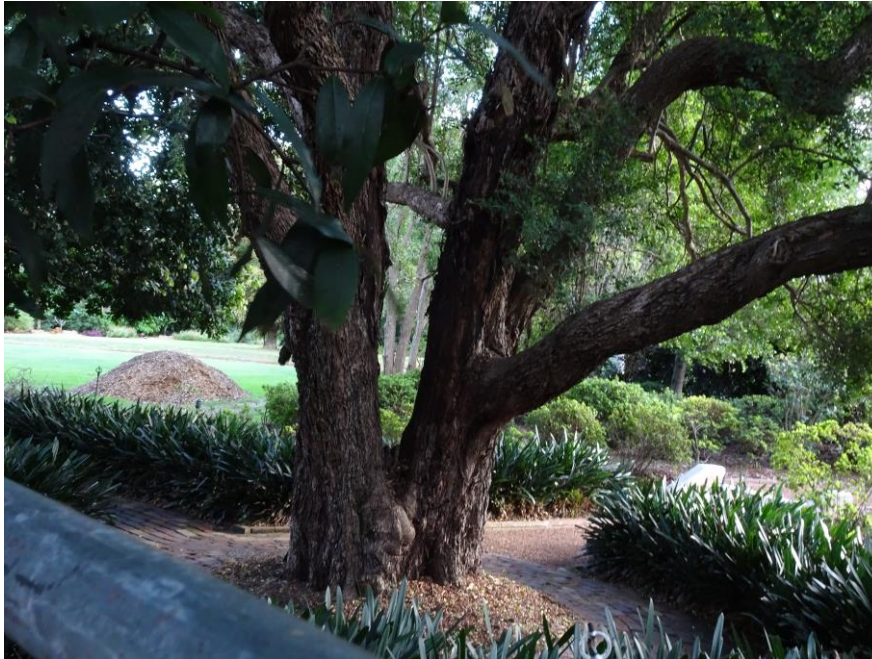
**Plate 7** *Syzygium paniculatum* Magenta Cherry located in the middle of the brick path adjacent to the eastern boundary works, facing south (identified as T19 in the Tree Plan provided in Appendix 1)

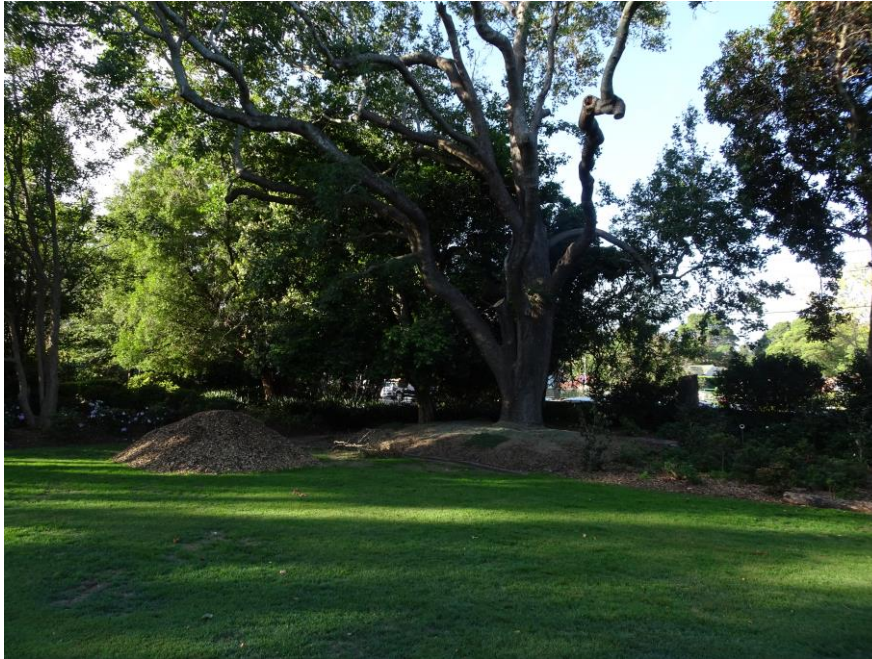
**Plate 8** *Liquidamber styraciflua* in the eastern planting bed, facing east Brick path

Two of the trees in the eastern planting bed within the study area have been assessed as having low significance due to loss of crown, or compromised root systems. The most significant tree in this group is a large *Liquidamber styraciflua* (Tree No. 16) (Plate 8) which is one of the largest specimens in the group of trees on this boundary. The *Liquidamber* is larger than 22m and is a dominant feature in the planting bed adjacent to the lawn. The tree has been affected by the piling up of lawn clippings at its base reducing oxygen and air exchange to the roots and the poor state of the canopy has reduced the appearance of this specimen.

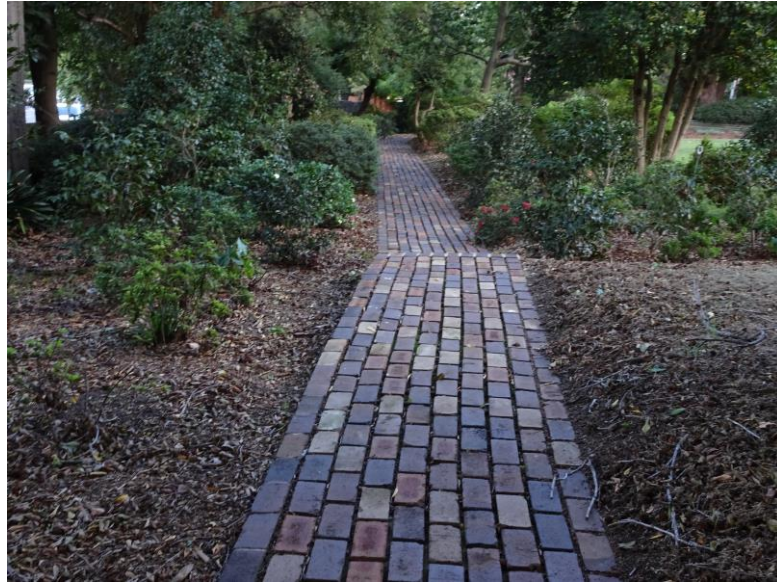
**Plate 9** Brick pathway along the eastern planting bed, facing south

The brick path (Plate 9) is part of a path network that runs parallel to the brick wall on the eastern boundary of Mahratta and is used as part of a meditation walk by the School of Philosophy. The path is made of bricks which are not mortared. The path is a distinctive feature along the eastern planting bed within the study area and defines the western edge of the garden bed in this area.

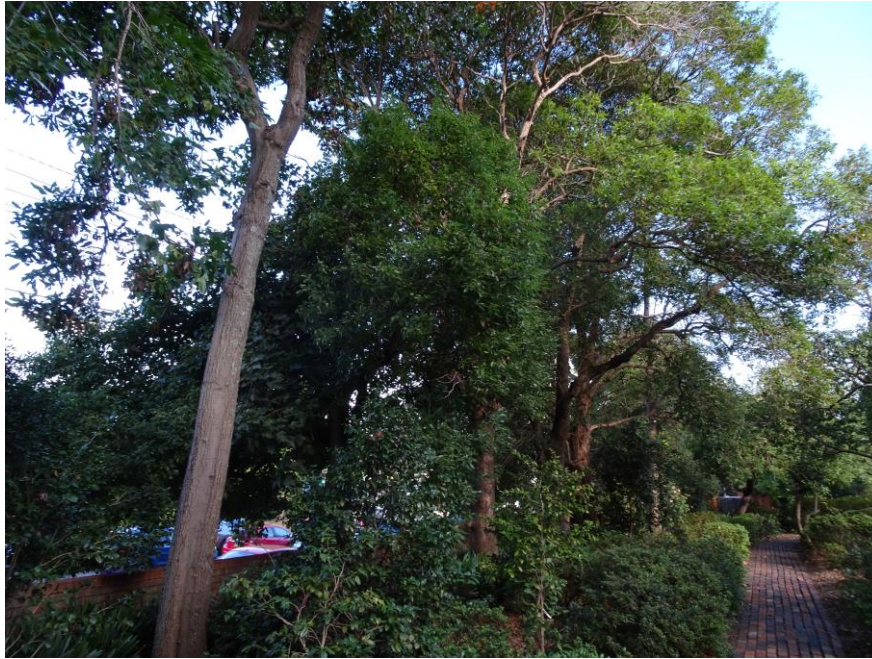
**Plate 13** Typical view of gardens within Mahratta [5] grounds with brick boundary wall, facing south (ie. the study area)

A 1.8m high brick wall (Plate 13 and 15) is located on the eastern and southern boundaries. The walls were designed by Douglas Agnew and built with the house during the Second World War.<sup>48</sup> The bricks are a red brick similar to the house construction. The wall on the southern boundary has two gate openings. The gate on the corner of Fox Valley Road and Pacific Highway has been rebuilt to be permanently closed (refer Appendix 4 - Section 60 application by Paul Dignam in 1998.) The walls on both the southern and eastern boundaries have been repaired in several places which is clear from the difference in brick colours and the changes to the mortar which varies from white to black. There is currently an open section on the eastern boundary within the study area, where the wall has been removed to avoid collapse (refer Appendix 3 - Section 60 application by David Scobie in 2016) and has not been replaced. The open parts of the boundary are secured with temporary fencing (Plate 6 and 12).

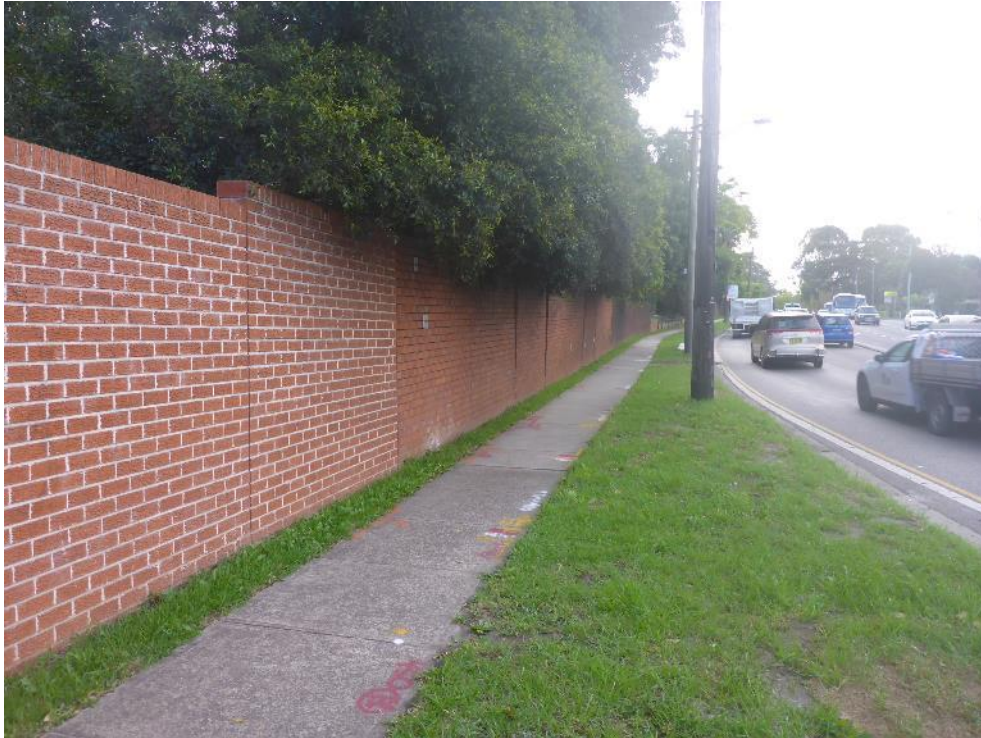
**Plate 15** Eastern brick boundary wall of Mahratta and adjacent road reserve, facing north-west (note – the different brick colours and mortar)

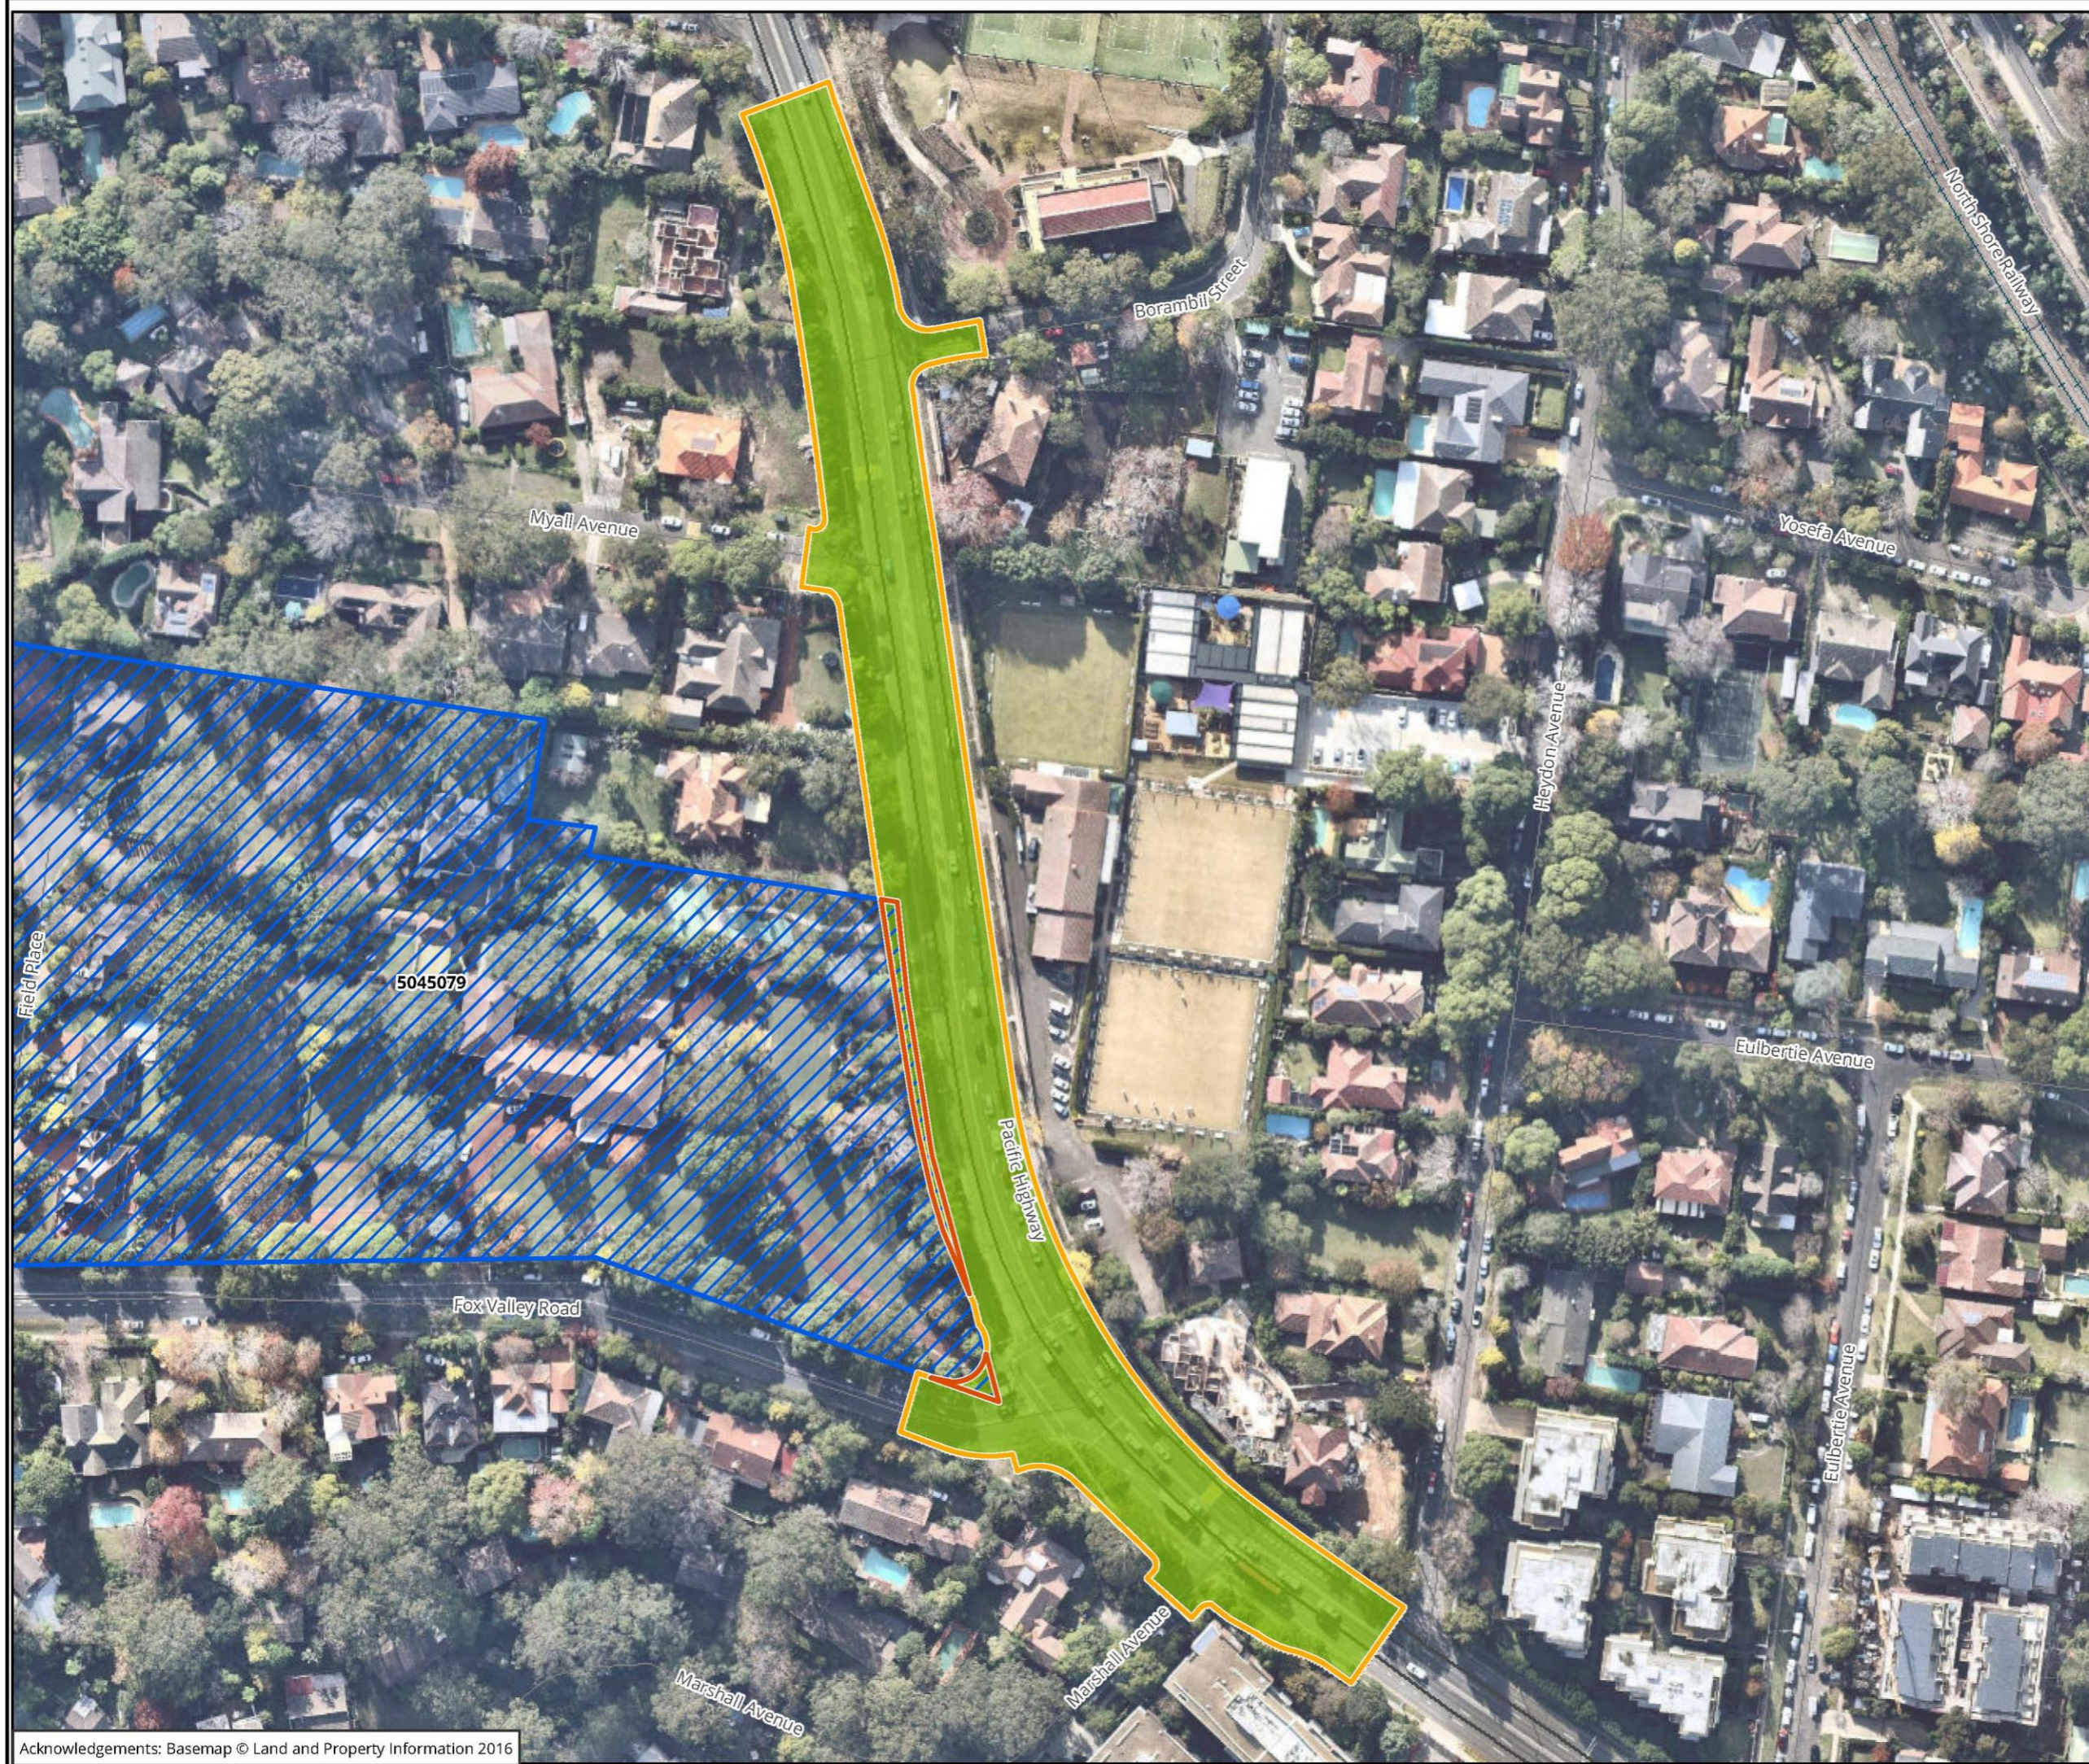
**Figure 15 Assessment of archaeological potential**

Designation	Description	Probable feature(s)	Possible construction date	Likely sub-surface integrity	Archaeological potential
Heverlee property [1]	Property boundary, landscaped gardens	Wall foundations, post holes, garden beds, cuts, fill deposits	c.1900	Disturbance or removal of cuts, garden bed and fill deposits; truncation or removal of garden wall foundations	Low
Mahratta property [5]	Current brick wall property boundary, landscaped gardens	Wall foundations, garden beds, cuts, fill deposits	c.1939	Disturbance or removal of cuts, garden bed and fill deposits; truncation or removal of garden wall foundations	Low
