# Appendix H

## Non-Aboriginal Heritage Assessment (Local)

Pacific Highway Intersection Improvements in Wahroonga / Warrawee /  
Turrumurra  
Statement of Heritage Impact for Locally Significant Heritage Items within  
Ku-ring-gai Local Government Area

For Roads and Maritime Services

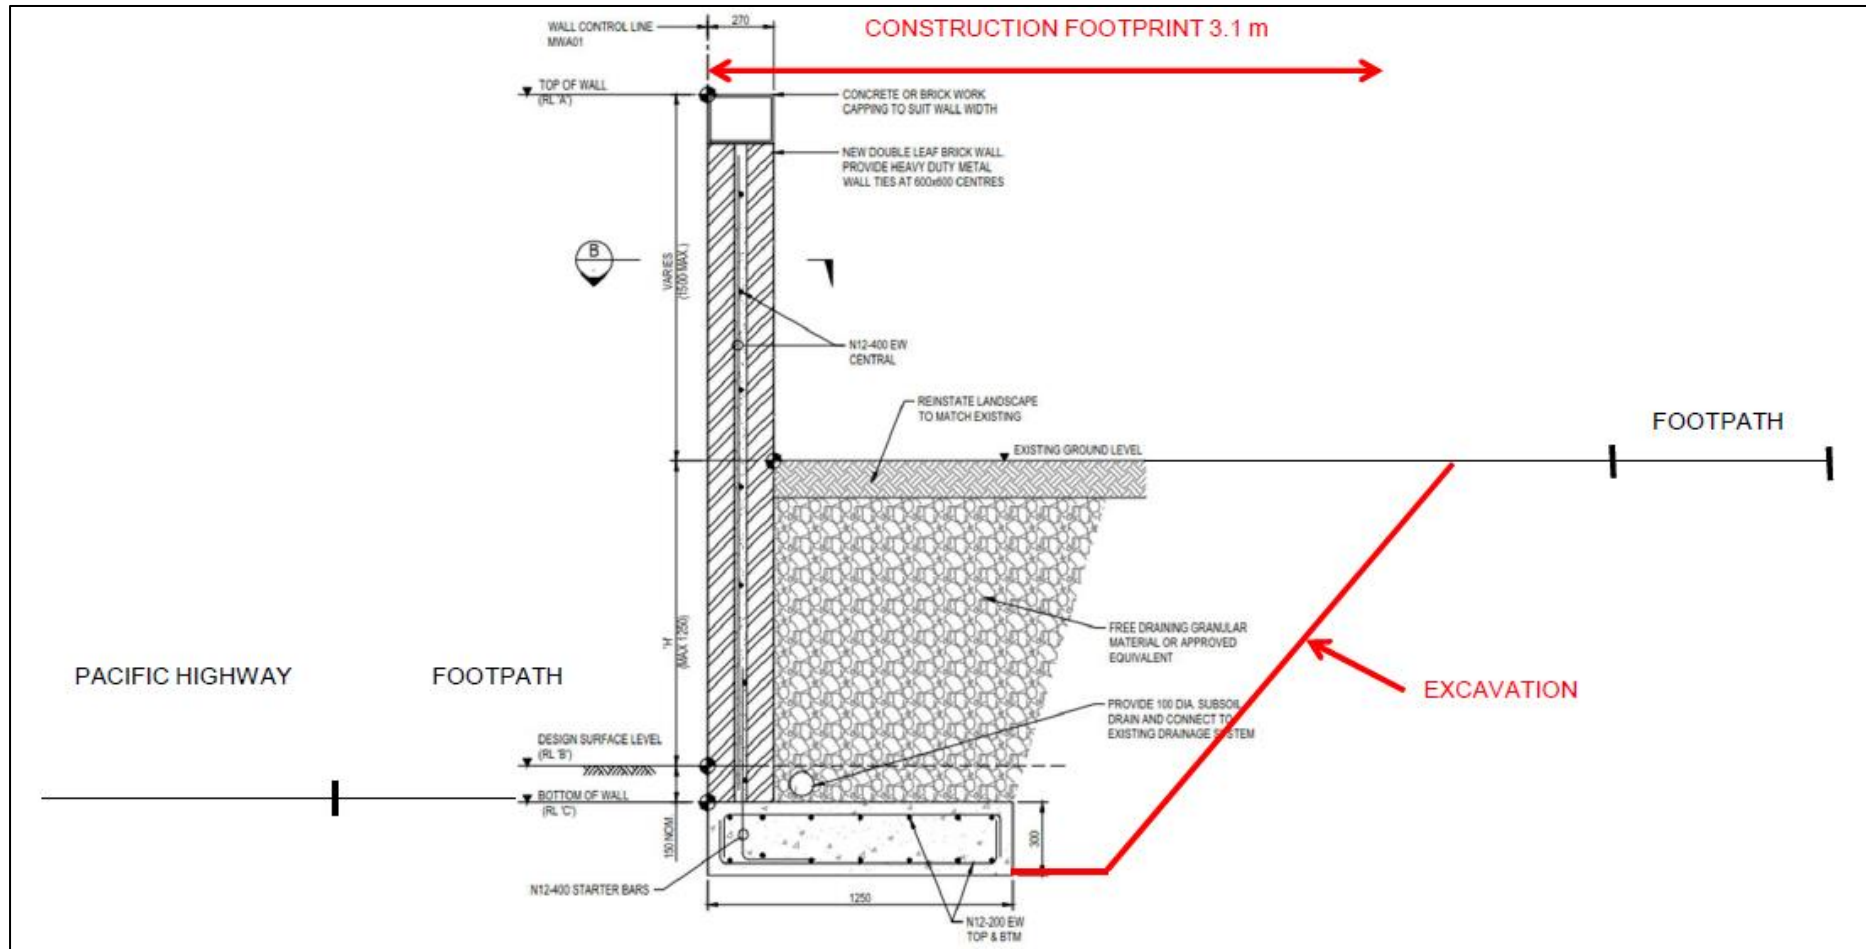
Figure 16 Section drawing of proposed pad footing retaining wall (Source: Roads and Maritime Services, 2018)

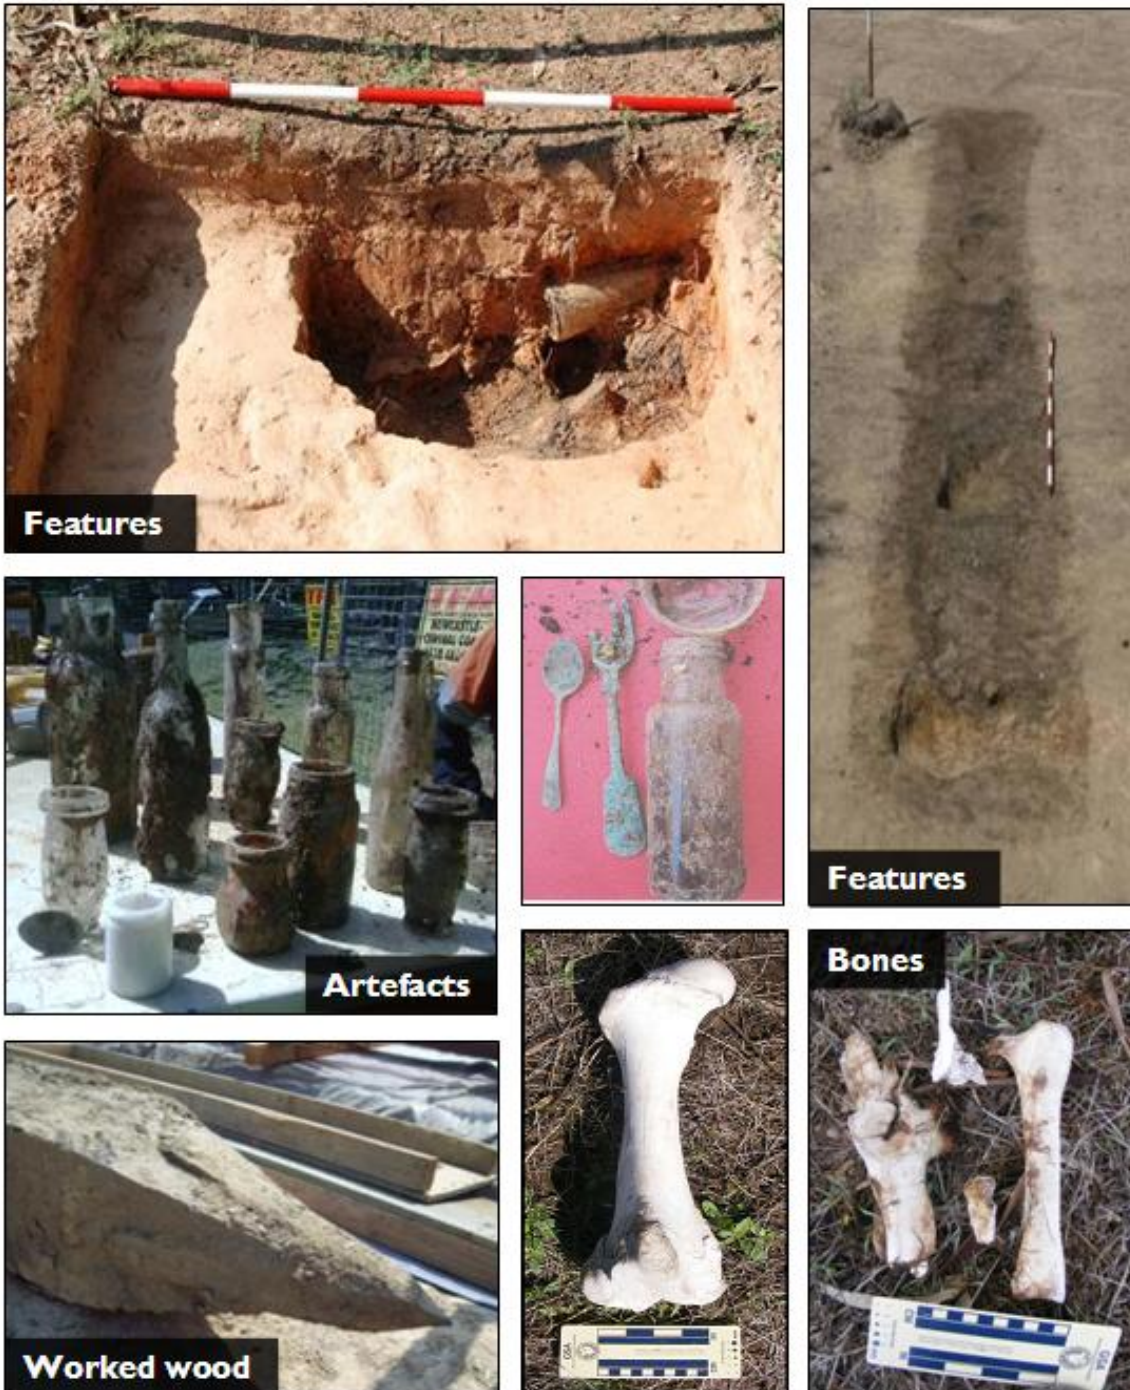
**Top left hand picture continuing clockwise:** Stock camp remnants (Hume Highway Bypass at Tarcutta); Linear archaeological feature with post holes (Hume Highway Duplication), Animal bones (Hume Highway Bypass at Woomargama); Cut wooden stake; Glass jars, bottles, spoon and fork recovered from refuse pit associated with a Newcastle Hotel (Pacific Highway, Adamstown Heights, Newcastle area).

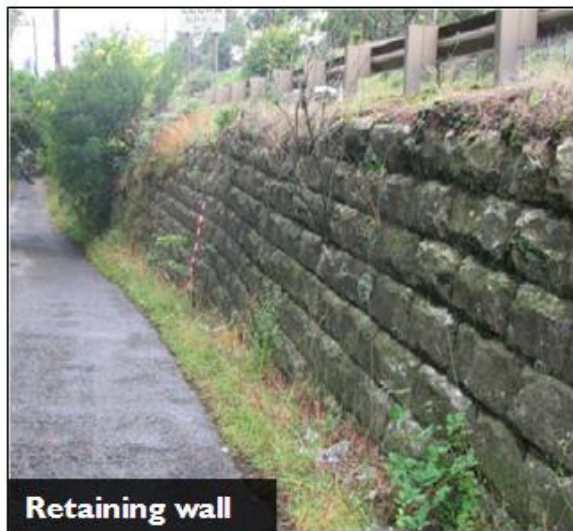
**Retaining wall**

**Top left hand picture continuing clockwise:** Woodstave water pipe with tar and wire sealing (Horsley Drive); Tram tracks (Sydney); Brick lined cistern (Clyde); Retaining wall (Great Western Highway, Leura).

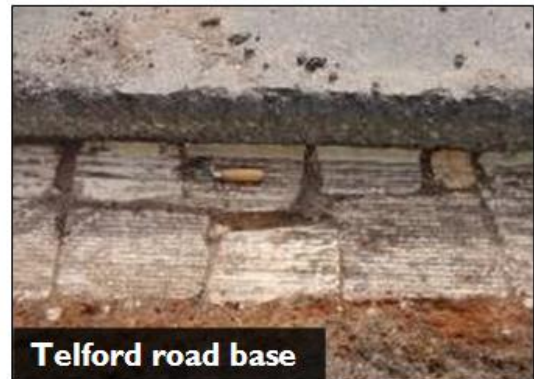
**Telford road base**

**Top left hand picture continuing clockwise:** Road pavement (Great Western Highway, Lawson); Sandstone kerbing and guttering (Parramatta Road, Mays Hill); Telford road (sandstone road base, Great Western Highway, Leura); Ceramic conduit and sandstone culvert headwall (Blue Mountains, NSW); Corduroy road (timber road base, Entrance Road, Wamberai).

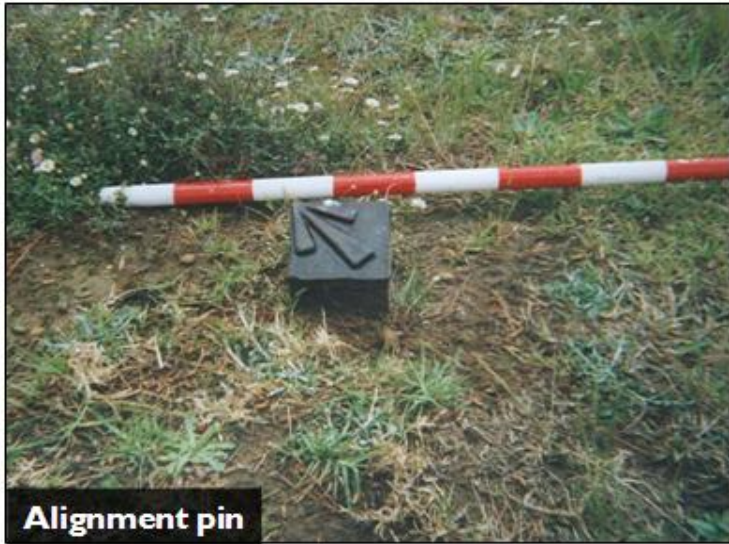
Alignment pin

**Top left hand corner continuing clockwise:** Alignment Pin (Great Western Highway, Wentworth Falls); Survey tree (MR7, Albury); Survey tree (Kidman Way, Darlington Point, Murrumbidgee); Survey tree (Cobb Highway, Deniliquin); Milestone (Great Western Highway, Kingswood, Penrith); Alignment Stone (near Guntawong Road, Riverstone). Please note survey marks may have additional statutory protection under the *Surveying and Spatial Information Act 2002*.

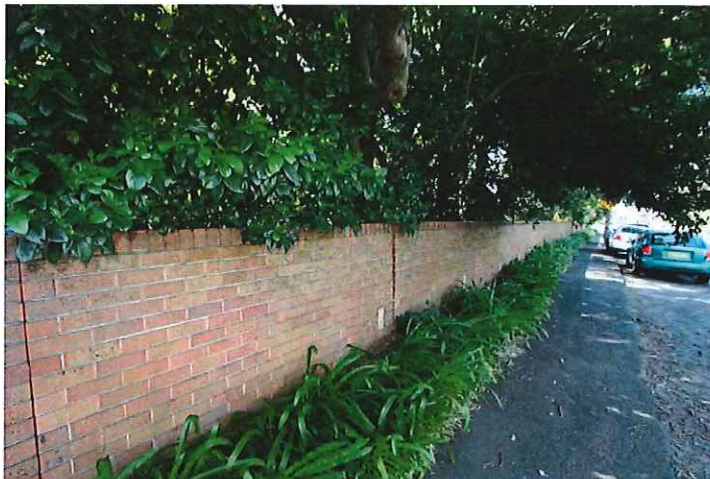
2. View looking down Fox Valley Road to the Pacific Highway. The wall is nominally 1200mm high to this portion of the boundary.

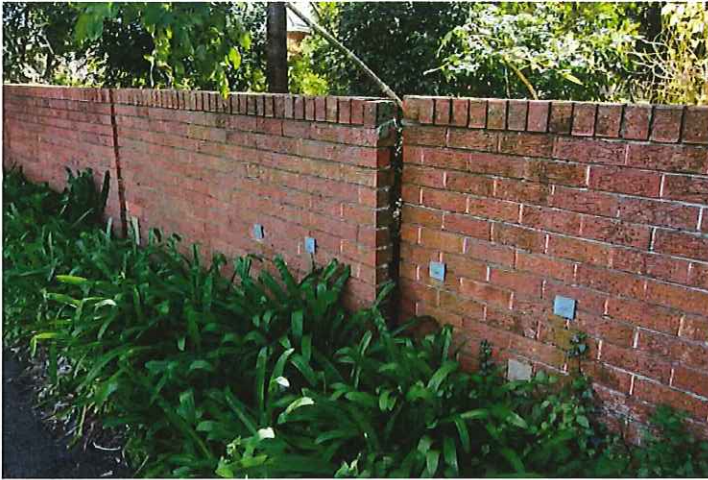
3. An example of major movement, noting previous restraints.

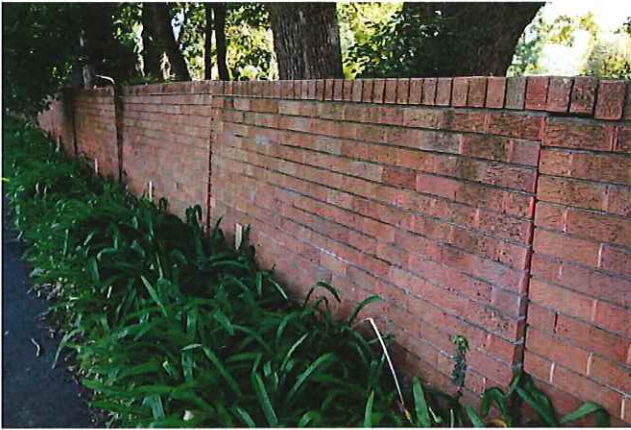
4. The view looking back from the Pacific Highway illustrating the extent of typical movement. The panels are nominally 3000mm long and between 1200mm and 1500mm high.

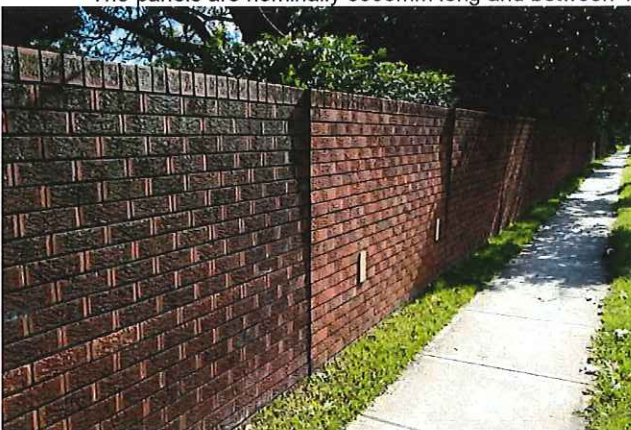
5. A general view looking up the Pacific Highway illustrating the number of panels with movement.

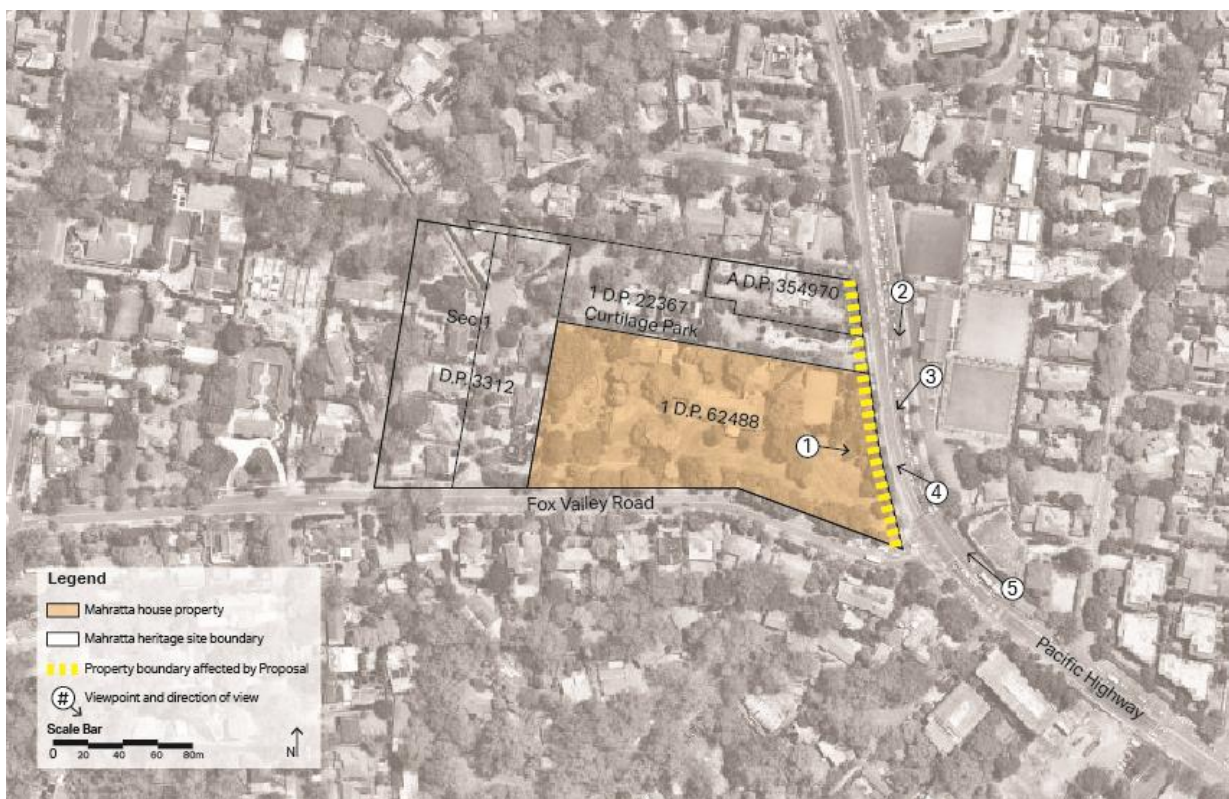
**Figure 1 Viewpoints in relation to the Mahratta site and the location of the proposed changes to Mahratta as a result of the Proposal**

Changes to the views from within and outside the Mahratta site as a result of the Proposal are assessed using five viewpoints (refer Figure 1):

1. From within the Mahratta heritage curtilage (to the east of the house on the driveway leading to the front gates);
2. From the Pacific Highway at the driveway of the Warrawee Bowling Club and Function Centre (north of Fox Valley Road);
3. From the Warrawee Bowling Club and Function Centre on the Pacific Highway (north of Fox Valley Road);
4. From the Pacific Highway opposite the Mahratta site (just north of the Fox Valley Road intersection); and
5. From the Pacific Highway (south of Fox Valley Road).

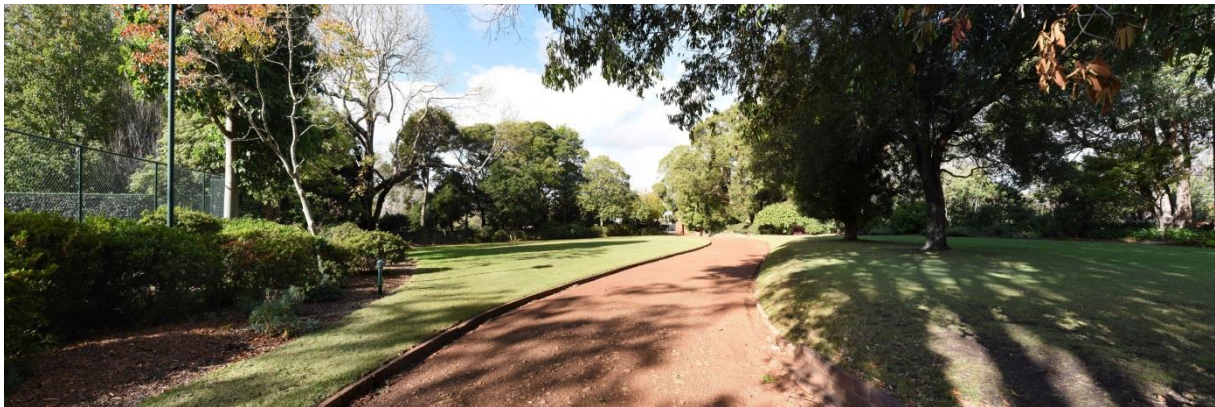
**Figure 2 Viewpoint 1 (existing): Existing view from within the Mahratta heritage curtilage looking towards the eastern boundary and corner gateposts at the intersection of the Pacific Highway and Fox Valley Road (looking south east)**

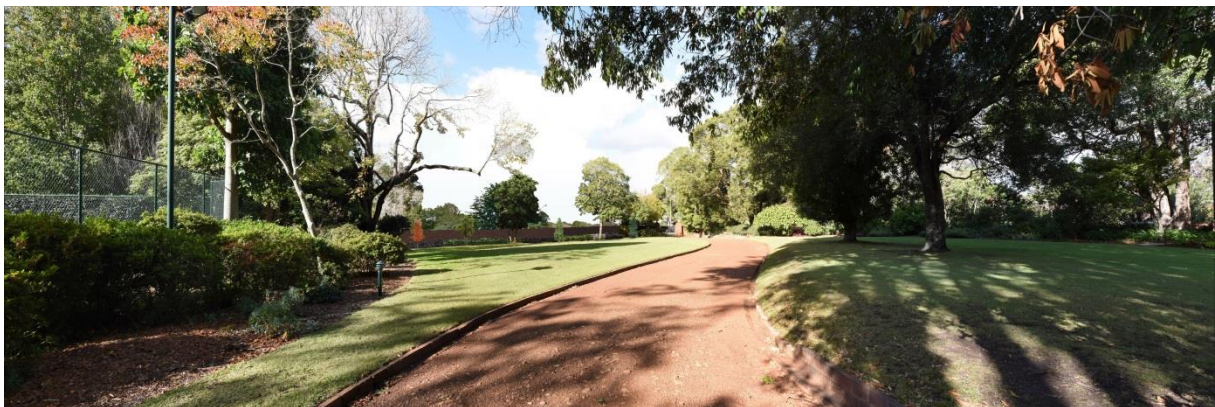
**Figure 3 Viewpoint 1 (just after construction): Visual simulation showing the extent of the changes to the viewpoint due to the Proposal (just after construction, with indicative tree and shrub planting), including removal of about 20 trees and the shifting of the boundary wall about 3.5 metres westwards towards the house, reducing the garden bed along the boundary**

<p>location;</p> <ul style="list-style-type: none"> <li>The changes as a result of the Proposal would be seen at close proximity, particularly as the eastern edge landscape contains a ‘therapeutic meditation walk’ through the trees and shrubs.</li> </ul>
<b>Magnitude of change</b>	<p>The magnitude of change to the view from this location would be ‘High’.</p> <p>The removal of boundary trees and shrubs would leave gaps in the canopy which would open up views to the road corridor and passing tall vehicles, and views to the brick wall from inside the site, however, some of the trees to be removed have already been damaged from a storm event or are currently ailing. The changes as a result of the Proposal would be confined to the eastern boundary of the site.</p> <p>Part of the change in the boundary landscape to be removed would be behind the tennis courts, which would screen changes to some of the landscape. However, the eastern boundary shrubbery would still contain the therapeutic meditation path, which would continue to be a destination within the garden, although being positioned closer to the new brick wall and Highway.</p>

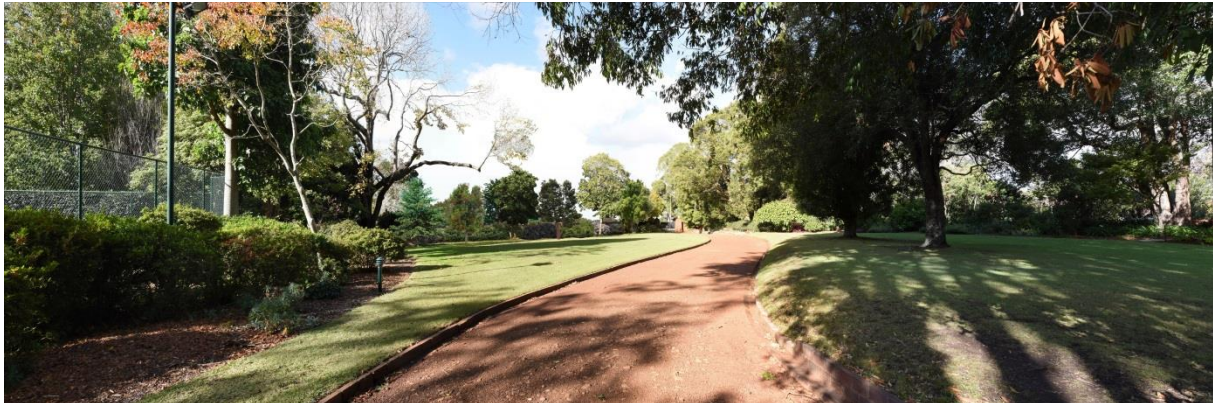
**Figure 4 Viewpoint 1 (established vegetation):** Visual simulation showing the eastern boundary of the Mahratta site with more established mature shrub and tree growth (based on tree and shrub planting included as mitigation in Figure 3)

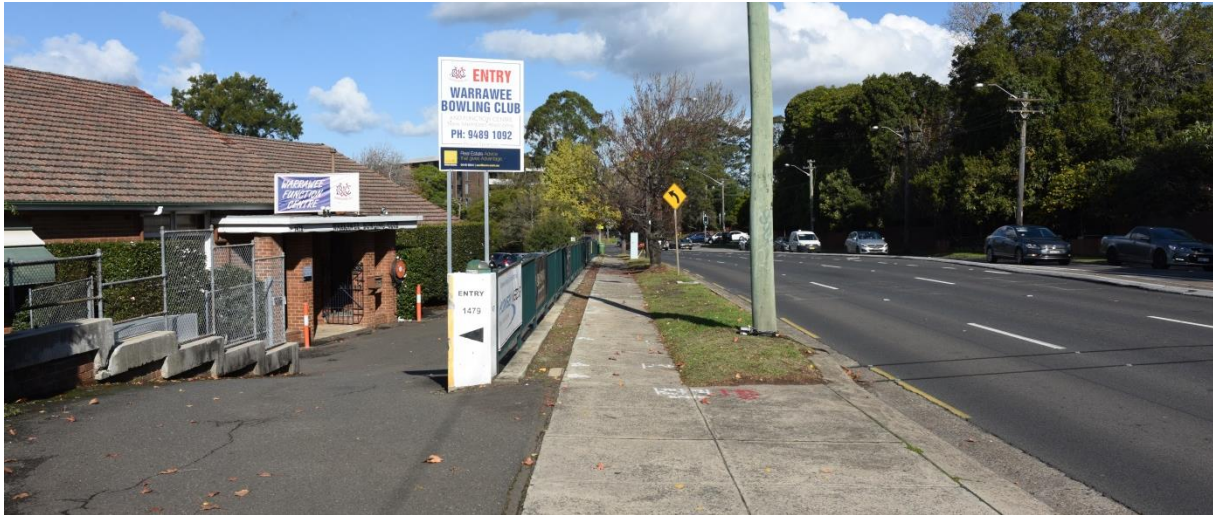
**Figure 5 Viewpoint 2 (existing): Viewpoint southbound along the Pacific Highway which is positioned at the entry driveway of the Warrawee Bowling Club and Function Centre**

<p><b>Magnitude of change</b></p>	<p>The magnitude of change to the view from this location would be 'High'. The road pavement itself would be widened to three lanes at this location, with the turning lane at Fox Valley Road lengthened towards the north.</p> <p>Along the road corridor a thick band of mixed screening vegetation within the Mahratta site would be removed, including mature trees which make up an almost continuous canopy along the Highway. The road pavement would extend further to the west of the existing road carriageway due to the widening of the Highway. The red brick wall on the eastern boundary of the Mahratta site would be moved westwards to accommodate the road widening. The brick wall would be rebuilt to be similar to the existing in terms of height, form and appearance.</p> <p>However, the number of trees remaining within the Mahratta site and within private properties on the south western corner of the Fox Valley Road intersection, provide a dark leafy backdrop which visually softens the impact of the removal of these trees. While the gaps in the tree canopy within Mahratta are visible, the overall 'leafy' character of the view is retained due to the remaining trees.</p> <p>Over a significant period of time, the replacement of a number of the trees lost would reduce the visual impact of the change.</p>

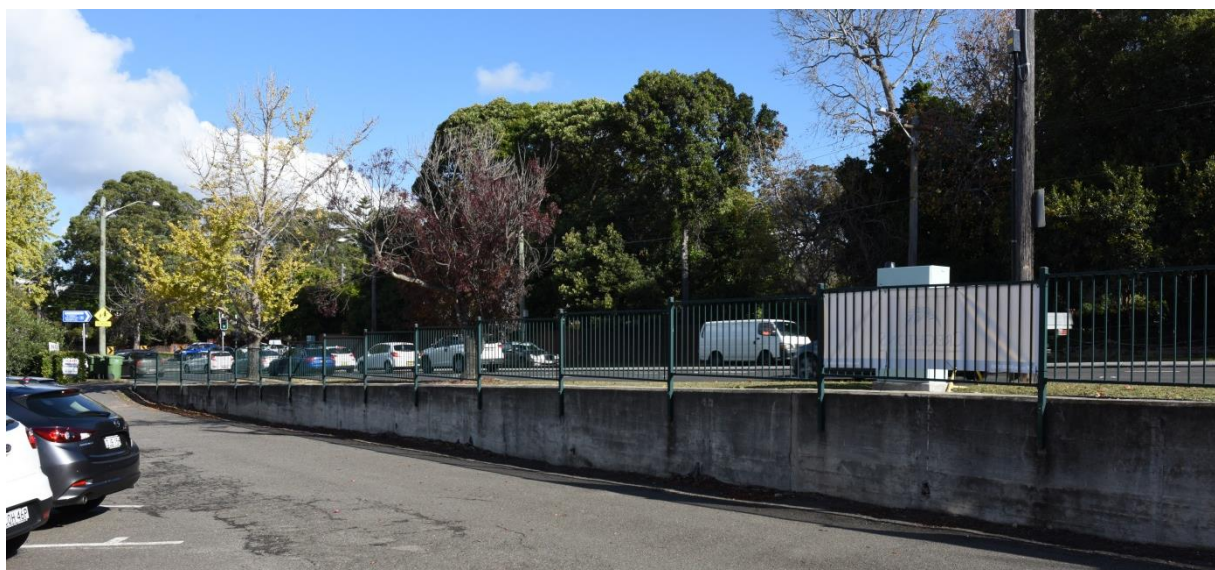
**Figure 6 Viewpoint 3 (existing):** Viewpoint towards the Pacific Highway from the carpark of the Warrabee Bowling Club and Function Centre with the Mahratta site (including the brick boundary wall and vegetation) in the background (looking south west)

<p><b>the view</b></p>	<p>Mahratta site, the shifting of the red brick boundary wall of Mahratta to the west, the widening of the Pacific Highway road corridor to the west, and the reconfiguration of the signalised intersection at Fox Valley Road.</p> <p>However, due to the partial screening of the Pacific Highway and Mahratta boundary fence by the ground level change, fencing and street trees in this location, the only element that would be particularly noticeable from this location would be the removal of trees, which would be seen as an opening up of the canopy along the boundary of the Mahratta site.</p>
<p><b>Sensitivity of receptors</b></p>	<p>The sensitivity of the view and the receptors has been assessed as ‘Moderate’. Although visitors to a recreational venue would typically have a ‘High’ sensitivity, the rating at this location is lowered due to the partial screening of the Proposal from a ground level change within the carpark, and the fact that the view to the Proposal (and Mahratta) are not seen from the clubhouse / function centre or from the bowling greens.</p> <p>The view from this location is not particularly sensitive as it is a view from a carpark to a busy road corridor with a concrete retaining wall and safety fencing in the foreground, partially screening the view across the road.</p>

<p><b>Magnitude of change</b></p>	<p>The magnitude of change to the view from this location would be ‘Low’. The changes seen would primarily be confined to the removal of the tree canopies along the eastern boundary of the Mahratta site.</p> <p>Changes to the road pavement and verge would not be seen from within the bowling club and function centre, nor from the bowling green due to the existing buildings and ground level difference in this location.</p> <p>The Proposal primarily affects the western side of the Highway on the opposite side of the road, meaning they would not be seen from close proximity.</p>
<p><b>Overall assessment</b></p>	<p>Using the Landscape Character and Visual Impact Assessment Matrix (refer Table 1) the overall visual impact would be ‘Moderate to Low’.</p>

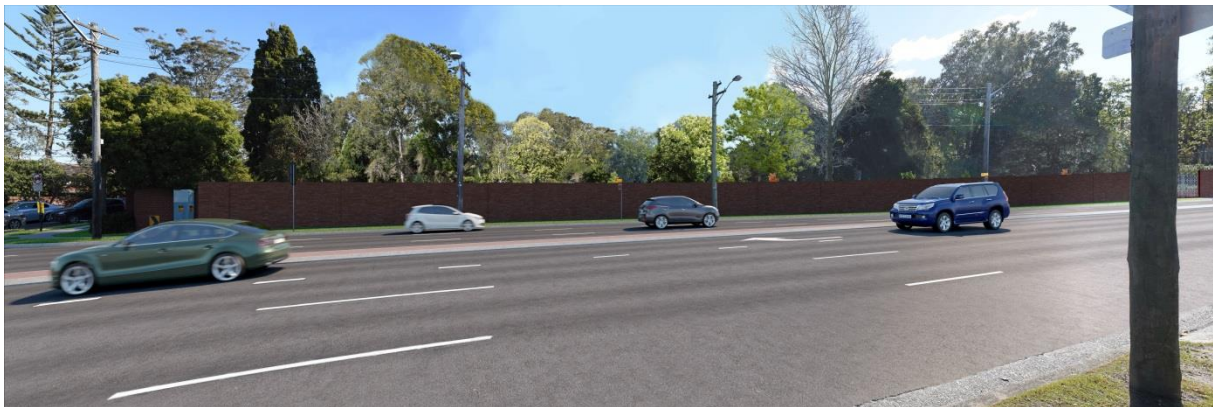
**Figure 8 Viewpoint 4 (just after construction):** Visual simulation showing the changes to the view towards the Mahratta site boundary (with indicative tree and shrub planting included as mitigation) showing the gaps in the mature tree canopy from the removal of trees along the boundary of this site just after construction

<b>Changes to the view</b>	<p>Changes in the view from this viewpoint would include:</p> <ul style="list-style-type: none"> <li>• Widening of the road pavement by one lane to the west (an additional northbound through lane);</li> <li>• Removal of trees within the Mahratta site and the associated boundary adjustment to accommodate the proposed road widening in this location; and</li> <li>• Replacement of the red brick wall on the eastern site boundary.</li> </ul> <p>Gaps in the almost continuous tree canopy fringing the road corridor would occur at the Mahratta site, where about 20 trees would be removed (refer Figure 8).</p>
<b>Sensitivity of receptors</b>	<p>The sensitivity of the view seen by road users have been assessed as ‘Moderate’ due to the following:</p> <ul style="list-style-type: none"> <li>• The Pacific Highway road corridor is somewhat scenic at this location given the ‘bushy’ character of the area, which is expressed in the well-established vegetation predominantly within private properties on either side of the Highway;</li> <li>• The Highway passes through a HCA at this location, with a high quality of housing stock with mature landscaped gardens;</li> <li>• The formal gates, solid red brick wall and mature exotic trees at this location comprise a landmark view along the Pacific Highway;</li> <li>• A moderate number of receptors (pedestrians) would obtain views to the Proposal, but this individual view would be seen as a series of individual, ‘snapshot’ views within their greater journey;</li> <li>• Pedestrians would obtain a brief view to the Proposal as they passed the Mahratta site heading north or south, although as with motorists, the view seen from this viewpoint would be a small proportion of the views experienced within their overall journey; and</li> <li>• Changes due to the Proposal would be seen at close proximity as the receptor passed the Mahratta site along the Highway.</li> </ul>

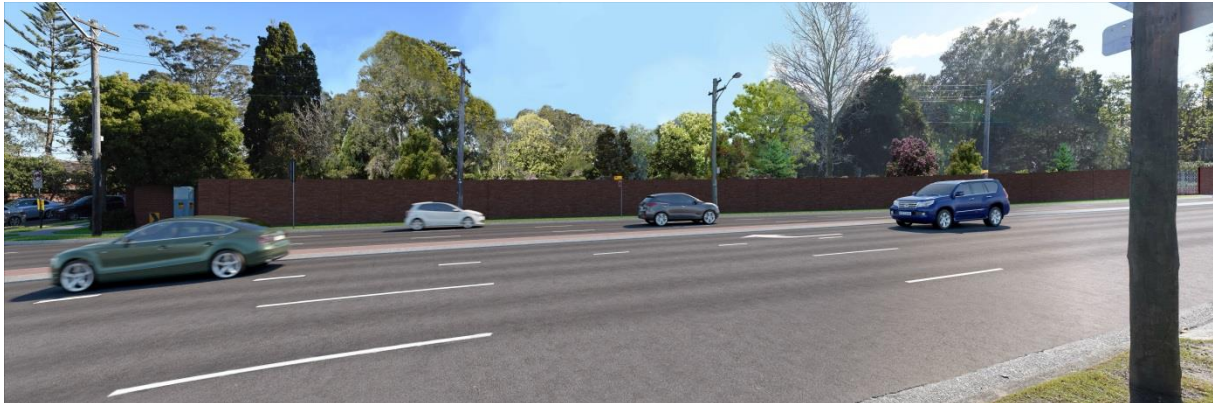
**Figure 9 Viewpoint 4 (established vegetation): Visual simulation showing the changes to the Mahratta site boundary showing more mature plant growth of the indicative tree and shrub planting shown in Figure 8**

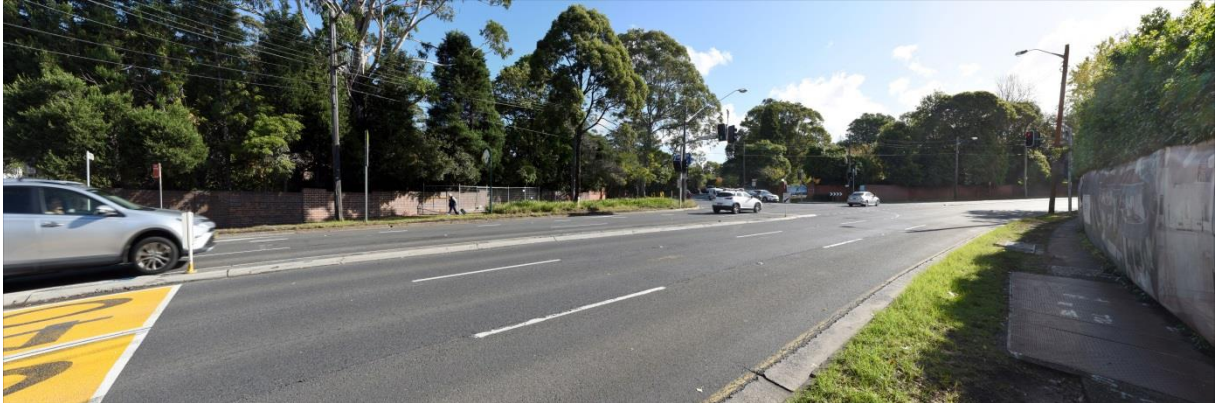
**Figure 10 Viewpoint 5 (existing):** Viewpoint on the Pacific Highway from the footpath looking north west towards Fox Valley Road intersection and the Mahratta site

<p><b>Magnitude</b></p>	<p>The magnitude of change to the view from this location would be 'High'. The road pavement itself would be widened to three lanes at this location, and the signalised intersection would be reconfigured at Fox Valley Road.</p> <p>Along the road corridor a thick band of mixed screening vegetation on private property would be removed, including mature trees which make up an almost continuous canopy along the Highway, including at the Mahratta site. The road pavement would move closer to the western side of the road due to the widening of the Highway. The red brick wall on the eastern boundary of Mahratta would be moved westwards to accommodate the road widening.</p> <p>However, the number of trees remaining within the Mahratta site and within private properties on the south western corner of the Fox Valley intersection provide a dark leafy backdrop which visually softens the impact of the removal of the trees. The intersection appears visually wider due to the removal of the two mature eucalypts on the south western corner of the intersection, and the gaps in the tree canopy within the Mahratta site are visible. However, the overall 'leafy' character of the view is retained due to the remaining trees.</p> <p>Over time, the replacement of a number of the trees lost would reduce the visual impact of the change, as shown in Figure 12.</p>

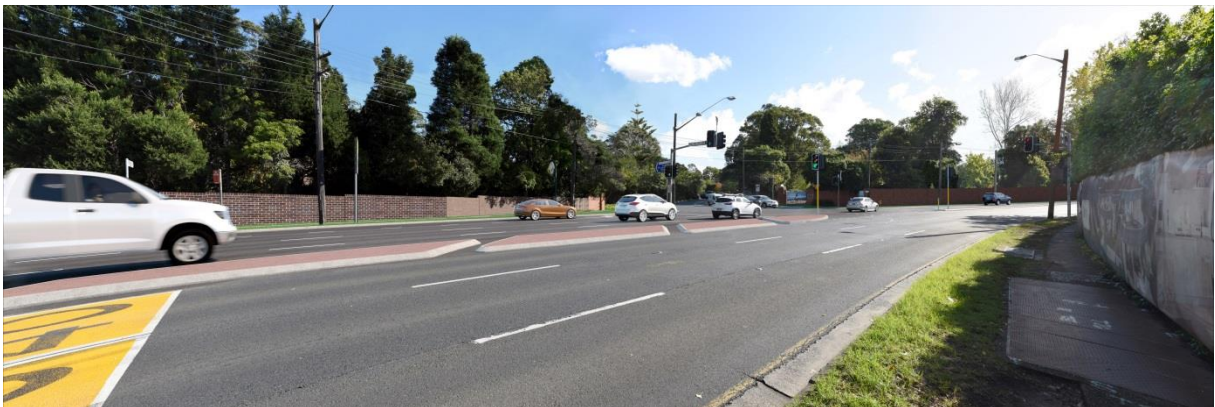
**Figure 11 Viewpoint 5 (just after construction):** Visual simulation showing the change to Fox Valley Road intersection and the Mahratta site boundary (with indicative tree and shrub planting included as mitigation), showing the gaps in the canopy from the removal of trees along the boundary of this property

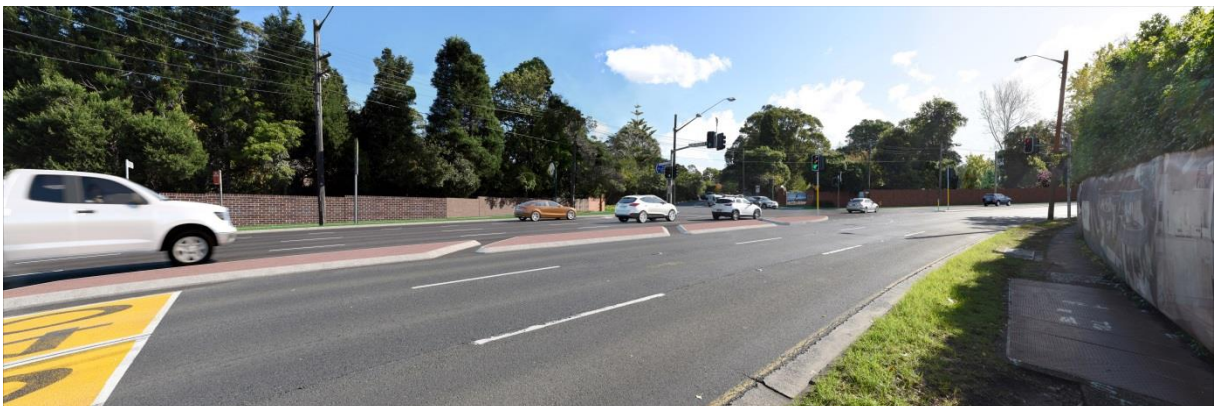
**Figure 12 Viewpoint 5 (established vegetation):** Visual simulation showing the change to Fox Valley Road intersection and the Mahratta site boundary, showing more mature plant growth in the indicative planting shown in Figure 11)

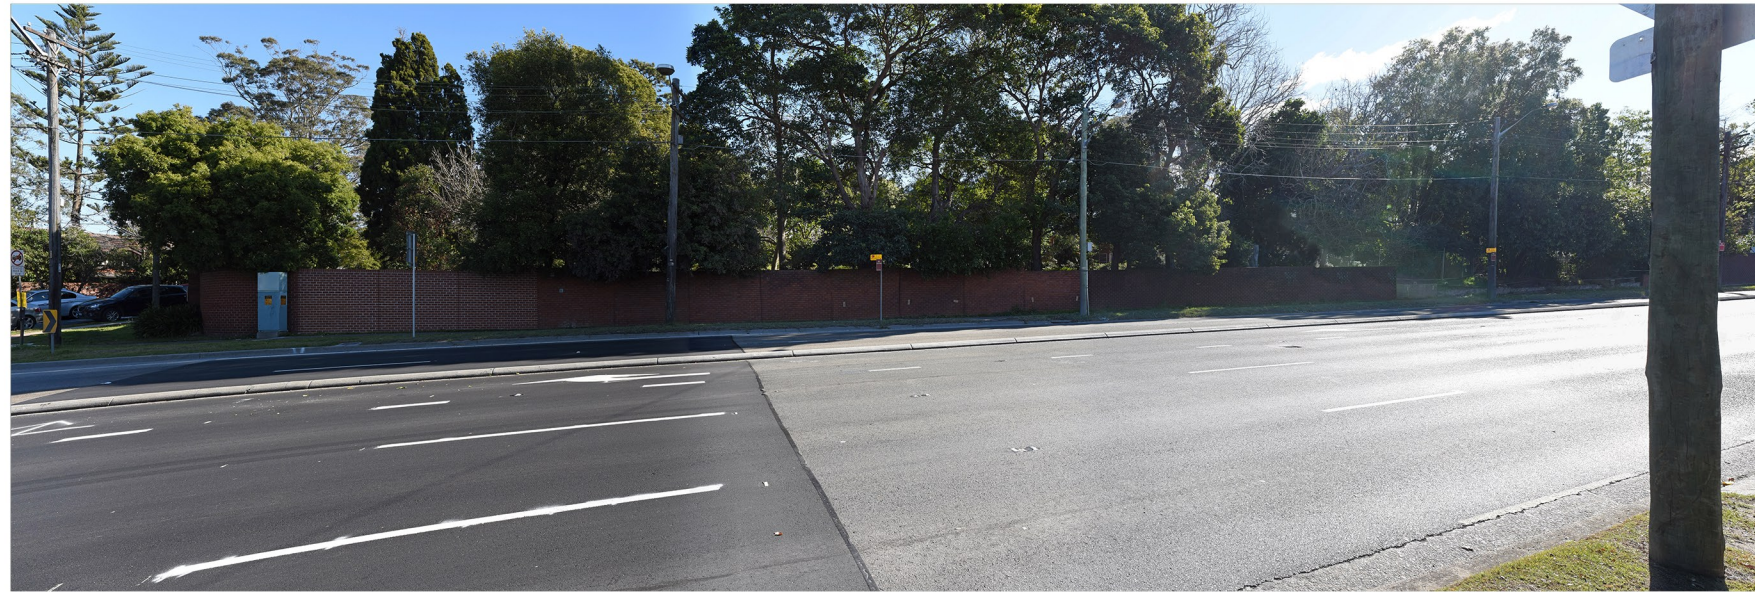
Existing –  
North of Fox Valley Road intersection opposite “Mahratta” / School of Practical Philosophy - Wahroonga (looking north west)

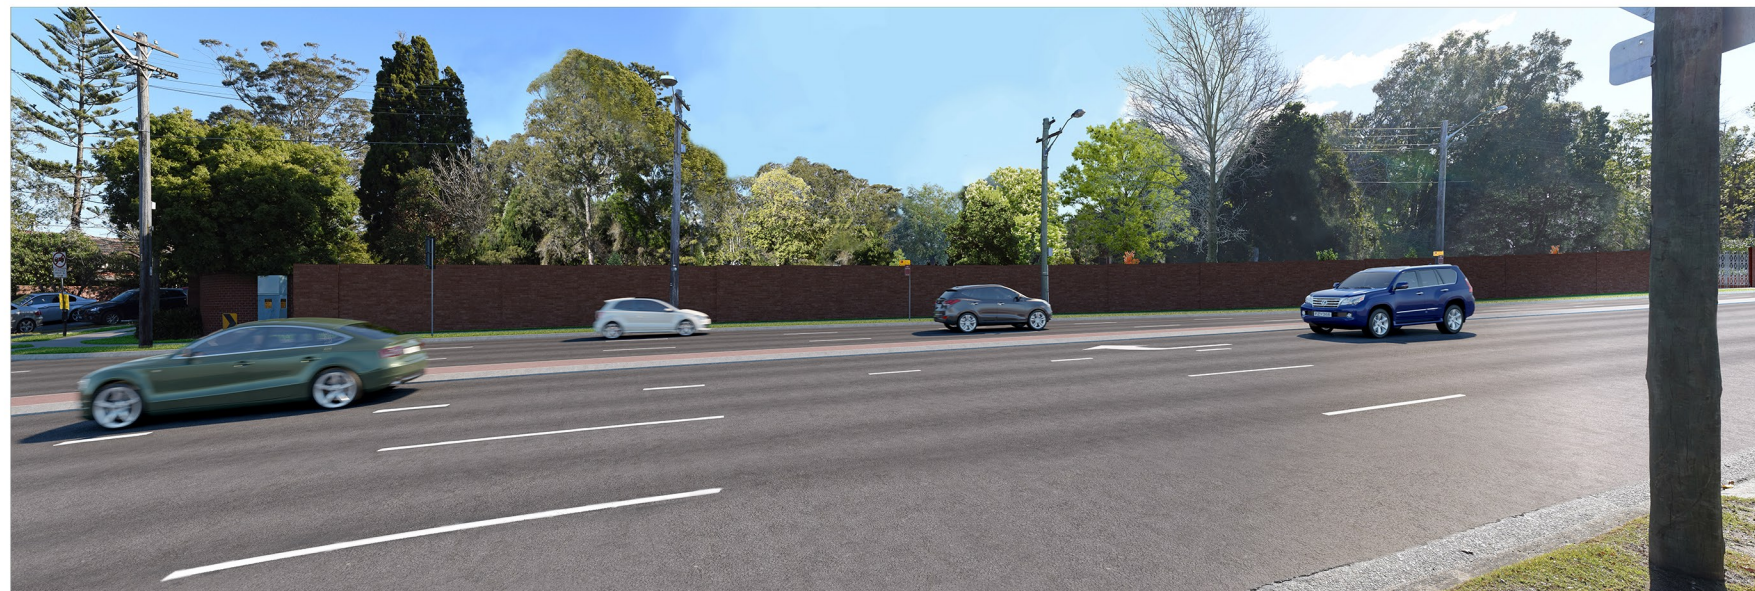
Visualisation of Proposal (Just After Construction) –  
North of Fox Valley Road intersection opposite “Mahratta” / School of Practical Philosophy - Wahroonga (looking north west)

*\*Proposed roadside planting indicative only and subject to future consultation with property owners*

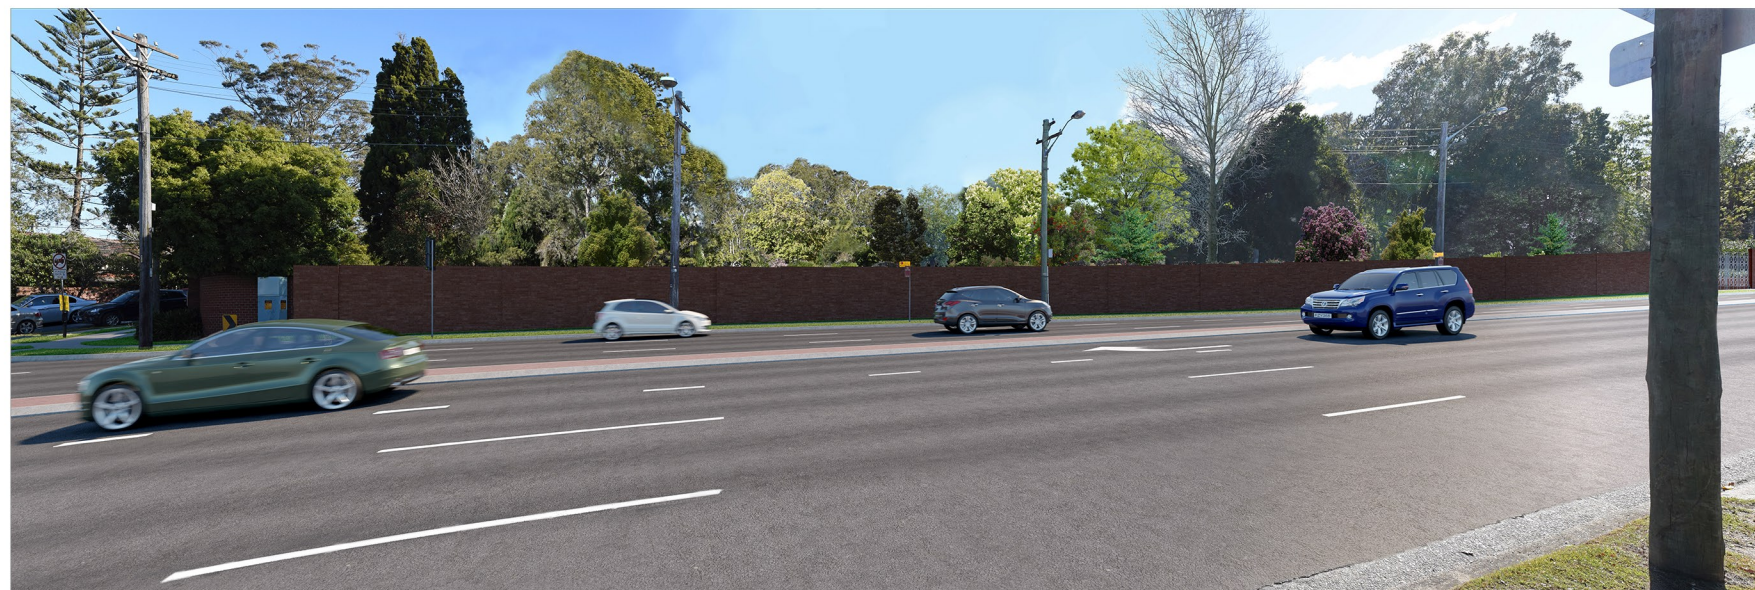
Visualisation of Proposal (Established Vegetation) -  
North of Fox Valley Road intersection opposite “Mahratta” / School of Practical Philosophy - Wahroonga (looking north west)

*\*Proposed roadside planting indicative only and subject to future consultation with property owners*

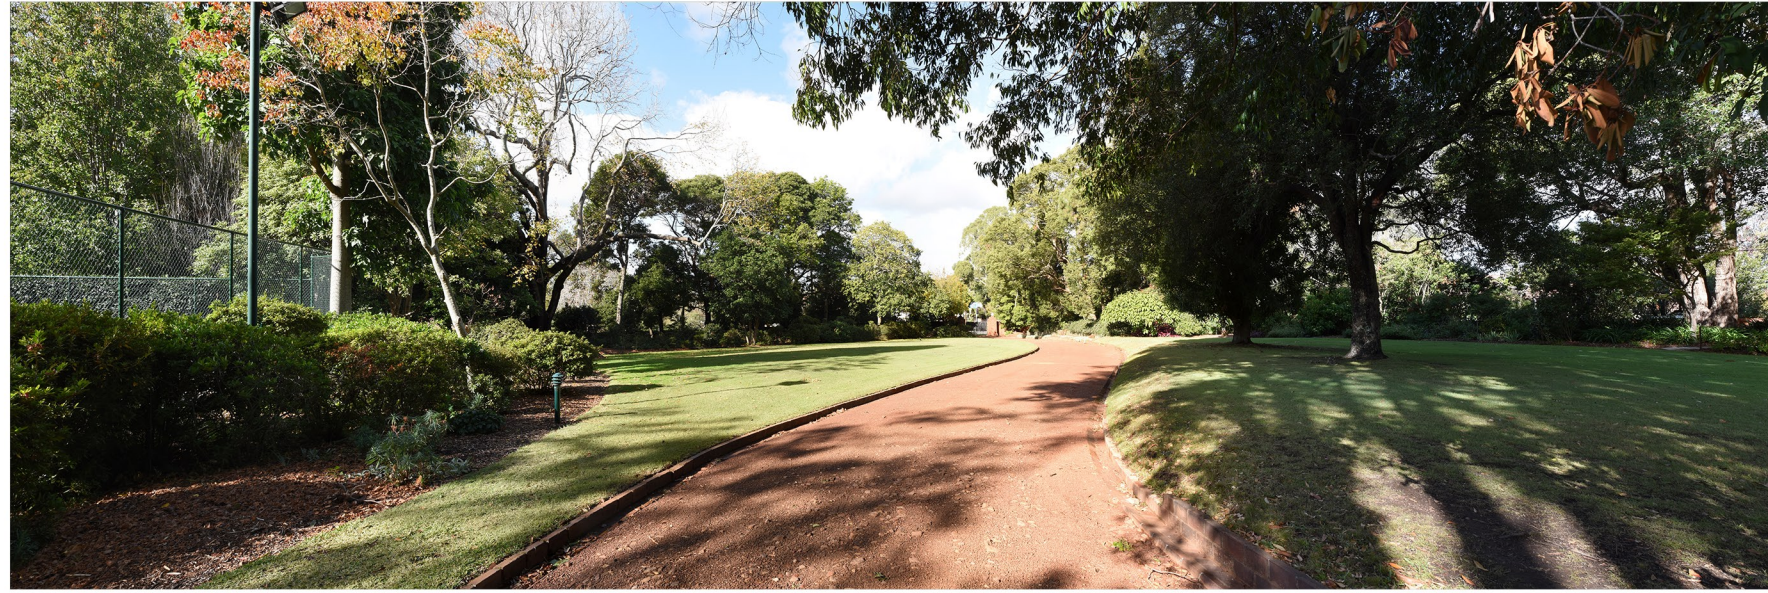
Existing –  
Within “Mahratta” / School of Practical Philosophy - Wahroonga (looking east from main building entrance/driveway)

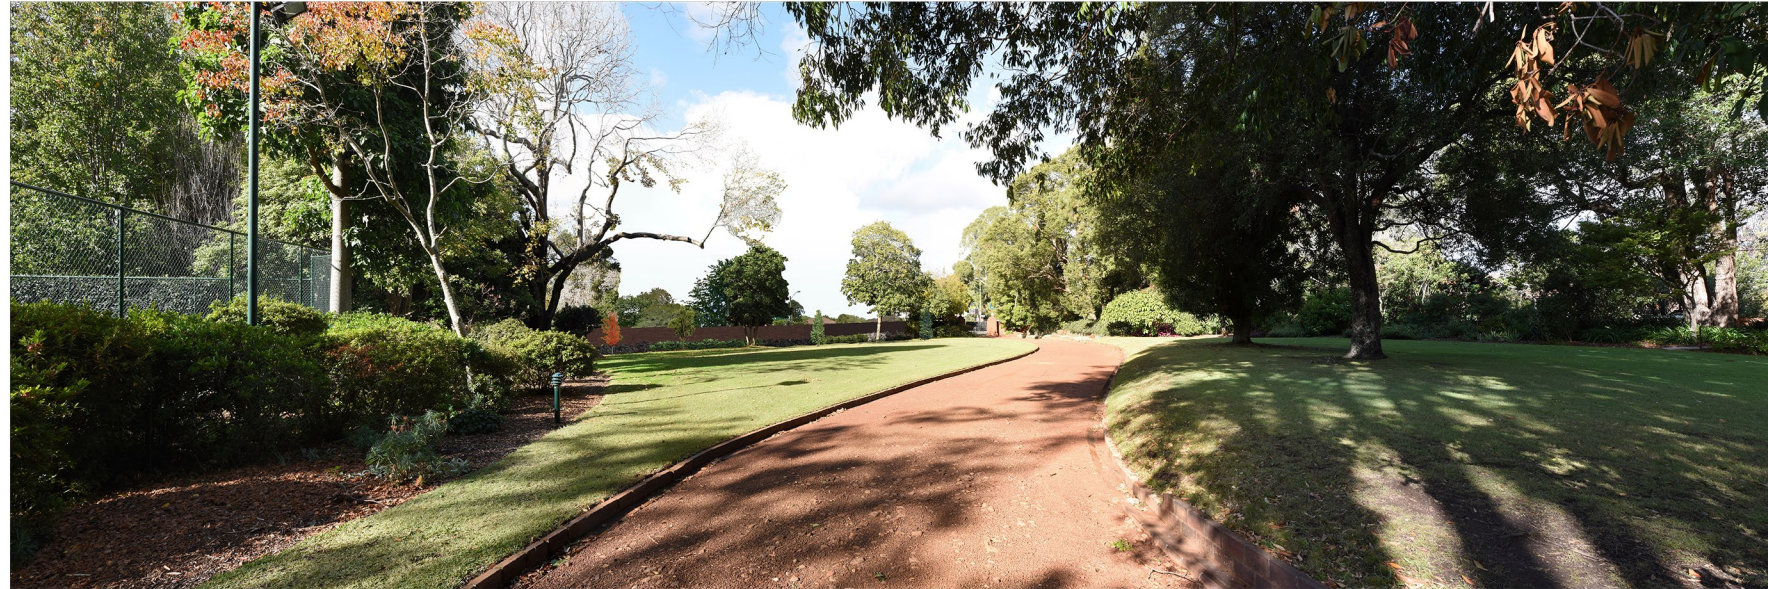
Visualisation of Proposal (Just After Construction) –  
Within “Mahratta” / School of Practical Philosophy - Wahroonga (looking east from main building entrance/driveway)

*\*Proposed roadside planting indicative only and subject to future consultation with property owners*

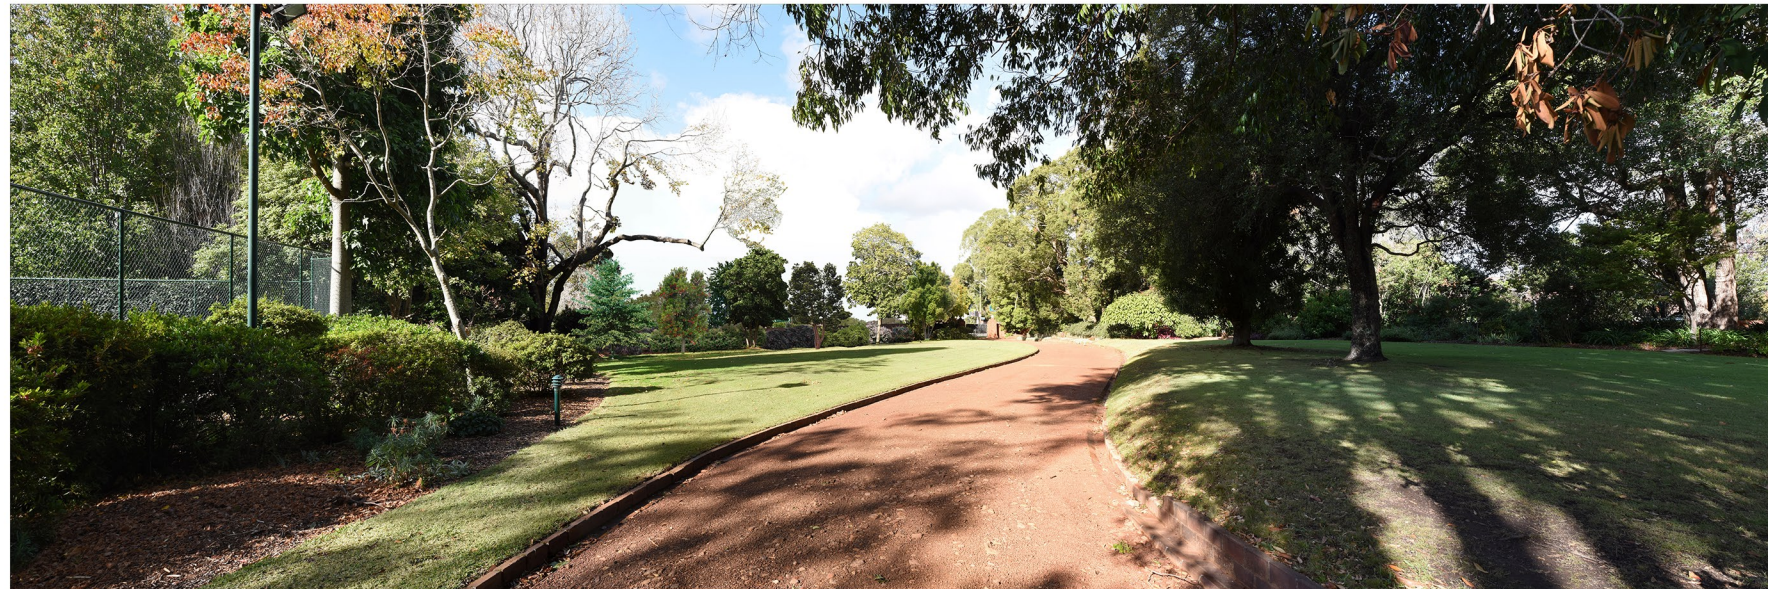
Visualisation of Proposal (Established Vegetation) -  
Within “Mahratta” / School of Practical Philosophy - Wahroonga (looking east from main building entrance/driveway)

*\*Proposed roadside planting indicative only and subject to future consultation with property owners*
