TAP 3 Banksia Railway Station

Statement of Heritage Impact

IA230700-RPT-002_SoHI | Final

Transport for NSW

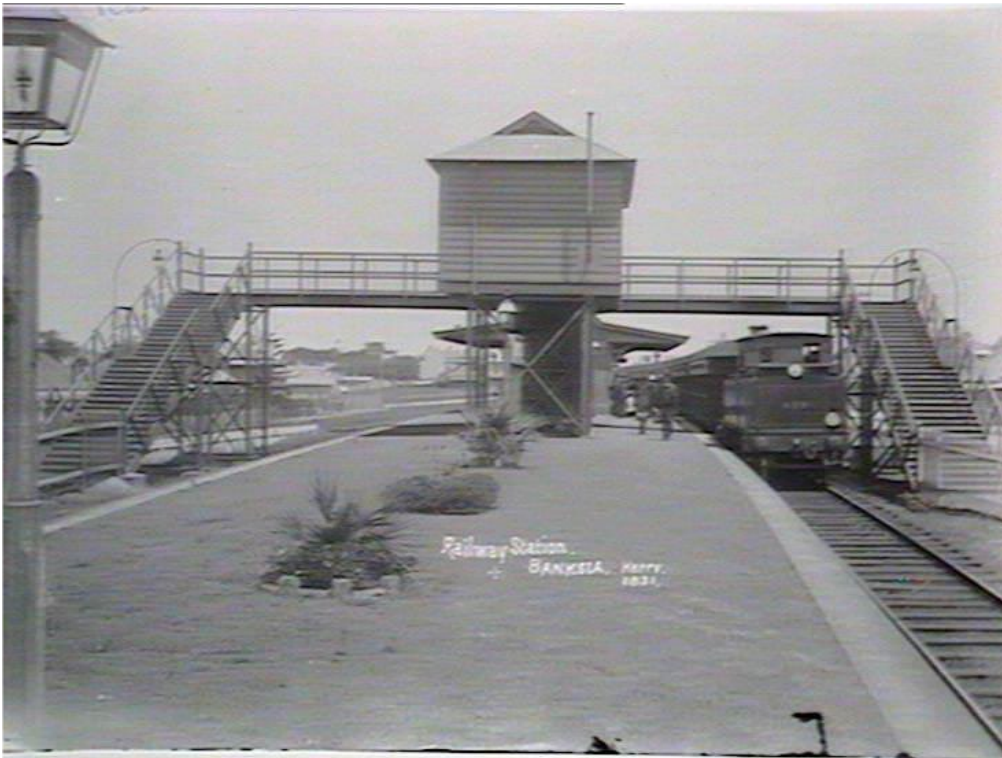
The 1906 Banksia Station comprised a station platform, and a small station building (current Platform 2/3 building) sited to the south of the platform. The station pedestrian footbridge expanded from Railway Street to Hattersley Street with a small weatherboard ticket office located to the north of the footbridge (Figure 4.4 and Figure 4.5). The station platform featured several small garden beds along with a signal box located to the southwest of the original platform. A lamp room was originally sited to the southern boundary of the island platform (Figure 4.6).

Figure 4.5: Banksia Station looking north, 1910s (Source: SHD Banksia Station group)

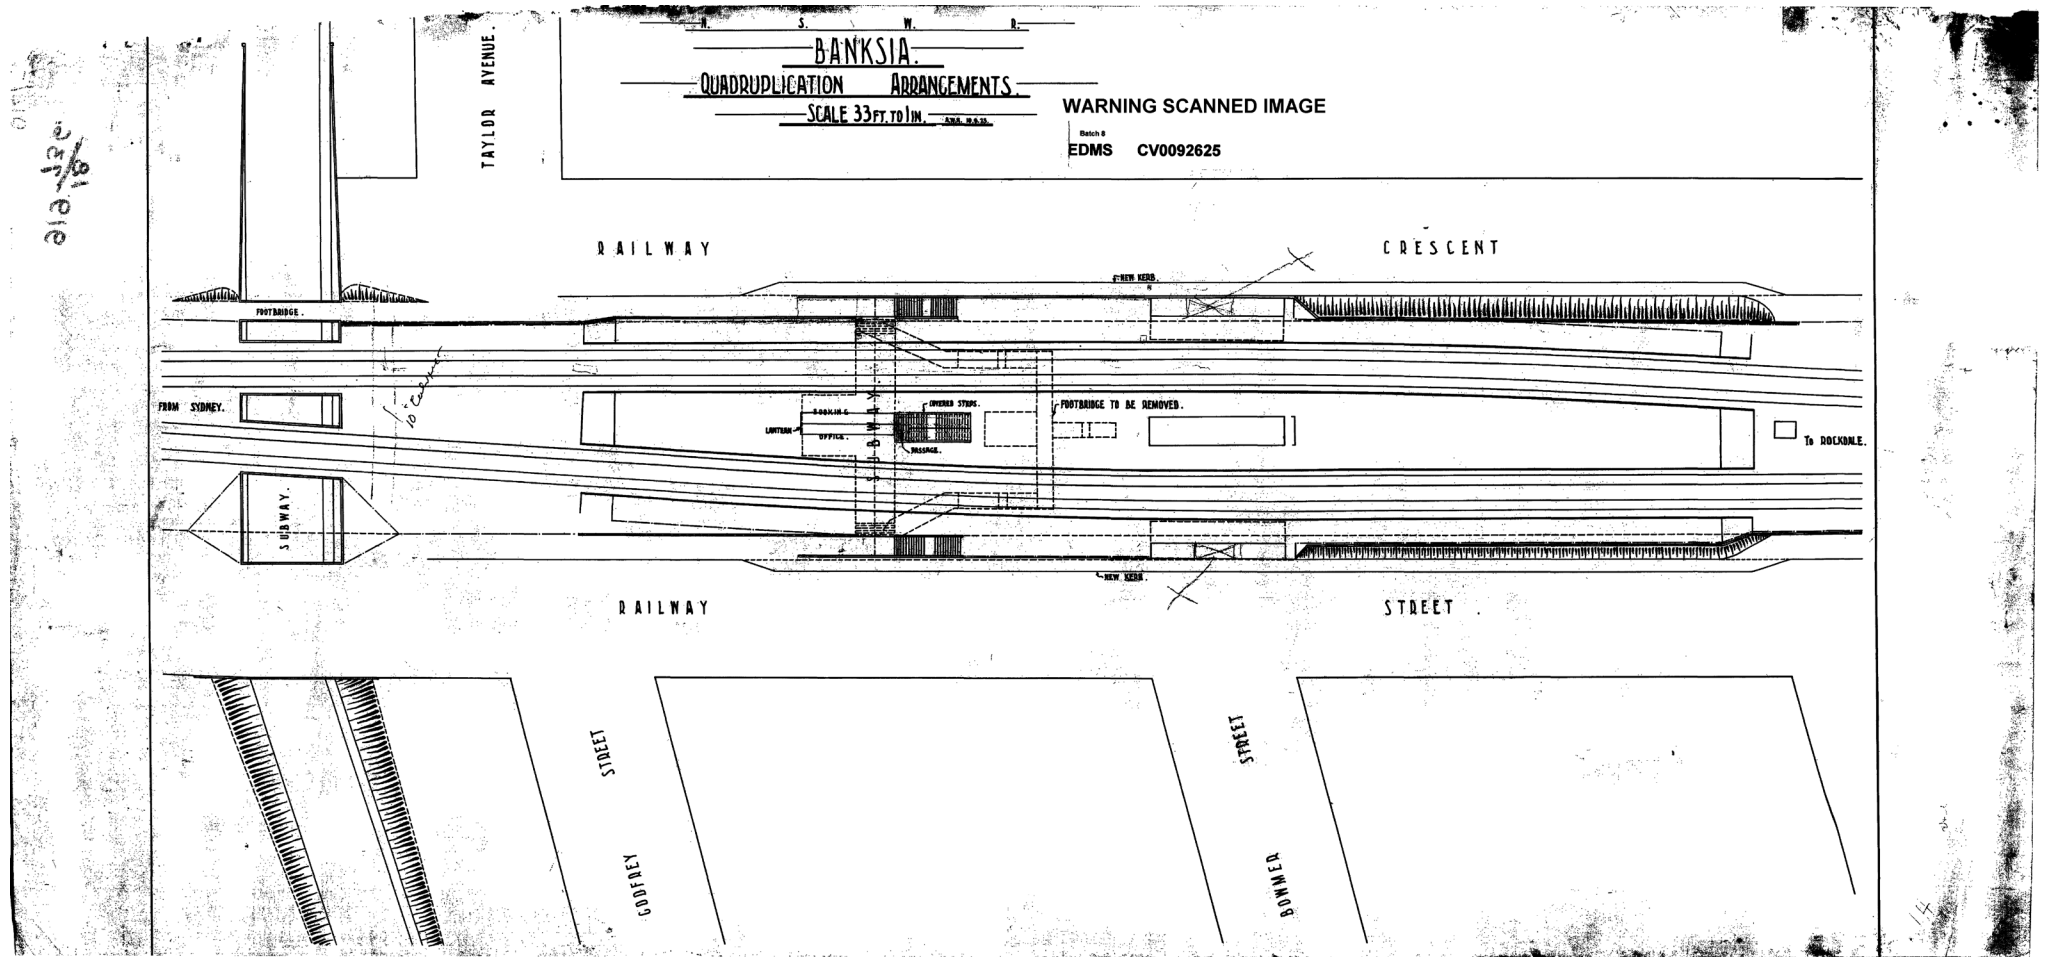
Figure 4.10: Banksia Station completed quadruplication arrangements, c. 1923 (Source: Source: Sydney Trains plan room)

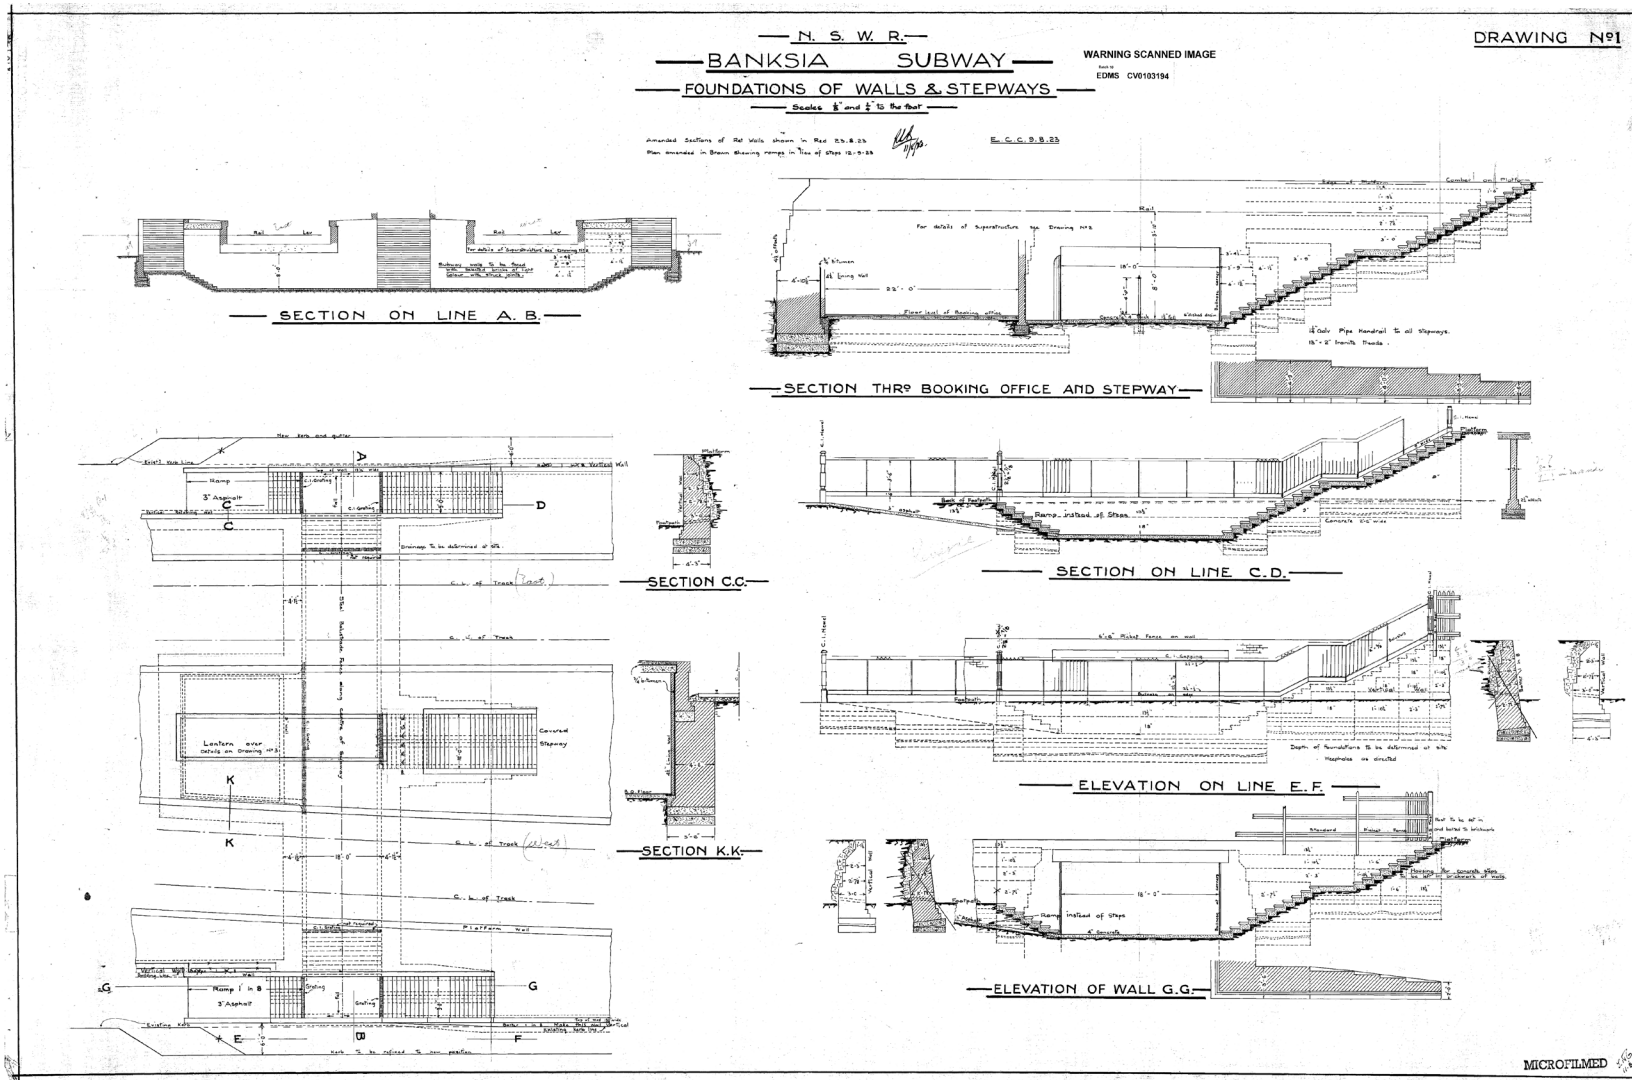
Figure 4.15: N.S.W.R Banksia Station foundations of walls and stepways, c. 1923 (Source: Sydney Trains plan room)

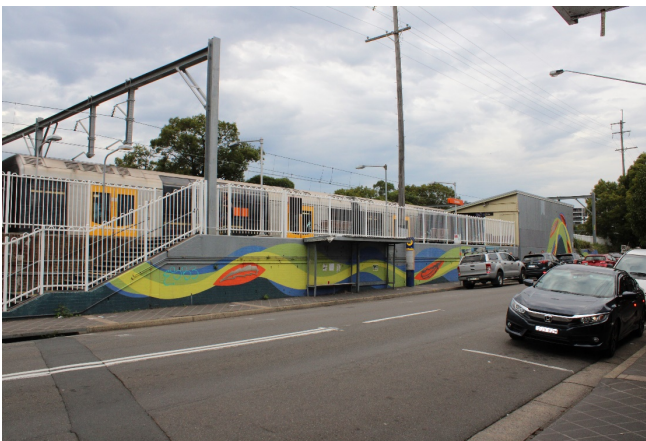
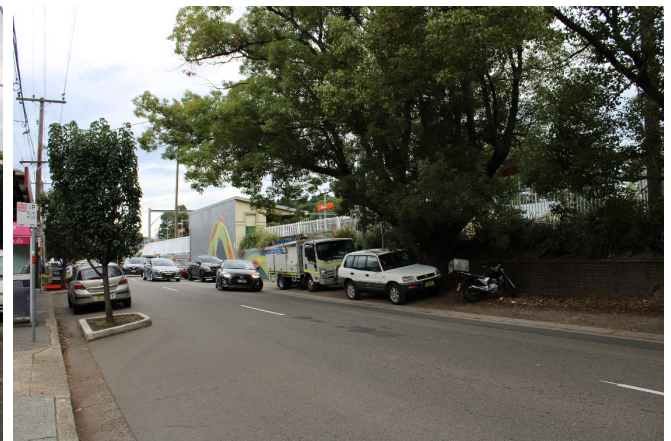
The station is located between Railway Street (Figure 5.1 and Figure 5.2) and Hattersley Street (Figure 5.3 and Figure 5.4) and is entered from both streets via a pedestrian subway which accesses all platforms. Access to the station is also possible from stairs from both entrances. There are two side platforms and one island platform (Platforms 2/3).

Figure 5.1: Entrance to Banksia Station on Railway Street, facing east (Source: Jacobs 2020)

Figure 5.2: Entrance to Banksia Station on Railway Street, facing north east (Source: Jacobs 2020)

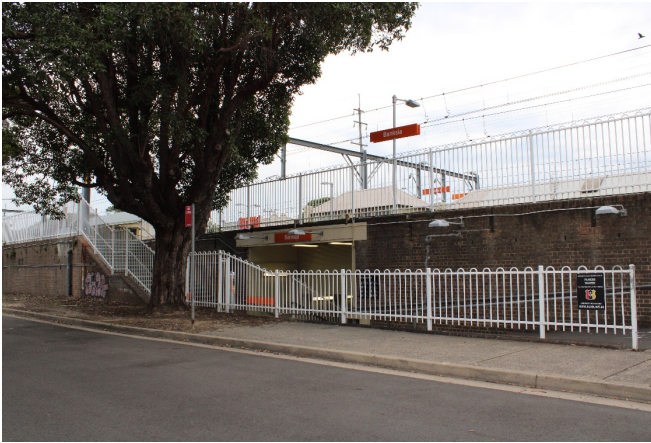
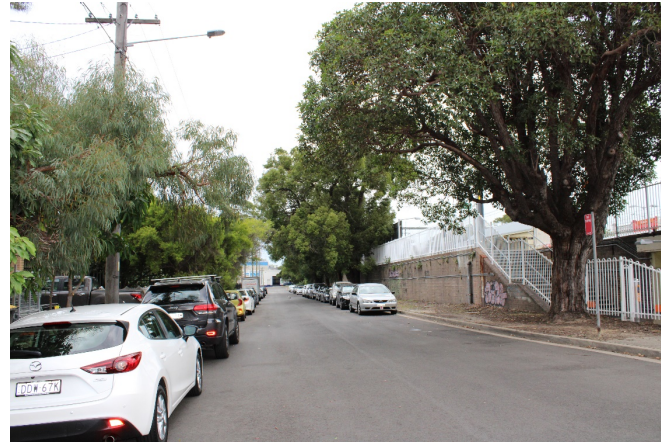
Figure 5.3: Entrance to Banksia Station on Hattersley Street, facing west (Source: Jacobs 2020)

Figure 5.4: Entrance to Banksia Station on Hattersley Street, facing south (Source: Jacobs 2020)

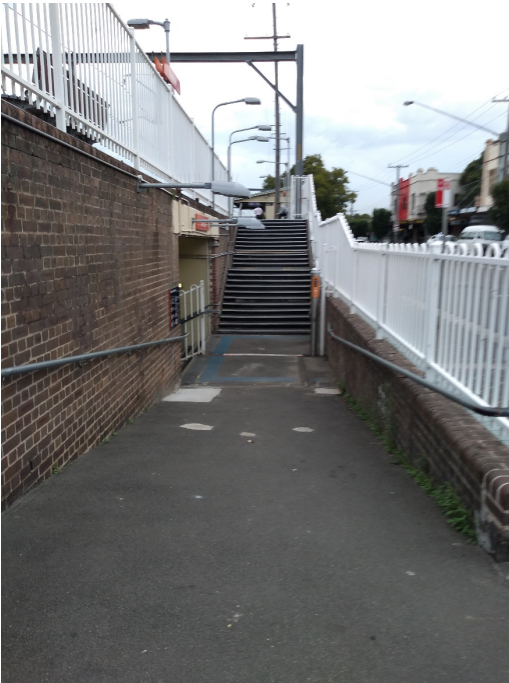
The pedestrian subway provides access to all platforms along with the booking office. Entry to the subway on Railway Street is provided via sloped cement ramp (Figure 5.5). The ramp is adjacent to a brick retaining wall. A through stair at the ramp landing also provides access to Platform 1 (Figure 5.6 and Figure 5.7). At the lowest point of the ramp, a set of stairs provides access to the pedestrian subway (Figure 5.8 and Figure 5.9).

Figure 5.5: Entrance to subway on Railway Street, facing south (Source: Jacobs 2020)

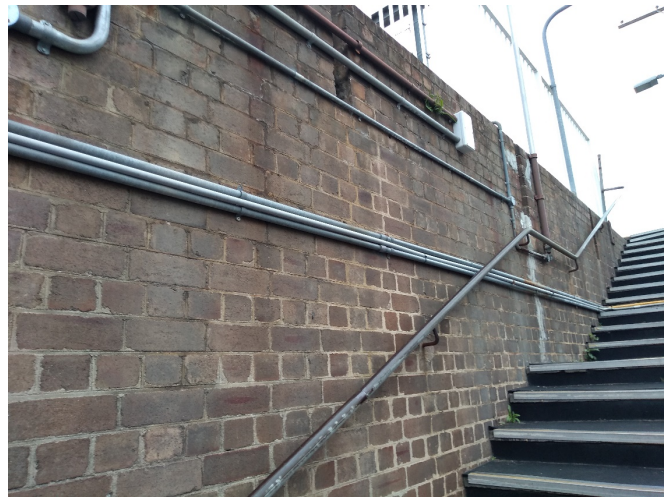
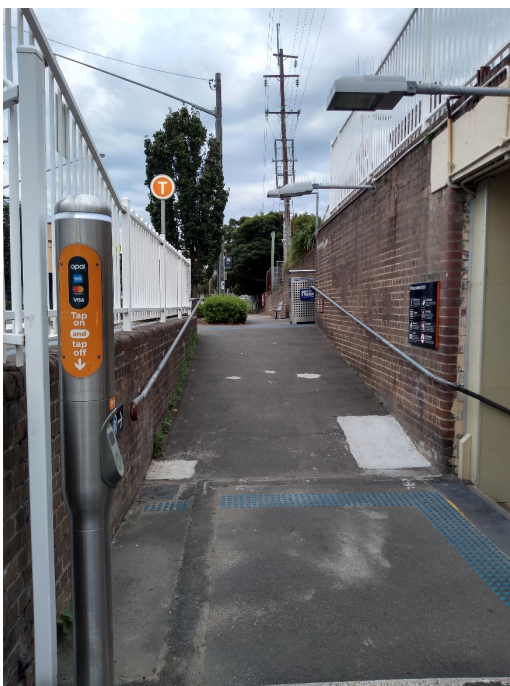
Figure 5.6: Detail of staircase to Platform 1 accessed from Railway Street, facing south) (Source: Jacobs 2020)

Figure 5.7: Entrance to subway on Railway Street, facing north (Source: Jacobs 2020)

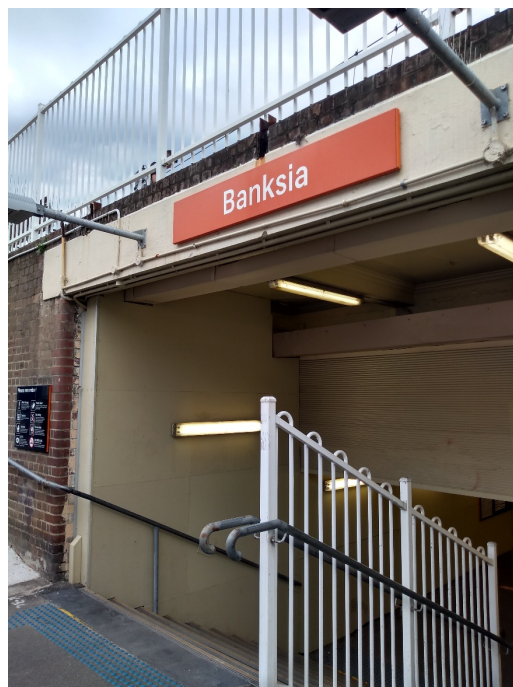
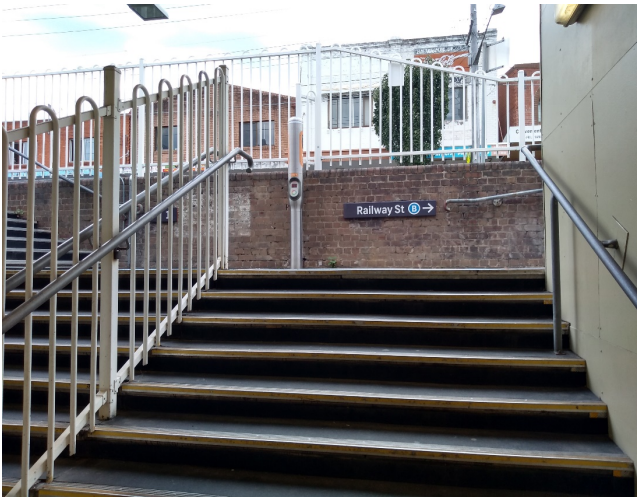
Figure 5.8: Detail of subway entrance on Railway Street side, facing east (Source: Jacobs 2020)

Figure 5.9: Detail of subway entrance on Railway Street side, facing west (Source: Jacobs 2020)

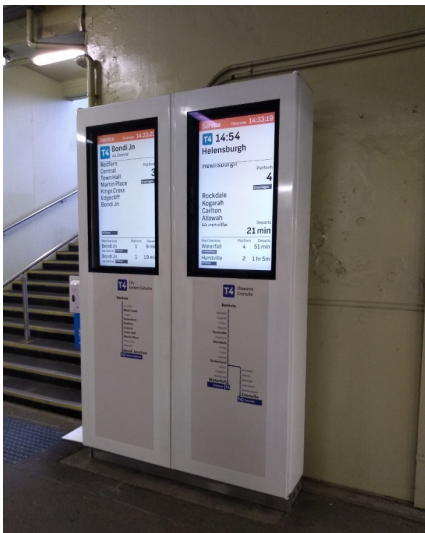
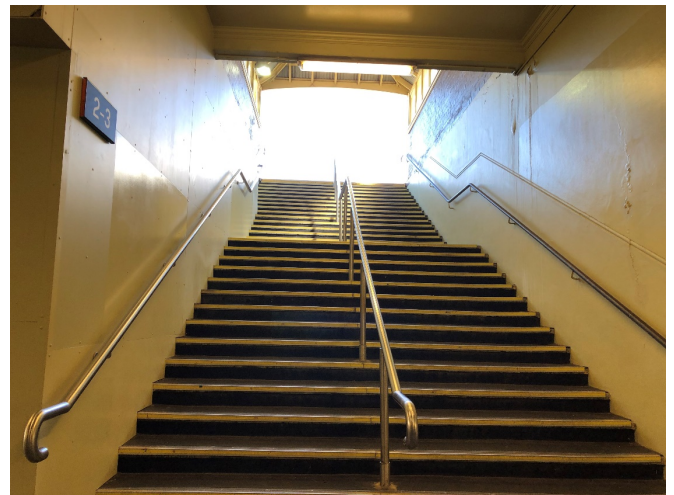
The pedestrian subway is approximately 32 metres long (Figure 5.10). The interior of the subway is a combination of exposed face brick at the higher levels and rendered plaster walls at pedestrian level with integrated dado details and stop mouldings to verticals. The later plasterboard panels to conceal services and manage water ingress are likely fibre cement panelling. There are several areas which have no plasterboards however, the brickwork has been painted the same yellow cream colour. Halfway down the subway is a booking office, an electronic timetable and a stairwell which provides access to Platform 2/3 (Figure 5.11 and Figure 5.12).

Figure 5.11: Electronic train timetable located in subway, facing south (Source: Jacobs 2020)

Figure 5.12: Stairs leading from subway to Platform 2/3, facing south (Source: Jacobs 2020)

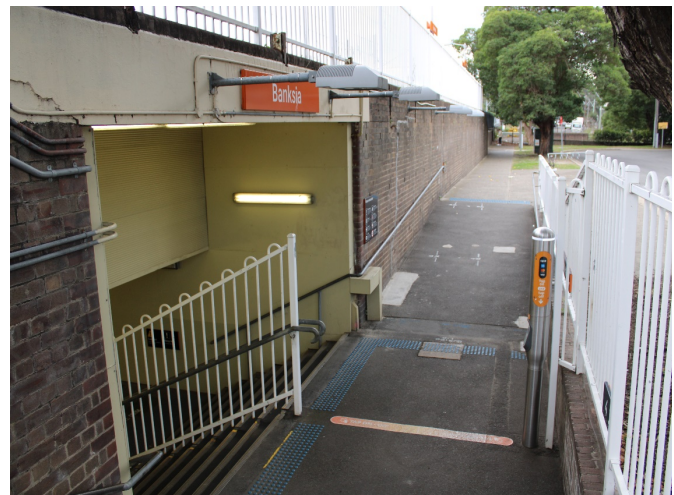
The Hattersley Street entrance mirrors the entrance on Railway Street, wherein the subway leads to a set of stairs which leads up to street level (Figure 5.13 and Figure 5.14). A sloped cement ramp is located to the north, and a set of stairs leading to Platform 4 to the south (Figure 5.15).

Figure 5.14: Detail of subway entrance on Hattersley Street, facing north (Source: Jacobs 2020)

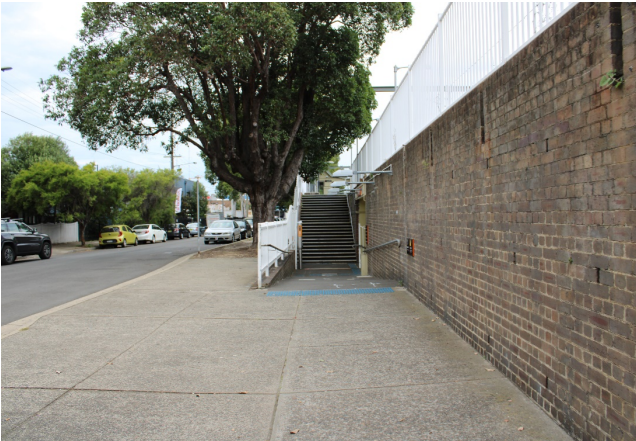
Figure 5.15: Entrance to subway on Hattersley Street, facing south (Source: Jacobs 2020)

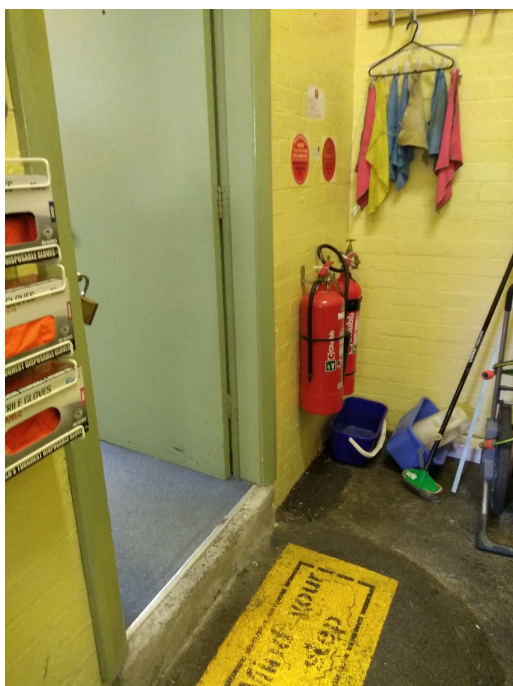
The booking office located in the middle of the subway consists of a small room with a ticket window (Figure 5.16). The original ticket window has been infilled and is no longer visible. The booking office is entered through a modern doorway into a small storage area (Figure 5.17 and Figure 5.18). A former door would have been located to the north however, it has been subsequently bricked up. The walls and ceilings in the storage room consist of brick, support beams, and plasterboard, all of which have been coloured to a yellow cream (Figure 5.19 and Figure 5.20).

Figure 5.18: Entrance from subway to booking office, facing south west (Source: Jacobs 2020)

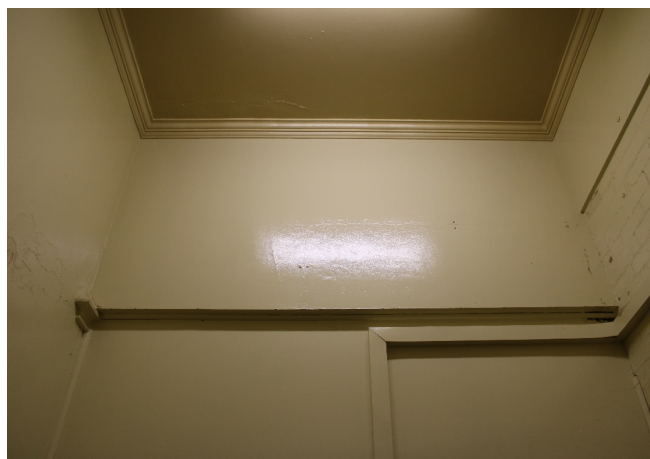
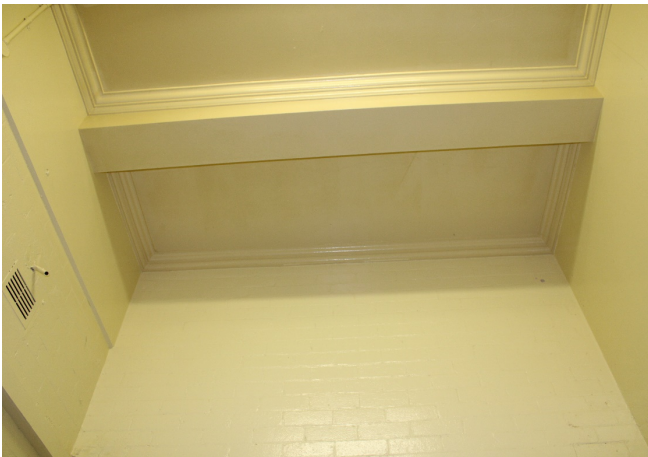
Figure 5.19: Detail of ceiling and brick walls in entry space for booking office (source: Jacobs 2020)

Figure 5.20: Detail of ceiling and brick walls in entry space for booking office (Source: Jacobs 2020)

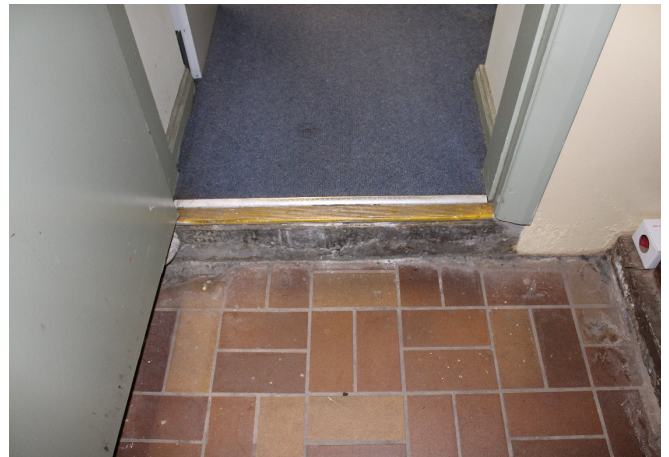
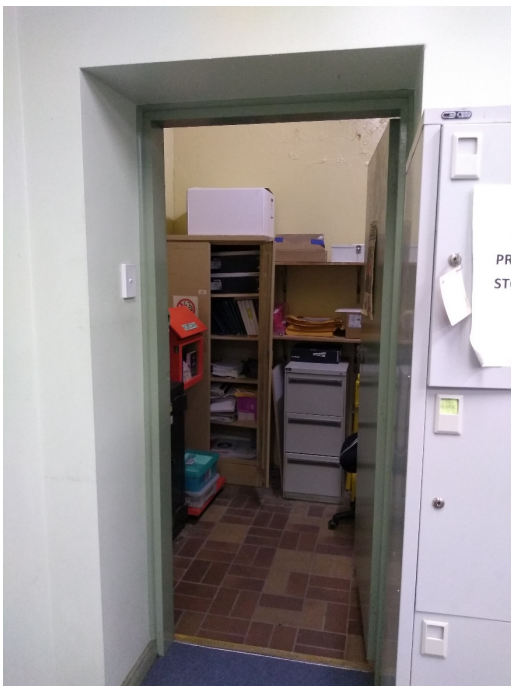
A small room is located northeast of the main booking office room. This room contains a tiled floor and houses office furniture and several filing cabinets (Figure 5.21 Figure 5.22). The storage room leads to the small booking office which contains a small kitchenette (Figure 5.23 and Figure 5.24). Adjacent to the kitchenette is a doorway which shows that the interior walls are offset from the original (Figure 5.25). This offset has meant the original booking office interior walls are intact (Figure 5.26 and Figure 5.27).

Figure 5.21: Detail of tiling in front of entrance to booking office (Source: Jacobs 2020)

Figure 5.22: Small room housing office materials (Source: Jacobs 2020)

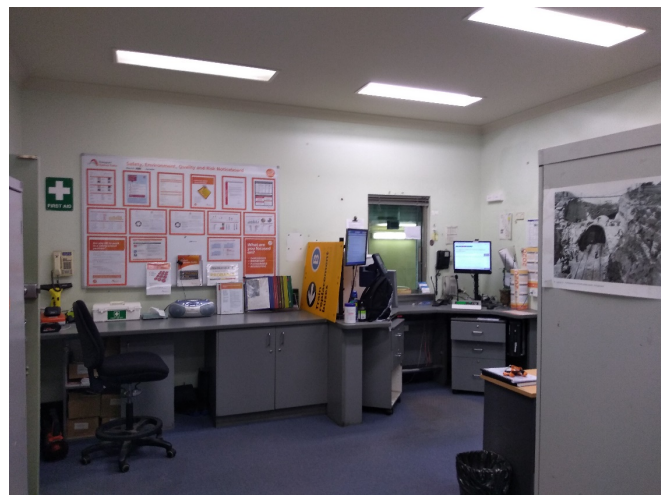
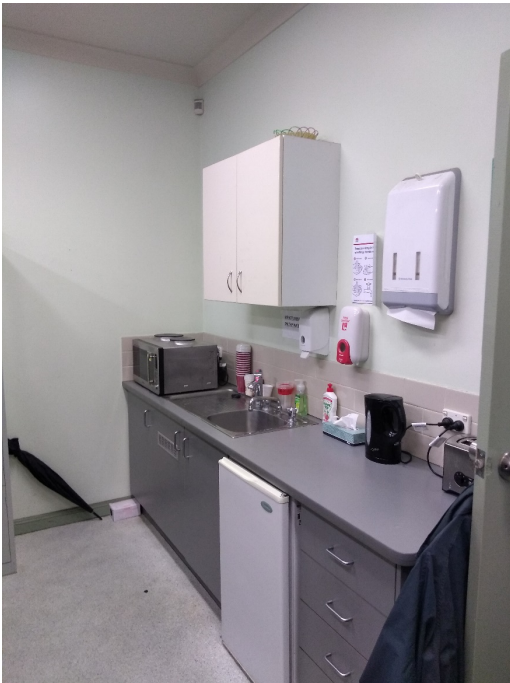
Figure 5.23: Interior booking office, facing south (Source: 2020)

Figure 5.24: Kitchenette in booking office (Source: Jacobs 2020)

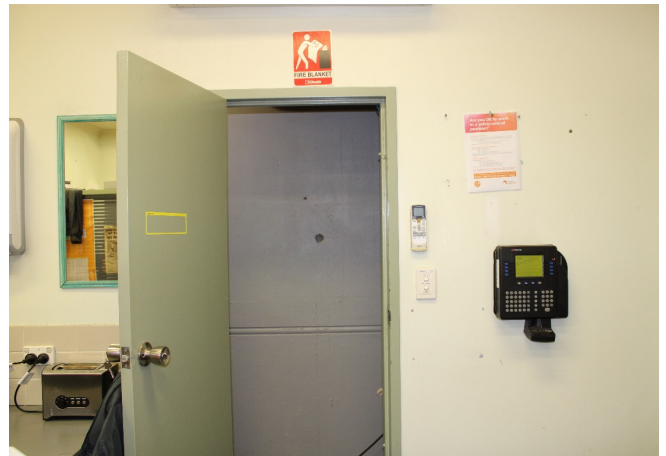
Figure 5.25: Door inset which shows original booking office interior (Source Jacobs 2020)

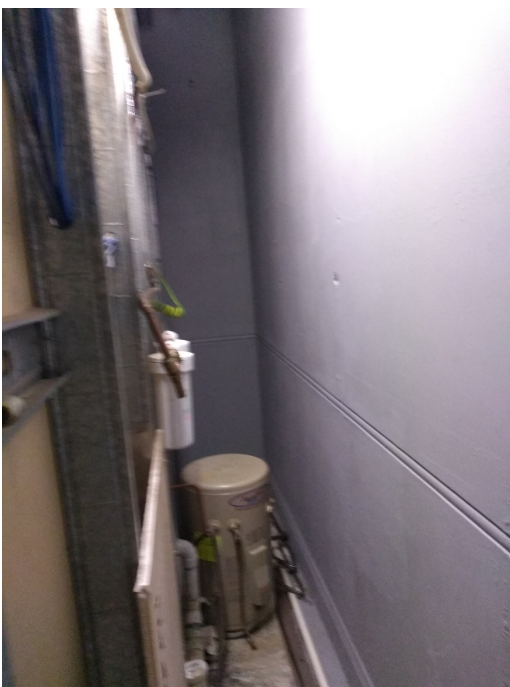
Figure 5.26: Detail on inset and spacing from original interior (Source: Jacobs 2020)

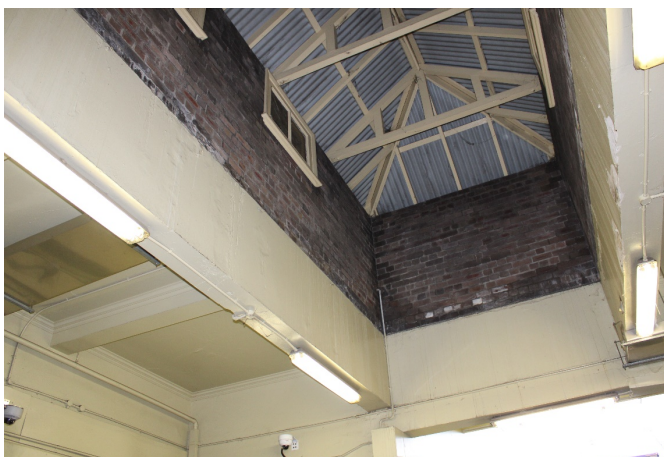
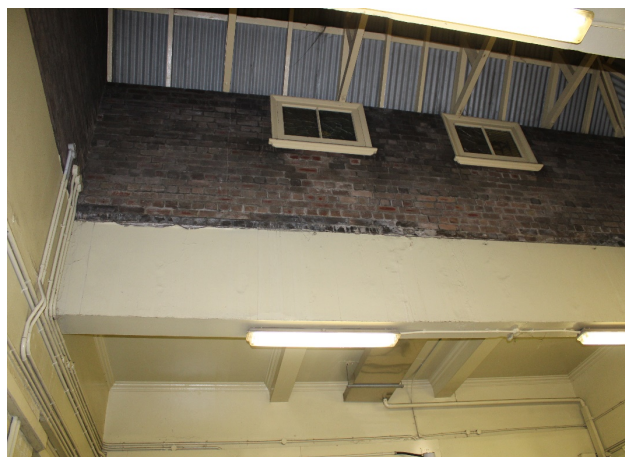
To the north of the pedestrian subway is a narrow vaulted corrugated steel roof structure which shelters the booking office and subway below (Figure 5.28). The brown face brickwork is visible, along with several timber framed windows. These timber frames, along with the timber roof beams have been painted a yellow cream. The windows would have enabled natural light to entry into the subway. They have been subsequently filled in (Figure 5.29). The subway lantern structure is visible on the northern end of Platform 2/3. The exterior bricks have been painted a similar yellow cream colour as within the subway (Figure 5.30 and Figure 5.31).

Figure 5.28: Northern lantern vaulted roof viewed from subway (Source: Jacobs 2020)

Figure 5.29: Northern lantern vaulted roof viewed from subway (Source: Jacobs 2020)

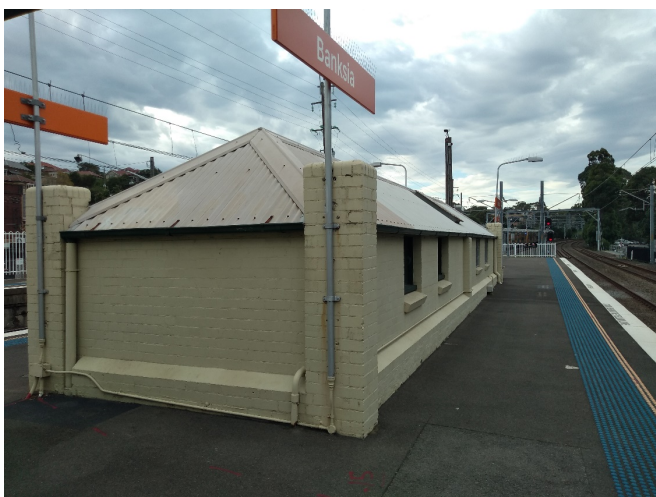
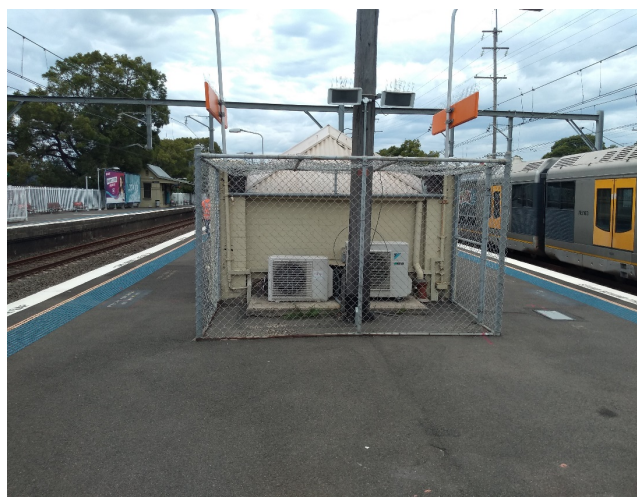
Figure 5.30: Exterior of vaulted roof, located on Platform 2/3, facing north west (Source: Jacobs 2020)

Figure 5.31: Exterior of vaulted roof, located on Platform 2/3, facing south (Source: Jacobs 2020)

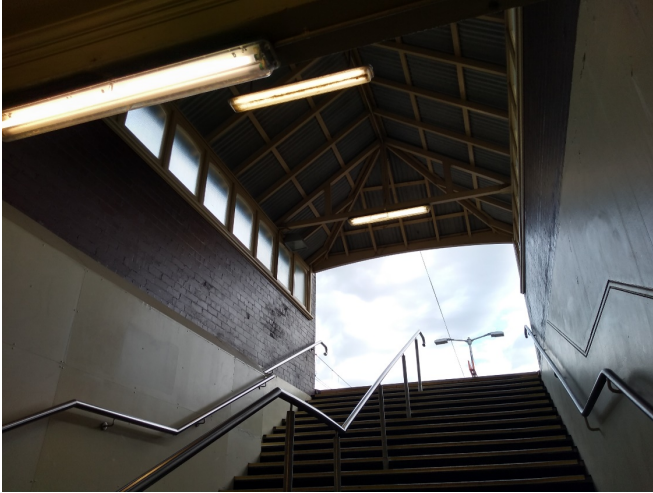
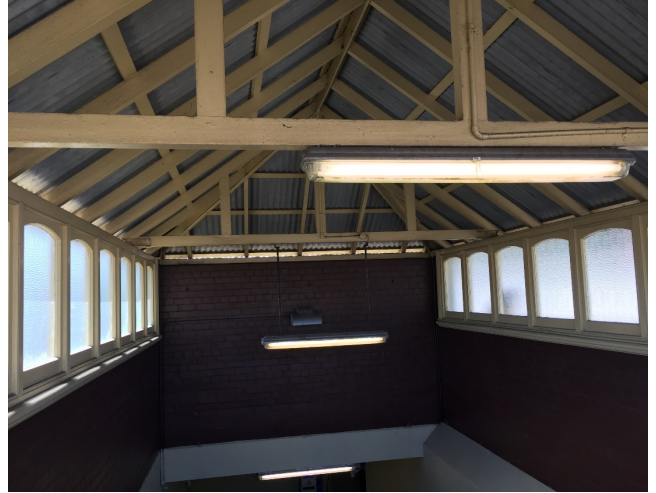
The stairwell which provides access to Platform 2/3 is enclosed by a hipped corrugated steel roofed brick and timber structure above (Figure 5.32 and Figure 5.33). The structure has fixed timber framed windows each side which provide natural light into the stairwell and down into the subway (Figure 5.34). The roof timber beams have been painted a yellow cream, while the brickwork has been painted earthy brown (Figure 5.35).

Figure 5.32: Stairwell and roof leading to Platform 2/3, facing south (Source: Jacobs 2020)

Figure 5.33: Detail of roof covering over stairwell, facing north (Source: Jacobs 2020)

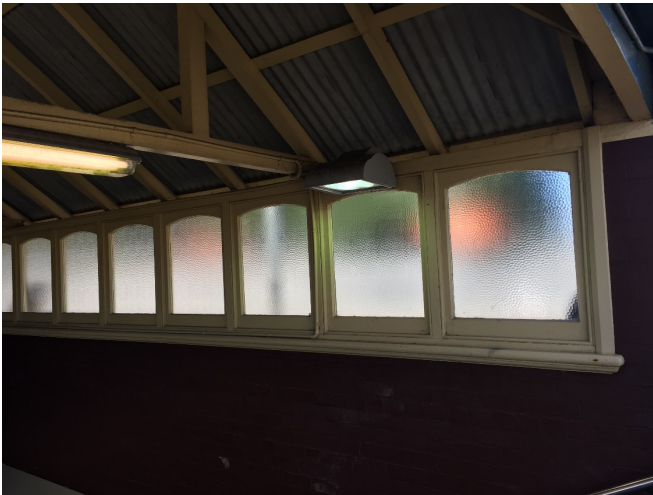
Figure 5.34: Detail of windows and brick work of the stairwell lantern structure, facing north east (Source: Jacobs 2020)

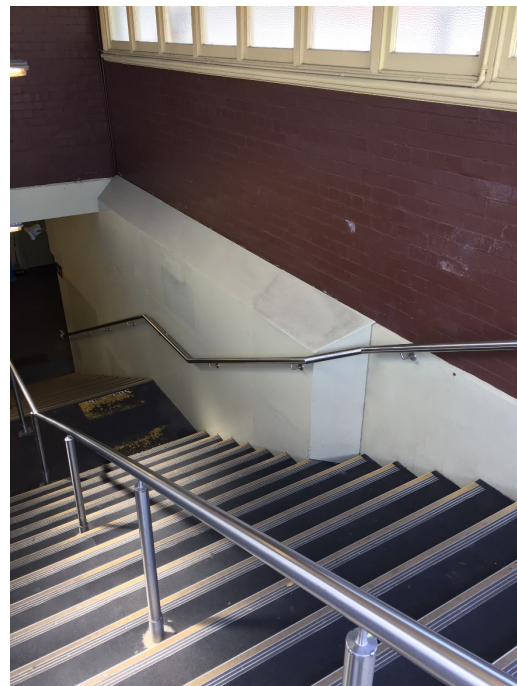
Figure 5.35: Detail of alterations in stairwell, facing north (Source: Jacobs 2020)

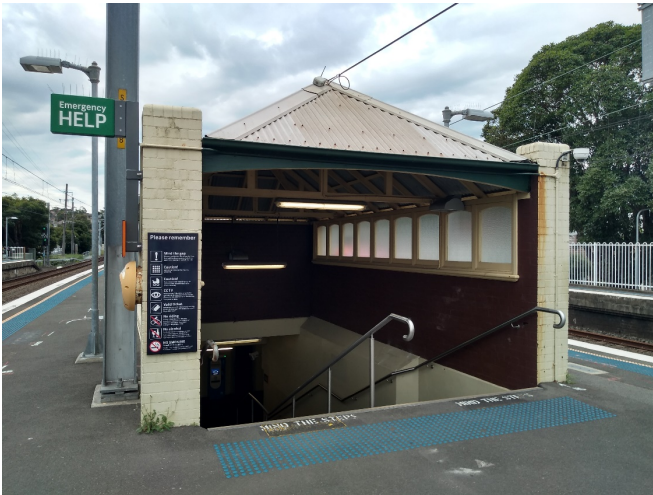
The lantern structure is located on Platform 2/3 between the northern subway lantern and platform building. The brick and timber surfaces have been painted the same yellow cream as the timber beams. An emergency help point is located on the west side of the building (Figure 5.36). The row of frosted glass windows is visible along the east and west sides of the building (Figure 5.37). Both the stairwell lantern structure and the subway lantern structure (described in Section 5.3.1) are located in line with one another on Platform 2/3 (Figure 5.38).

Figure 5.36: Entrance to stairwell lantern structure from Platform 2/3, facing north (Source: Jacobs 2020)

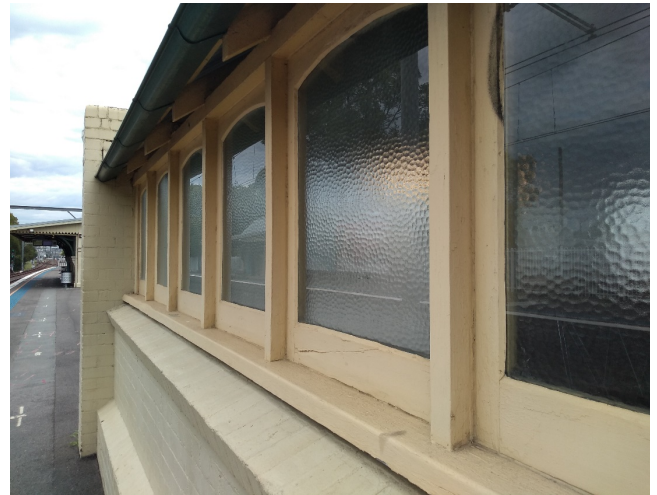
Figure 5.37: Detail of exterior windows of stairwell lantern structure, facing south east (Source: Jacobs 2020)

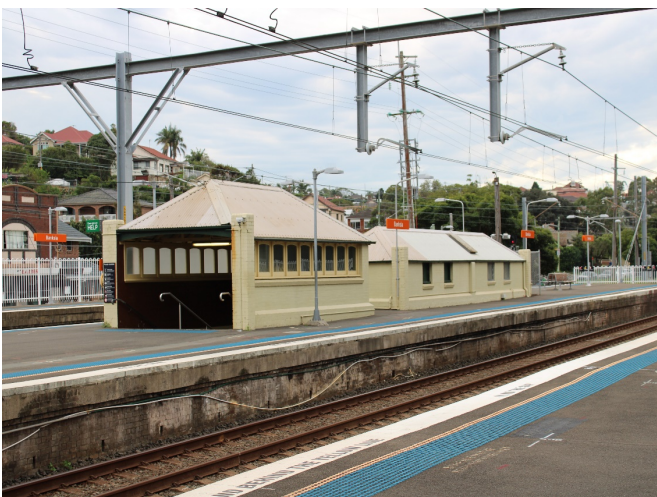
Figure 5.38: Exterior of both lantern structures, facing north west – taken from Platform 4 (Source: Jacobs 2020)

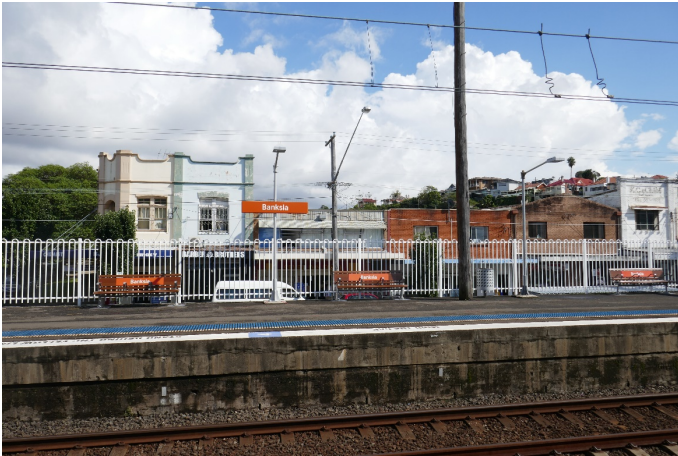
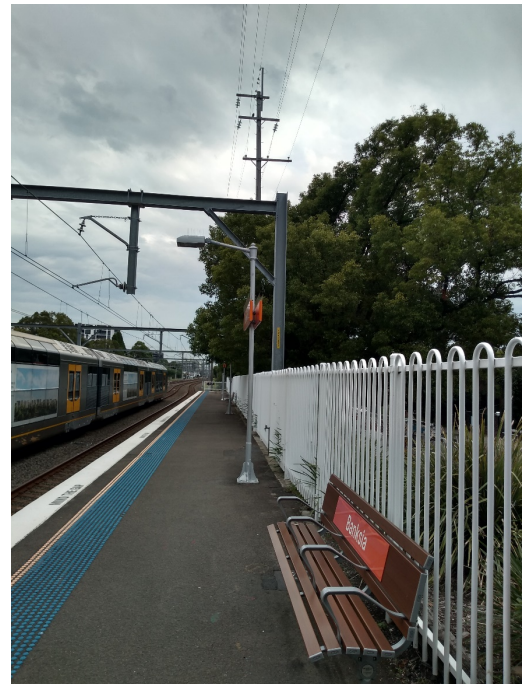
Platform 1 is a perimeter platform located adjacent to Railway Street. Built in 1923, the platform consists of an asphalted platform with concrete and brick coping (Figure 5.39). Seat benches are available on the length of the platform, along with lights and rubbish bins (Figure 5.40).

Figure 5.39: View of Platform 1 from Platform 2, facing west (Source: Jacobs 2020)

Figure 5.40: Platform 1, facing south (Source: Jacobs 2020)

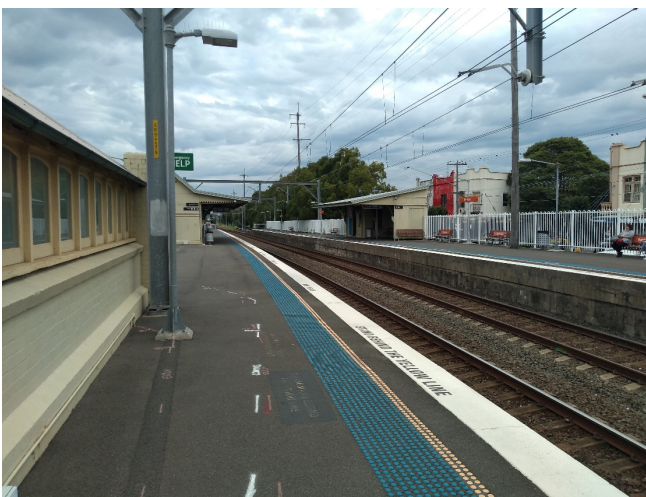
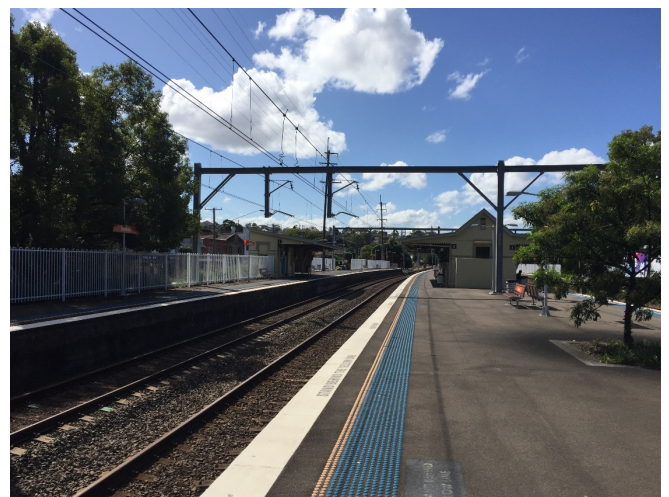
Platform 2 forms part of the original island platform constructed in 1906. The platform consists of an asphalted layer with concrete and brick coping (Figure 5.41 and Figure 5.42). Bench seats are available on the length of the platform, along with lights and rubbish bins. The platform has been extended northward since its original construction.

Figure 5.41: Platform 2, facing south (Source: Jacobs 2020)

Figure 5.42: Platform 2, facing north (Source: Jacobs 2020)

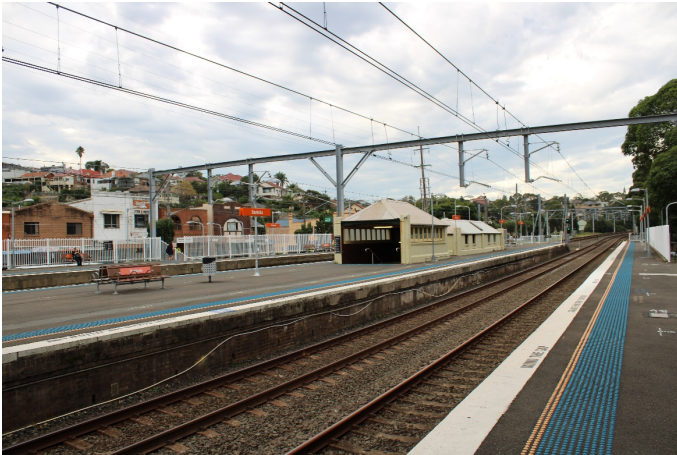
Platform 3 forms part of the original island platform constructed in 1906. As with Platform 2, this platform has an asphalted layer with concrete and brick coping. Bench seats are available on the length of the platform, along with lights and rubbish bins. The platform has been extended northward since its original construction.

Figure 5.43: View of Platform 3 from Platform 4, facing north west (Source: Jacobs 2020)

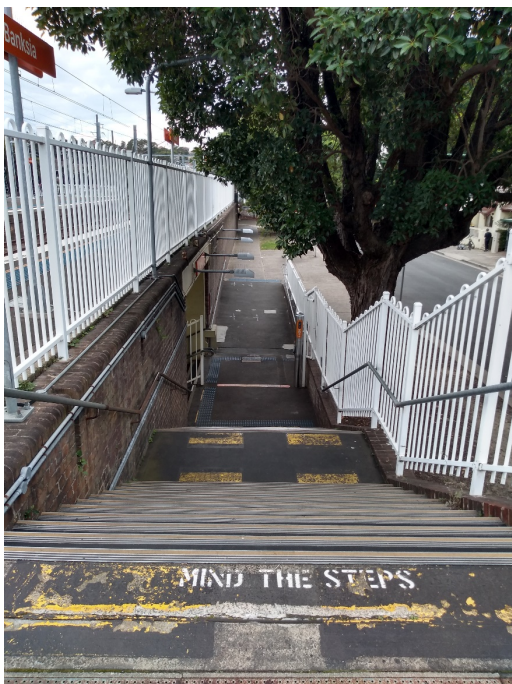
Figure 5.45: Entrance to Platform 4 from Hattersley Street, facing north (Source: Jacobs 2020)

Platform 4 was constructed in 1923 and is a perimeter platform at Banksia Station. The platform is adjacent to Hattersley Street and is accessed by pedestrian steps located near the subway entrance (Figure 5.45 and Figure 5.46). The platform consists of an asphalted platform with concrete and brick coping. Bench seats are available on the length of the platform, along with lights and rubbish bins (Figure 5.47 and Figure 5.48).

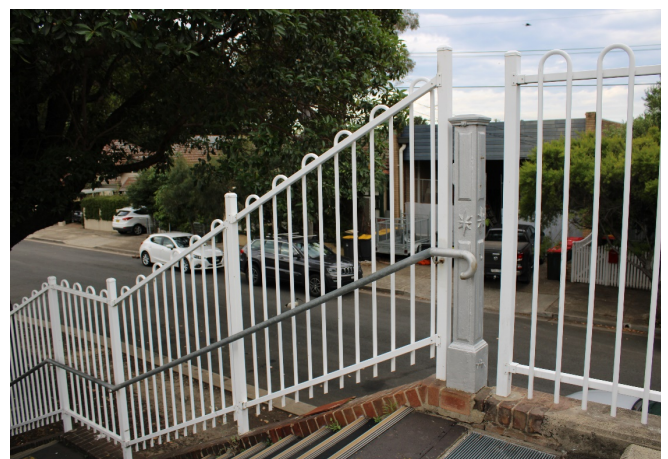
Figure 5.46: Detail of fencing on stairwell leading to Platform 4, facing north (Source: Jacobs 2020)

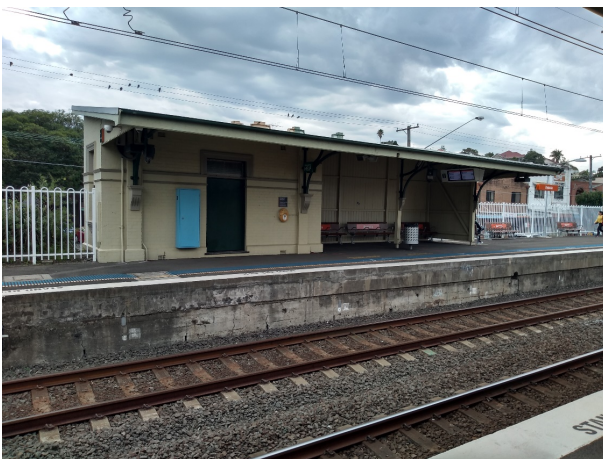
Figure 5.49: View of Platform 1 building from Platform 2, facing west (Source: Jacobs 2020)

Constructed in 1923, the building on Platform 1 is a small painted brick single storey building with an attached weatherboard waiting area (Figure 5.50) located towards the southern end of the platform (Figure 5.49). The building has a skillion corrugated steel roof with the overhanging awning cantilevered on steel brackets, mounted on rendered cement brackets (Figure 5.51). The brick section of the building has timber-framed double-hung windows, a 4-paned timber framed fanlight, and a modern timber flush door. The brick section of the building is decorated with stucco mouldings on the window and door heads. The window on the southern elevation of the building is covered over. The bottom sash of the window on the north elevation has a single horizontal glazing bar. Platform regrading has resulted in the original floor ventilation grates being covered over, however the original stone door threshold has been retained.

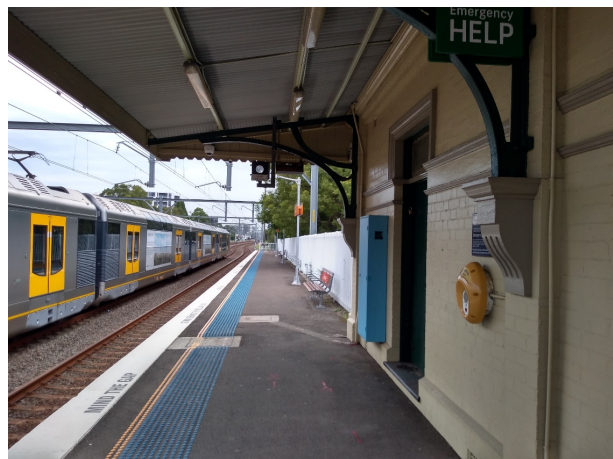
Figure 5.50: Platform 1 building, facing north (Source: Jacobs 2020)

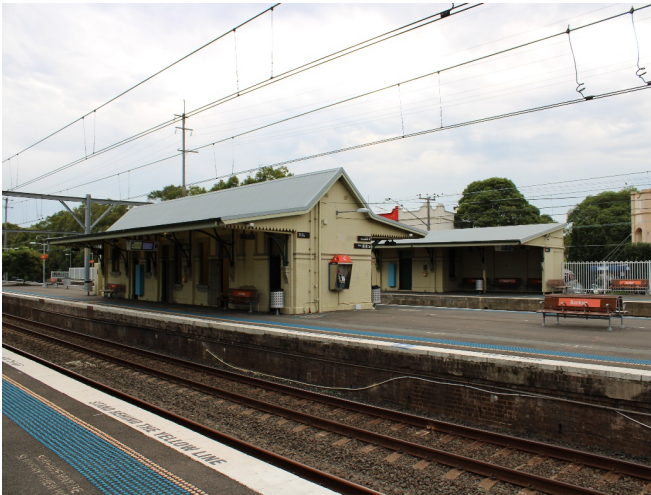
Figure 5.52: View of Platform 2/3 building from Platform 4, facing south west (Source: Jacobs 2020)

Constructed in 1906, the Platform 2/3 building is an example of a standard Type 11 railway building design. It is a painted brick single storey building with a gabled corrugated steel roof with sloped awnings on both sides (Figure 5.52 and Figure 5.53). Gable ends to north and south feature rectangular timber louvred vents. The building features timber-framed double-hung windows (windows within the waiting area have been removed) and two 8-paned fanlights. All doors are modern timber flush doors. The exterior walls feature two decorative stucco mouldings, the upper being more elaborate, and windows have decorative stucco sills (Figure 5.54). Decorative stucco mouldings also surround the window and door heads (Figure 5.56). The awnings on both sides of this building are identical, with sloped corrugated steel roofs cantilevered on steel brackets mounted on rendered cement wall brackets. The awnings have timber valances to each end (north and south) (Figure 5.56). There is an original door opening to the male toilets at the southern end of the building, which also features a brick screen wall. One window has been bricked up, and a number of windows are missing. Although the timber window frames remain in situ, the openings have been filled with modern steel security screens. The doorways to the waiting room have modern metal security doors. The original roof has been replaced and the original chimney stacks have been removed.

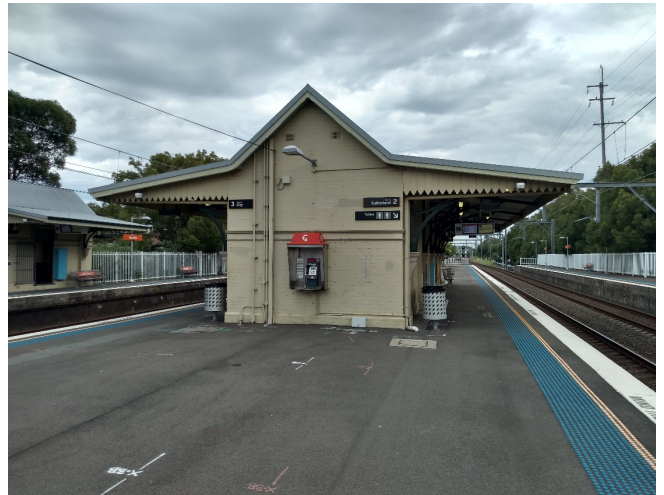
Figure 5.53: Platform 2/3 building, facing south (Source: Jacobs 2020)

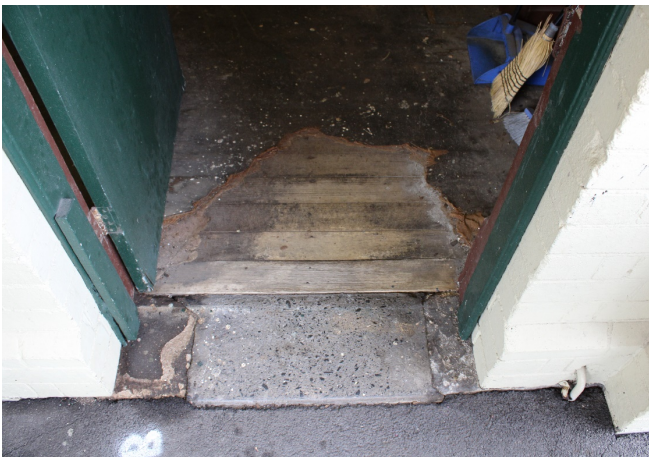
Figure 5.57: Original timber floorboards to storage room (Source: Jacobs 2020)

The small storage room in the Platform 2/3 building remains predominately intact and was utilised as a station manager's office between 1906 and 1923. The original timber floorboards are present throughout the extent of the room (Figure 5.57 and Figure 5.58). The original fireplace, grates and hearth remain intact (Figure 5.59). The storage room contains several heritage objects, these include: early rare timber-framed noticeboard with timber backing board and covered with hessian, timber office desk (drawers missing) with timber pigeonhole shelving above, early timber ticket cabinet with steel ticket holders inside, timber tray holding series of rubber stamps, desk with turned legs and two drawers, and cast iron sleeper tongs (Figure 5.60 and Figure 5.61). Although the original ceiling of corrugated iron with metal ceiling roses is present, modern light fixtures have been inserted to the centre of the ceiling (Figure 5.62).
