TAP 3 Banksia Railway Station

Statement of Heritage Impact

IA230700-RPT-002_SoHI | Final

Transport for NSW

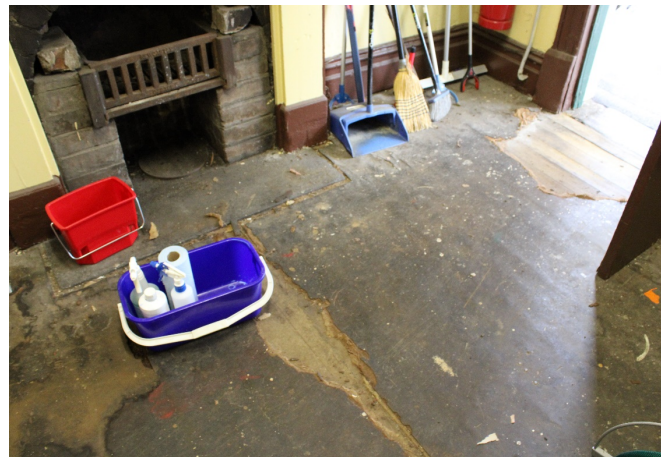
Figure 5.58: Original timber floorboards within storage room (Source: Jacobs 2020)

The small storage room in the Platform 2/3 building remains predominately intact and was utilised as a station manager's office between 1906 and 1923. The original timber floorboards are present throughout the extent of the room (Figure 5.57 and Figure 5.58). The original fireplace, grates and hearth remain intact (Figure 5.59). The storage room contains several heritage objects, these include: early rare timber-framed noticeboard with timber backing board and covered with hessian, timber office desk (drawers missing) with timber pigeonhole shelving above, early timber ticket cabinet with steel ticket holders inside, timber tray holding series of rubber stamps, desk with turned legs and two drawers, and cast iron sleeper tongs (Figure 5.60 and Figure 5.61). Although the original ceiling of corrugated iron with metal ceiling roses is present, modern light fixtures have been inserted to the centre of the ceiling (Figure 5.62).

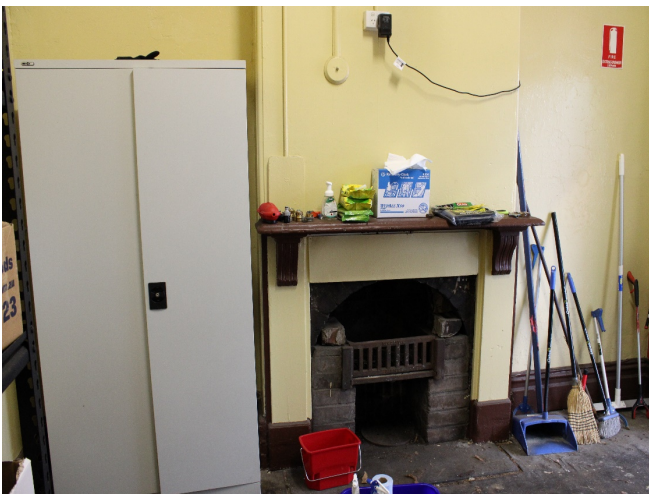
Figure 5.59: Original fireplace within storage room (Source: Jacobs 2020)

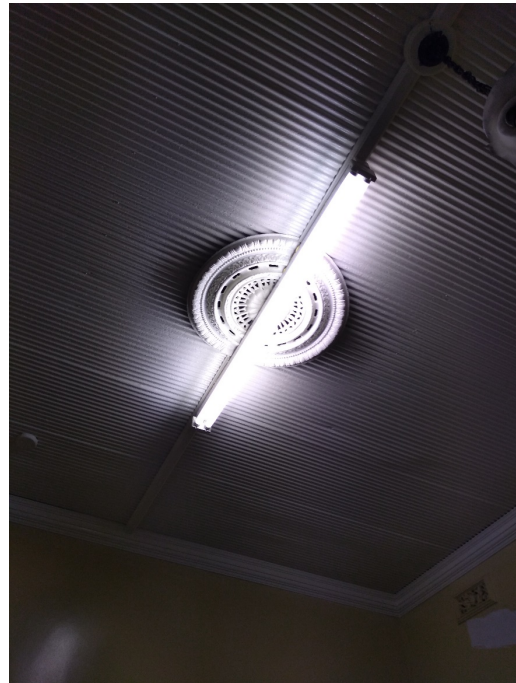
Figure 5.62: Original ceiling and rose within storage room (Source: Jacobs 2020)

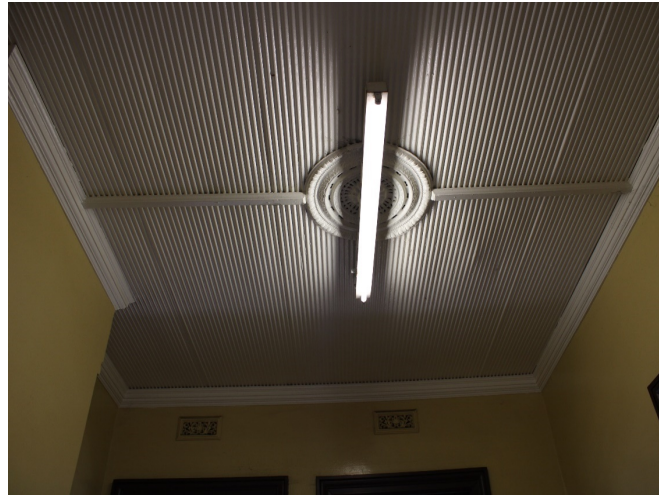
Figure 5.66: Original ceiling and rose within waiting room (Source: Jacobs 2020)

The original waiting room in Platform 2/3 building is accessed from both sides of the platform. Original timber floorboards are present under the later laminated floor surface (Figure 5.63). On the northern interior wall is a large mural of coastal banksia flowers painted by Leonie Morrison (Figure 5.64). Original timber waiting room benches are present (Figure 5.65). The entry doors and windows have been removed and replaced with modern security bars. The original fireplace has been infilled, however the original hearth is likely to still be present, as the floor rises slightly in this location. The original cornices, corrugated iron ceiling and ceiling rose are intact (Figure 5.66). The waiting room remains open to the public.

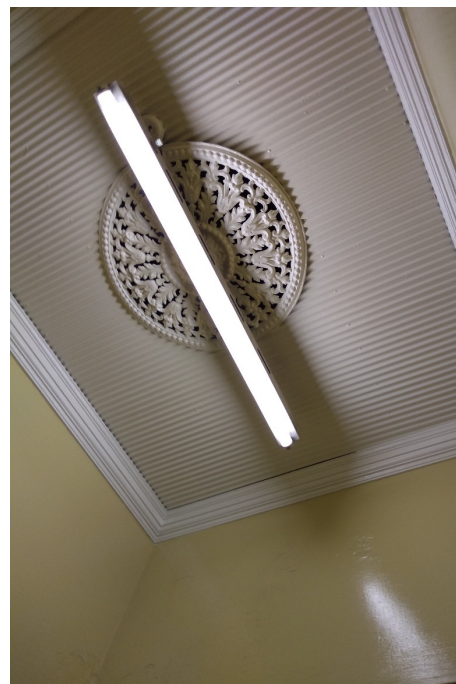
Figure 5.68: Original ceiling and rose within women's waiting room (Source: Jacobs 2020)

The women's waiting room and adjoining toilets in the Platform 2/3 building are accessed from both sides of the platform (Figure 5.67). Original timber floorboards may be intact below the modern flooring. Original corrugated iron ceiling, ceiling roses, cornices, and skirting boards remain intact within the waiting room (Figure 5.68). The original fireplace has been infilled.

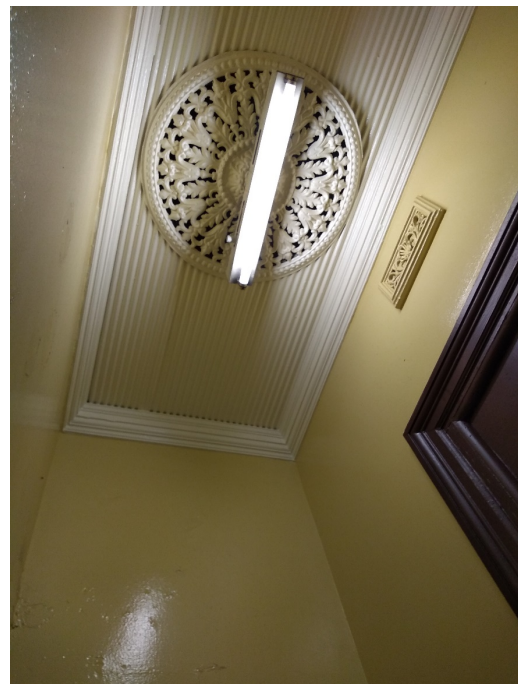
Figure 5.72: Original ceiling and rose within women's toilet stalls (Source: Jacobs 2020)

The women's toilets contain two stalls which are separated by a small room containing a sink (Figure 5.69). Stall locations appear to be original and the stall timber four pane doors are consistent with the construction period (Figure 5.70 and Figure 5.71). Renovations in the toilets have resulted in new tiled floors and walls. However, the original corrugated iron ceilings and ceiling roses remain intact (Figure 5.72).

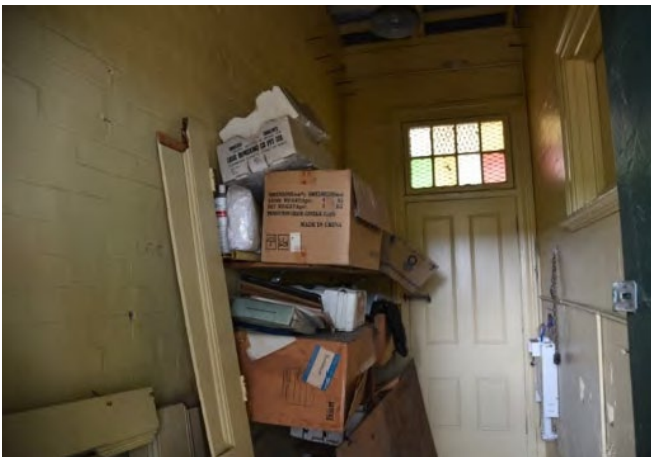
Figure 5.73: View of former cistern room (Source: Artefact Heritage (2020: 37))

'The former cistern room is currently utilised as a storage space (Figure 5.73). As the former use required little detailed attention, there is no ceiling and the roof structure is exposed. Brick walls have been painted and the concrete floor has been damaged and partially removed. The original coloured glass within the door transom remains intact. There is evidence of the original toilet openings along the southern wall of the room, which is a party wall to the men's toilet stalls (Figure 5.74). The locations of these openings depict that the original men's toilet stalls have been modified since construction.'

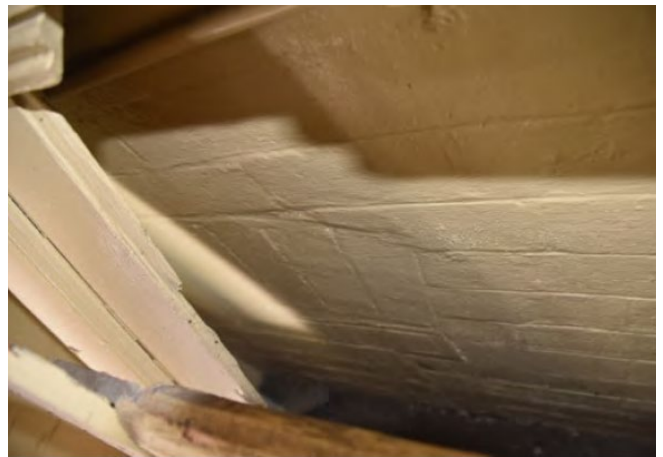
Figure 5.74: View of infilled openings within the cistern room (Source: Artefact Heritage (2020: 37))

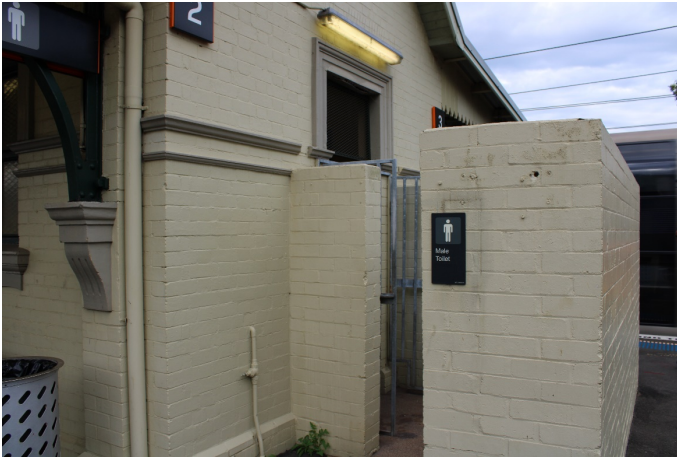
Figure 5.75: Entrance to men's toilet stalls (Source: Jacobs 2020)

The entrance to the men's toilets in the Platform 2/3 building is on the southern side of the building and is shielded by a brick privacy wall (Figure 5.75). The standard design from this period located the male toilets at the far end of the building and the room was accessed via a two-stage timber privacy screen. The opening in the end wall to provide access to the male toilets was typically a large opening with rendered mouldings – doors to the male toilets were not part of the standard design. Over time the timber privacy screens likely deteriorated given the unprotected vertical timber elements beyond the extent of the main roof. Subsequently many of the timber screens were replaced with brick screens as a more durable response. Many of the brick screens follow the historic two-stage alignment of the earlier timber screens (Pers. comms. Steven Barry 09/07/20). The original door has been removed and replaced with a modern security screen.

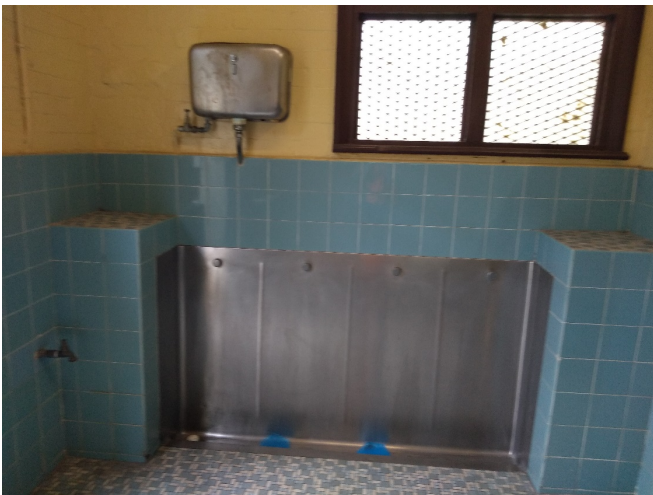
Figure 5.77: Interior of men's toilets (Source: Jacobs 2020)

The surface of the interior toilets consists of tiles (Figure 5.76). There are two stalls next to one another, with a urinal located on the west interior wall (Figure 5.77). The partition walls feature a curved brick parapet and timber battens to the top of the stalls. Modern tiles cover the original brickwork in sections. Original window openings have been partially covered, while the ceiling has been replaced with perforated panels.

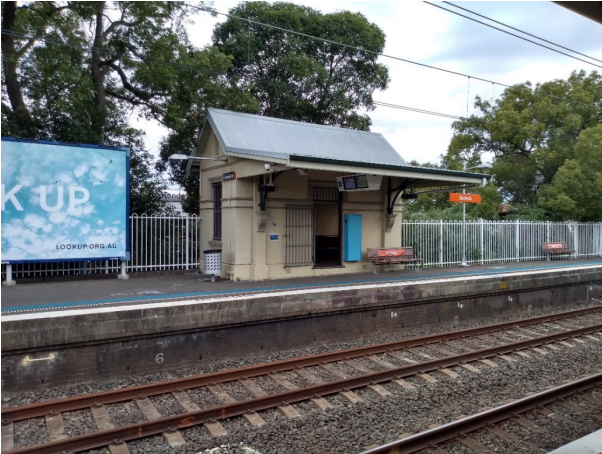
Figure 5.78: View of Platform 4 building from Platform 3, facing south east (Source: Jacobs 2020)

The building on Platform 4 is a small painted brick building (Figure 5.78) with a gabled corrugated steel roof and tongue-and-grooved timbered eaves (Figure 5.79). A corrugated steel sloped roof awning on the west side only is cantilevered on steel brackets mounted on rendered cement wall brackets, which are attached to a pair of pilasters either side of the central doorway. Original windows and the central door are missing, the openings filled with modern steel security door and screens. The walls of the building feature two stucco mouldings, the upper being more elaborate, and deep stucco mouldings around the fanlight opening above the central doorway. There are also decorative stucco sills to the window openings (Figure 5.80). There are rectangular timber-louvered vents with slightly arched heads to the gable ends.

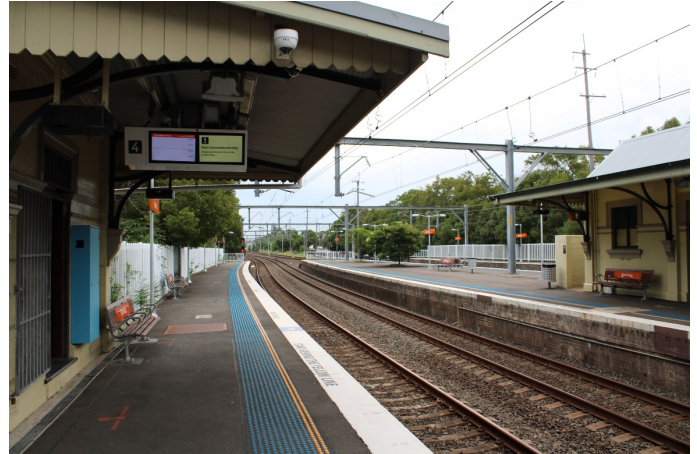
Figure 5.79: Platform 4, facing south (Source: Jacobs 2020)

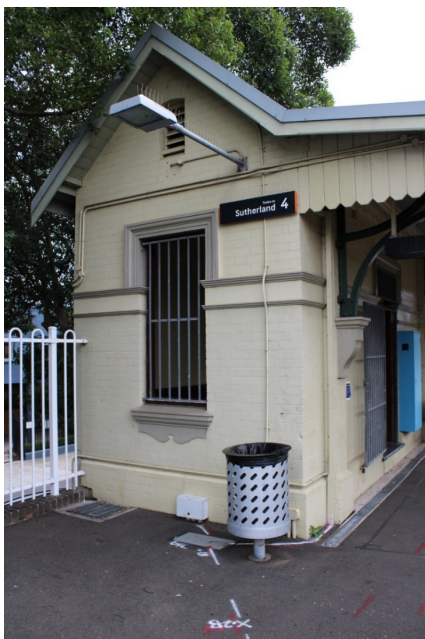
Figure 5.80: Platform 4, facing south (Source: Jacobs 2020)

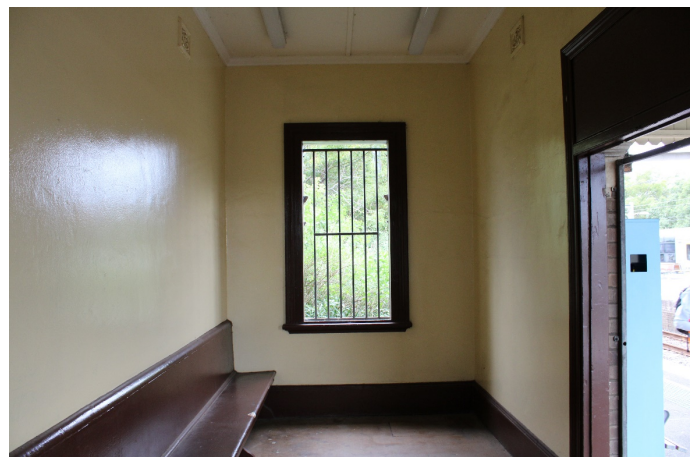
Figure 5.81: Interior of Platform 4 building, facing south (Source: Jacobs 2020)

The interior of the building is one single space which continues to function as a waiting room (Figure 5.81). The room consists of a timber-battened plaster ceiling with timber cornices, plastered walls, a slate threshold, and original timber seating. The original timber floorboards are evident below the modern floor surface.

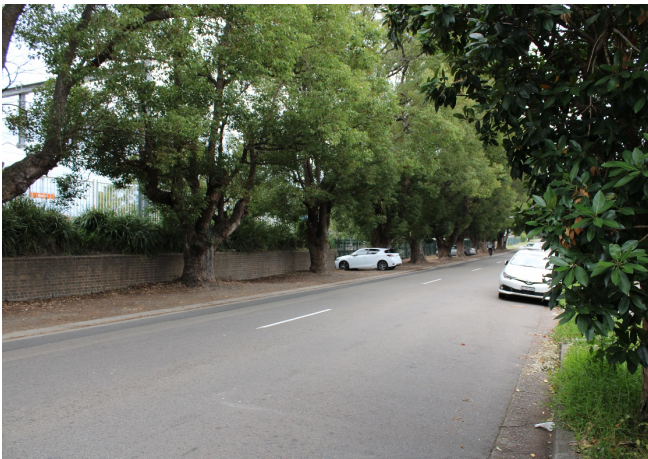
Figure 5.82: Brick retaining wall on Railway Street, facing south (Source: Jacobs 2020)

Surrounding Banksia Station are brick retaining walls built in 1923. The walls are located on both Railway Street and Hattersley Street. The walls are made from face brickwork and have a bullnose capping course. They are approximately 1.5 to 2 metres in height, reducing in height to both north and south ends. Part of the retaining wall on Railway Street forms the base of the Platform 1 building (Figure 5.82). Along the Railway Street side of the station, the retaining wall extends from a point opposite the Godfrey Street intersection at the north end, to a point opposite the Judd Street intersection at the south end. On the Hattersley Street side of the railway station, the brick retaining wall extends from a point opposite the Taylor Street intersection at the north end to a point at the south end on Hattersley Street opposite the rear of 345 Princes Highway. Part of the retaining wall on Hattersley Street, forms a base for the Platform 4 building (Figure 5.83 and Figure 5.84).

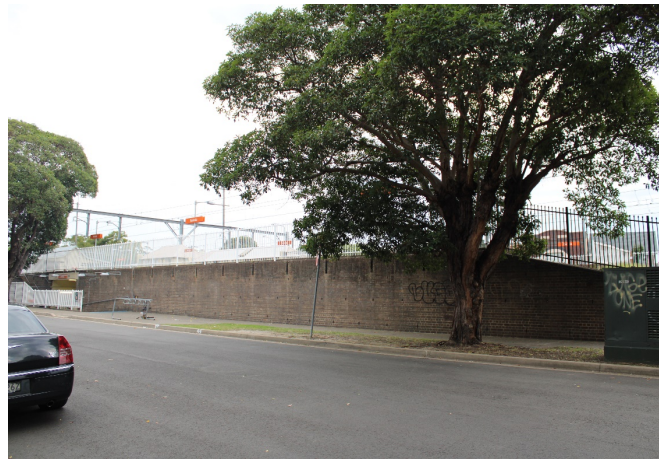
Figure 5.83: Brick retaining wall on Hattersley Street, facing west (Source: Jacobs 2020)

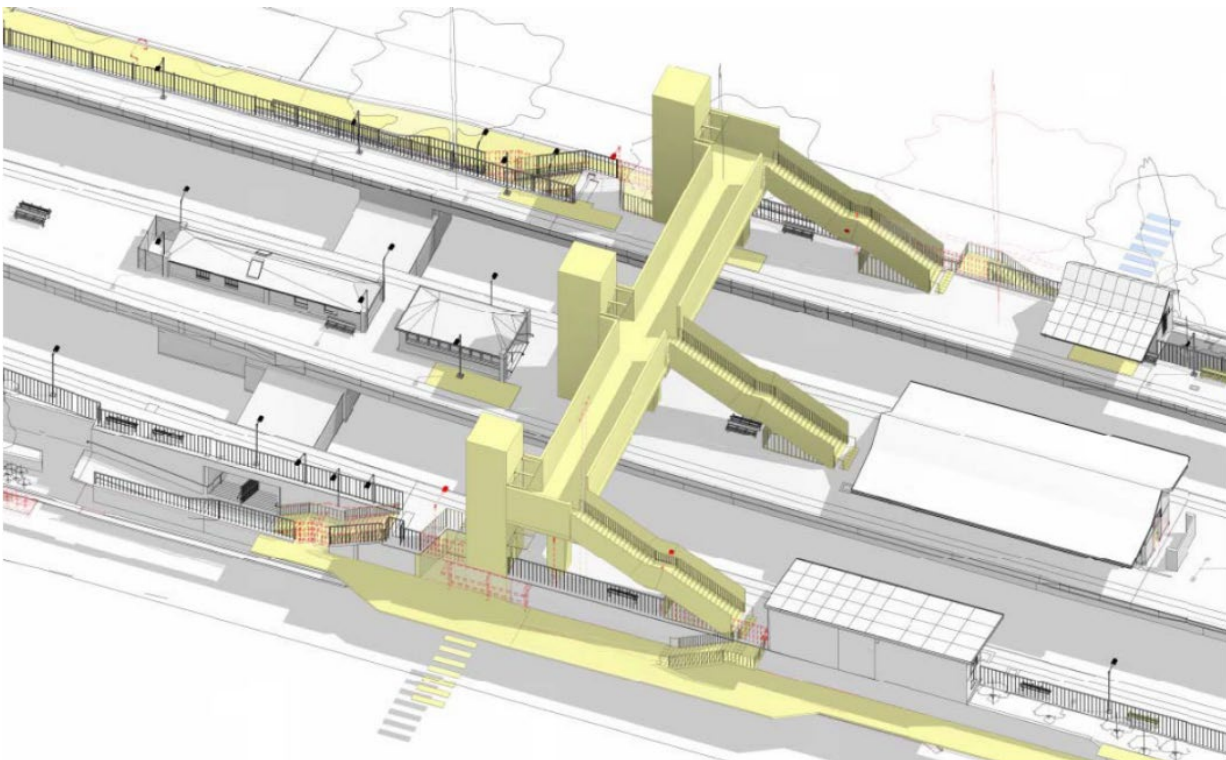
Figure 7.4: Banksia Station 2018 Preferred Option 3C Aerial view and Urban Design Plan

TfNSW developed a further concept design option based on option 2 from the AECOM study. This option was known as option 3C. Option 3C was selected to continue developing, as it provided the best customer experience, with the provision of a pedestrian bridge and accessible lifts linking the three platforms. Option 3C also has minimal to nil impact to the heritage fabric of the underpass (Figure 7.3 and Figure 7.4).

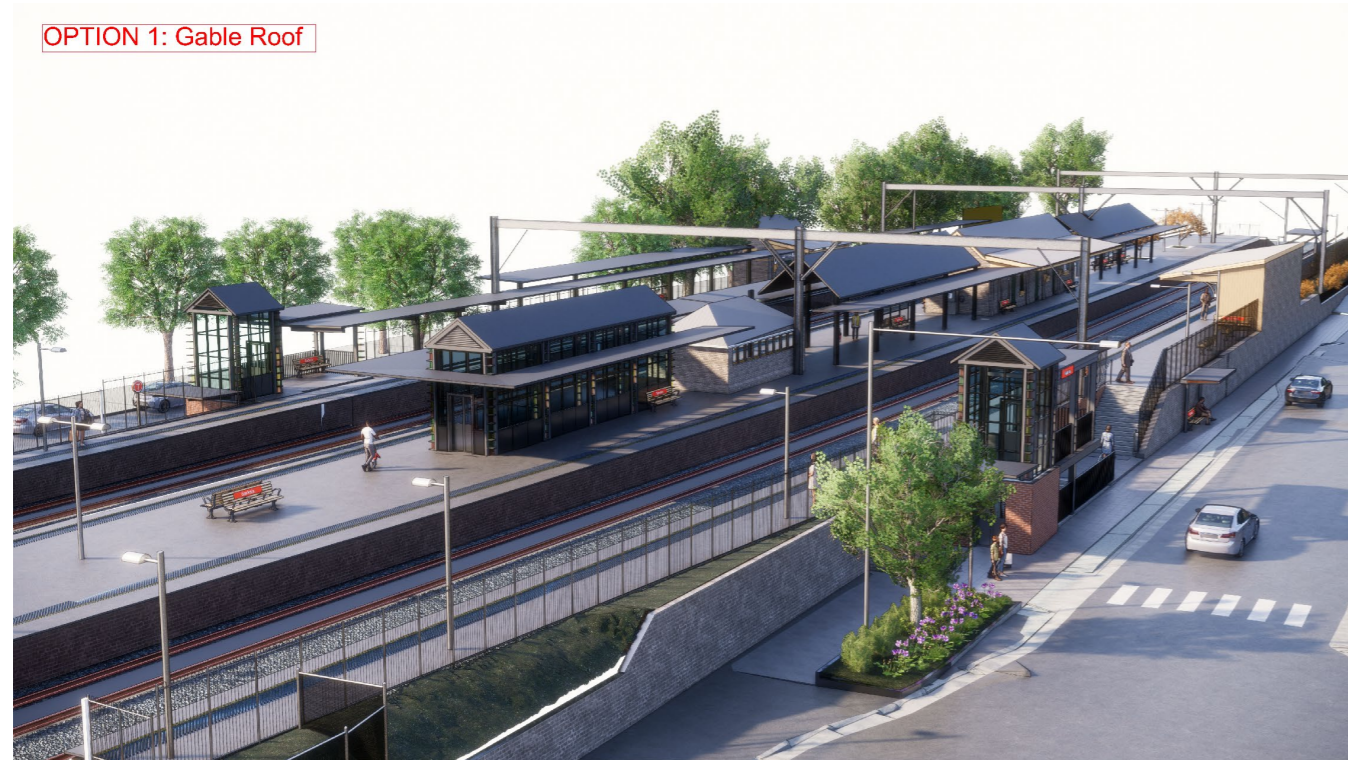
Figure 7.13: Option 1 – Gable roof (Source: Downer (2020))

As a result of this design process, three options for the platform canopies were presented at a meeting between Downer, TfNSW, and Arcadis on 23 June 2020 (Option 1, 2 and 3 in Table 7.7). Following an examination of all three options, a fourth option (Option 4) combining elements of the original options with minor modifications provided a best for project approach. Consensus was reached with this option due to the overall reduction in visual impact, simplified form that was consistent across all platforms and benefits to constructability. The four options are summarised in Table 7.6 and shown in Figure 7.13 to Figure 7.16.

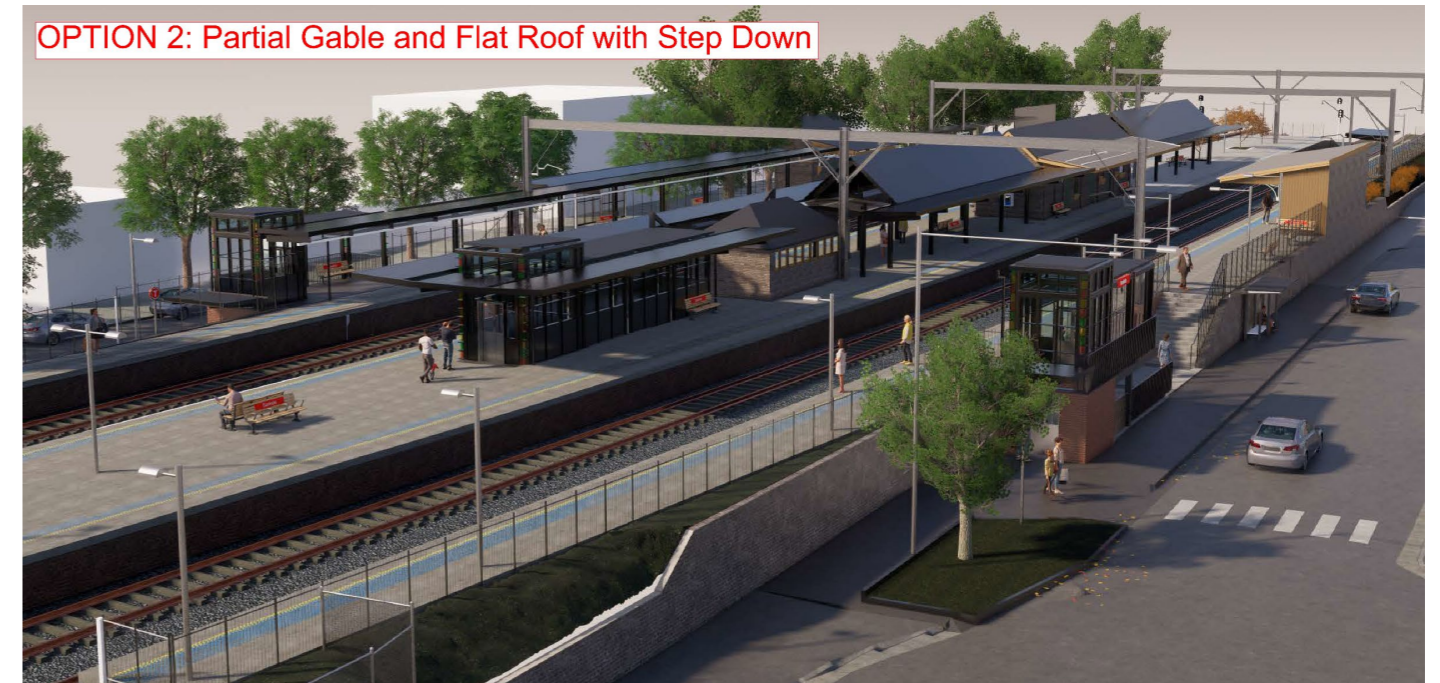
Figure 7.14: Option 2 – Partial gable and flat roof with step down (Source: Downer (2020))

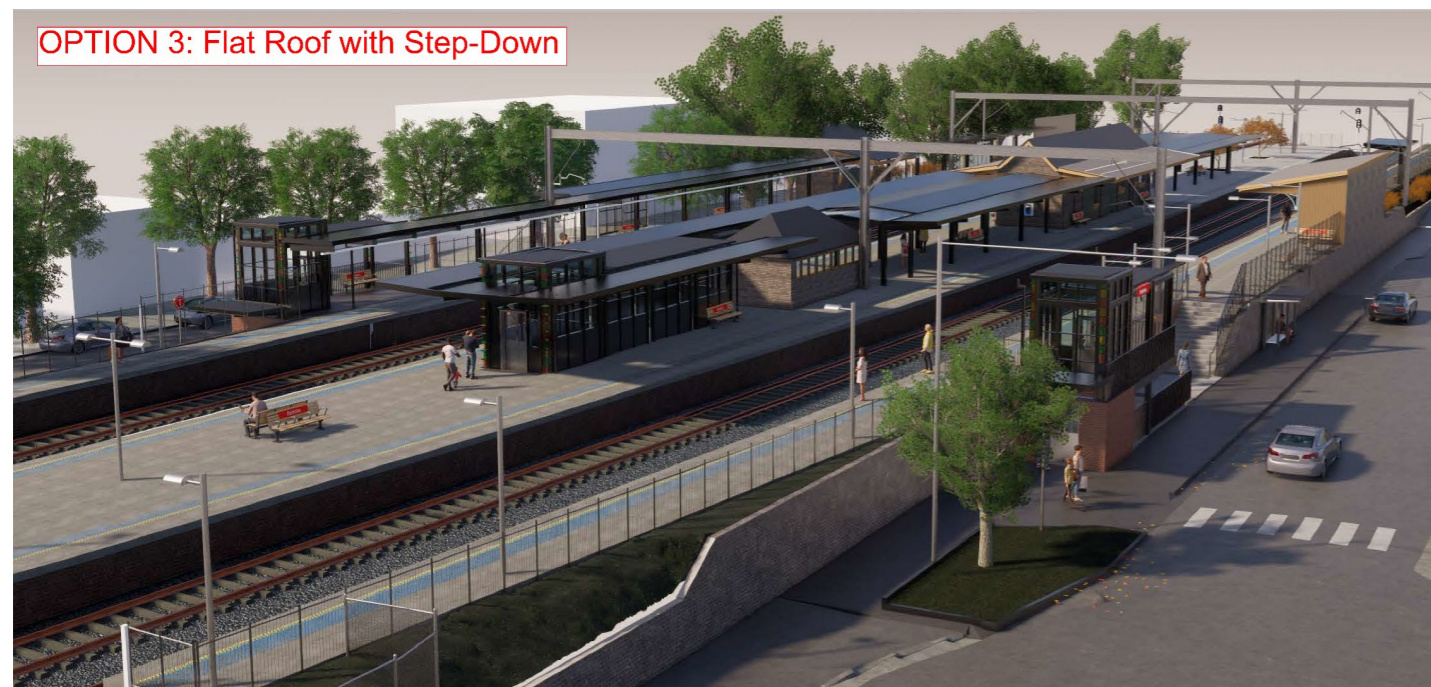
Figure 7.15: Option 3 – Flat roof with step down (Source: Downer (2020))

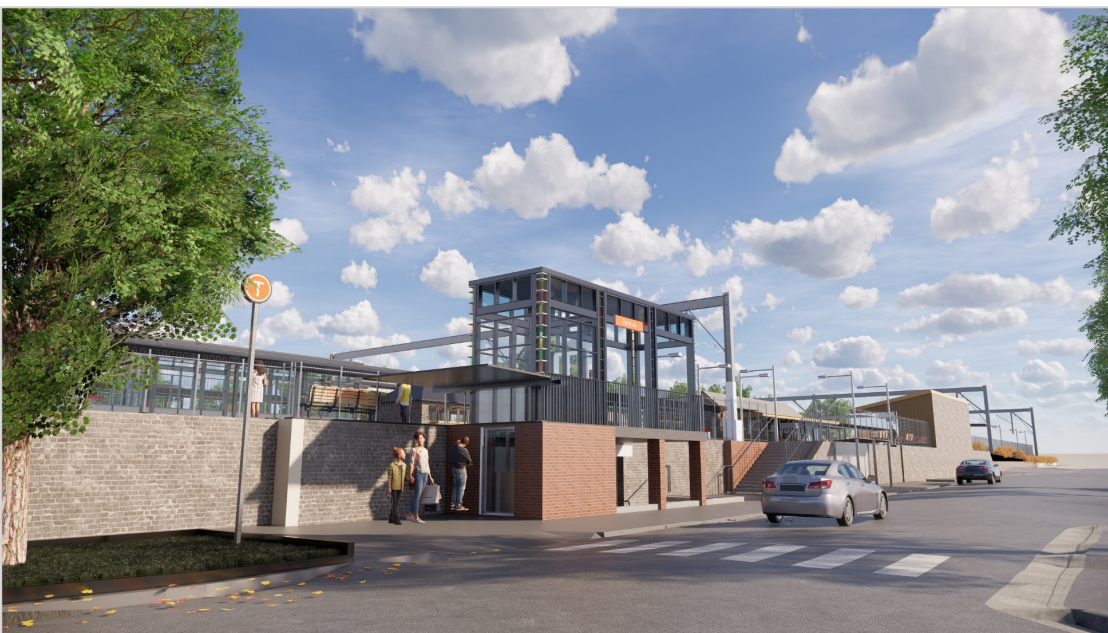
Figure 8.2: Proposed Railway Street entrance and lift structure on Platform 1

The proposed lifts would rise between 7-8 metres above the existing ground level. The lifts would be made from prefabricated steel and glass, with the lower portion of the lift structure surrounded by cladding (material and colour scheme to be provided as part of package design). The upper 1.6 metres of the lift would consist of a lift overrun with steel exhaust louvres and topped with flat roofs. New platform canopies would be installed to cover the lift access points, while new landing would be constructed to adjoin the existing platforms (Figure 8.2 and Figure 8.3).

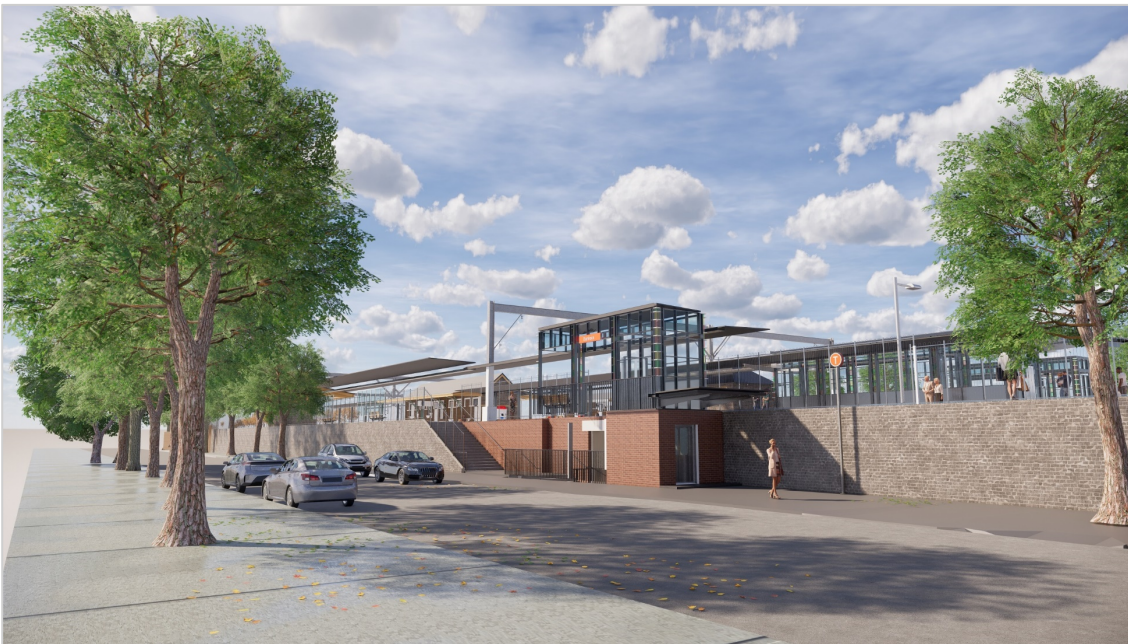
Figure 8.3: Proposed Hattersley Street entrance and lift structure on Platform 4

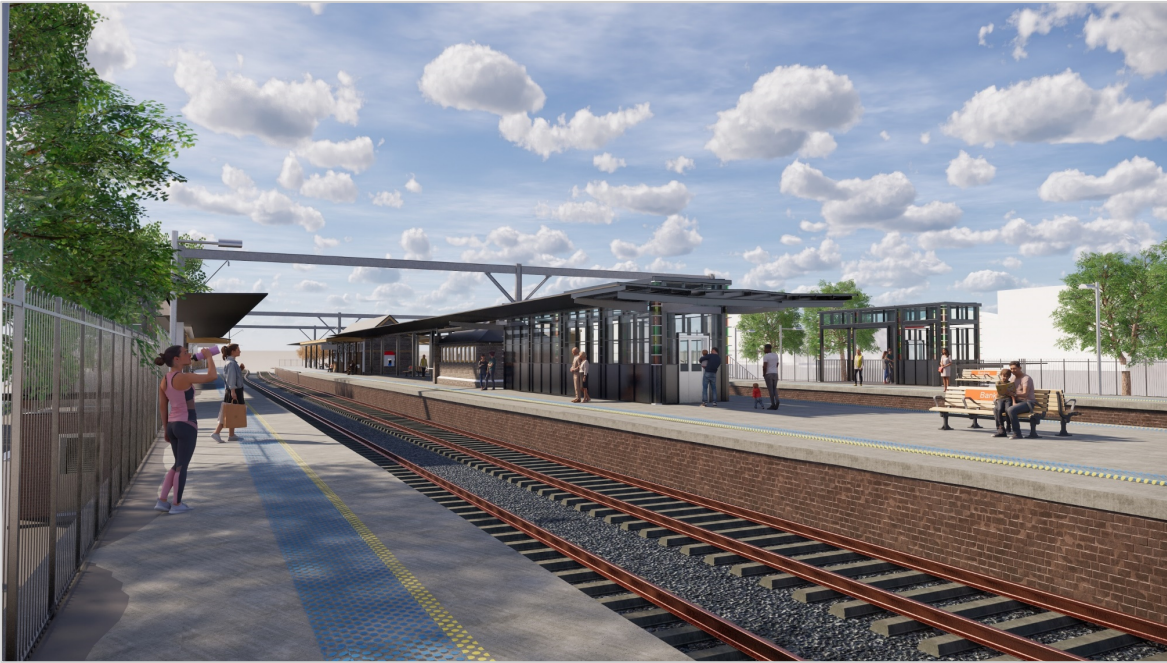
Figure 8.4: Platform 2/3 lift structure and canopies

The lifts would be made from prefabricated steel and glass, with the lower portion of the lift structure surrounded by cladding (material and colour scheme to be provided as part of package design) (Figure 8.4).

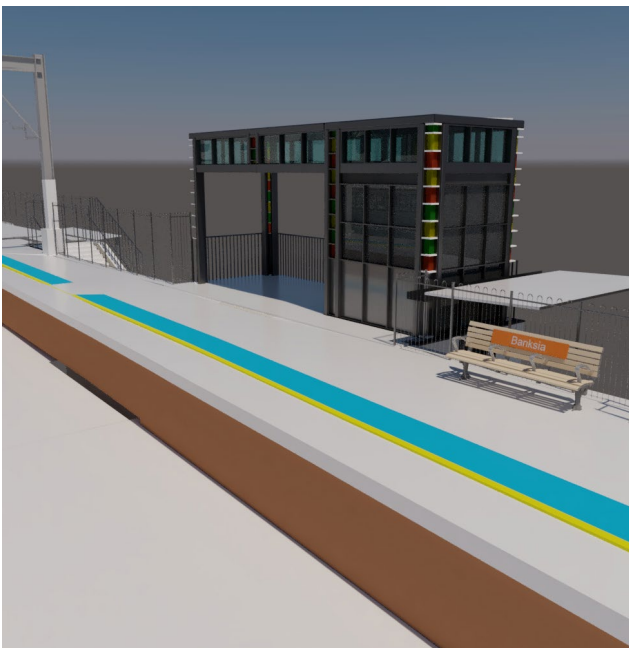
Figure 8.5: Lift 1 structure and canopy on Platform 1; facing southwest

One new platform canopy would be constructed at the boarding assistance zone on Platform 1, five and a half metres in length immediately south of, and integrated into, the lift structure (Figure 8.5).

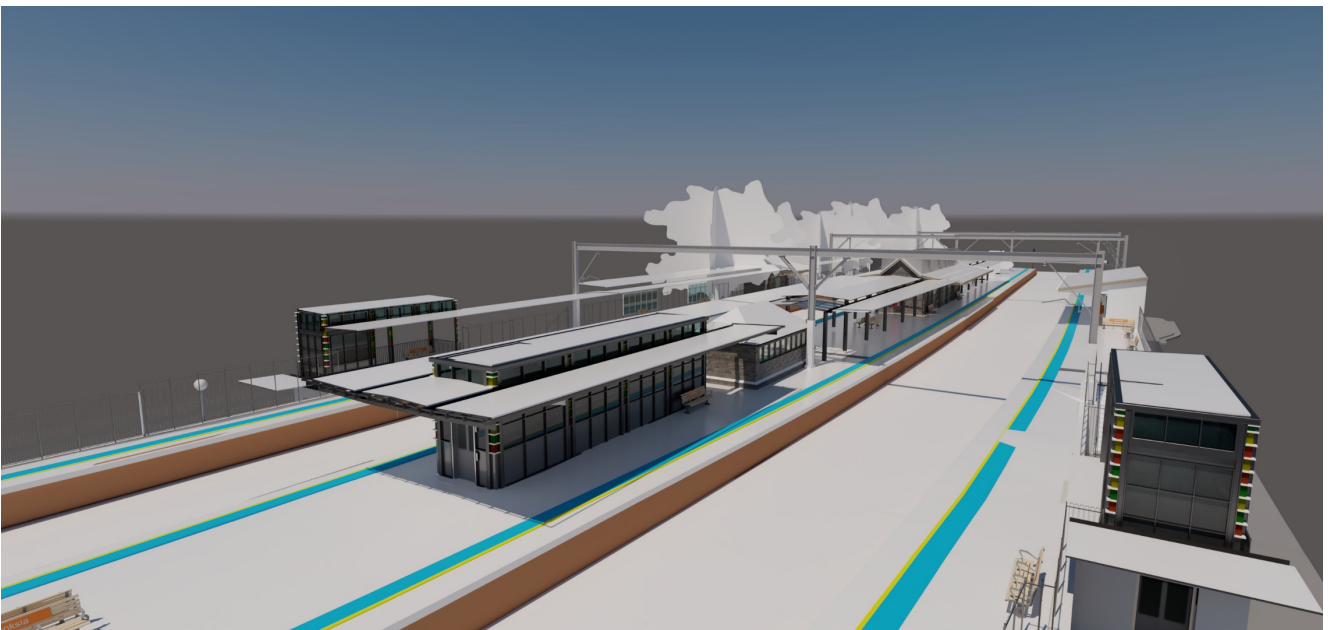
Figure 8.6: Platform 2/3 lift structure and canopies; facing south

One new platform canopy along of approximately 70 metres (excluding the awning of Platform 2/3 building) would be constructed along Platform 2/3. The two largest sections (between the Platform 2/3 stairwell lantern structure and the Platform 2/3 building, and from the Platform 2/3 building south along the platform) would be constructed with a central shallow gable, with cantilever awnings on either side which slope upwards towards the platform edges. In order to provide continual coverage between Lift 2, the existing stairs of the underpass, existing station building and the BAZ (25 metres south of the Platform 2/3 building), the eastern awning would extend north past the stairway lantern and integrate with a flat cantilever awning which wraps around the new lift/lantern structure. Glass roof panels are proposed at the canopy junctions with the existing Platform 2/3 building and the stairwell lantern structure (refer to Figure 8.6, Figure 8.7, Figure 8.8 and Figure 8.9).

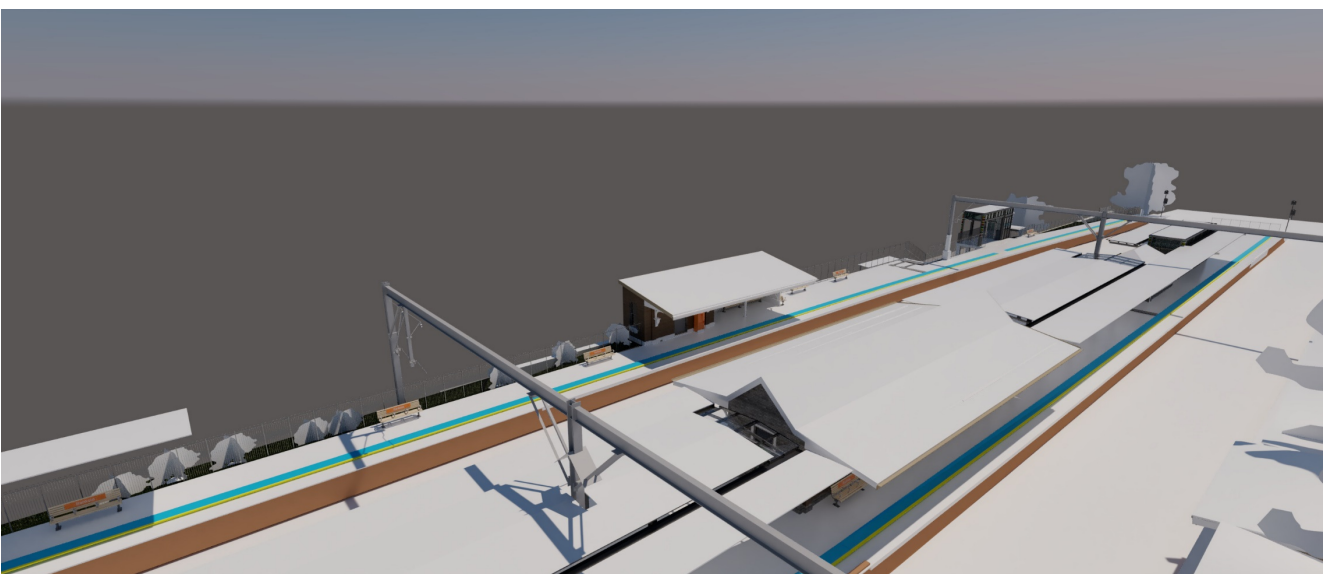
Figure 8.7: Platform 2/3 canopies and southern junction with the station building; facing northwest

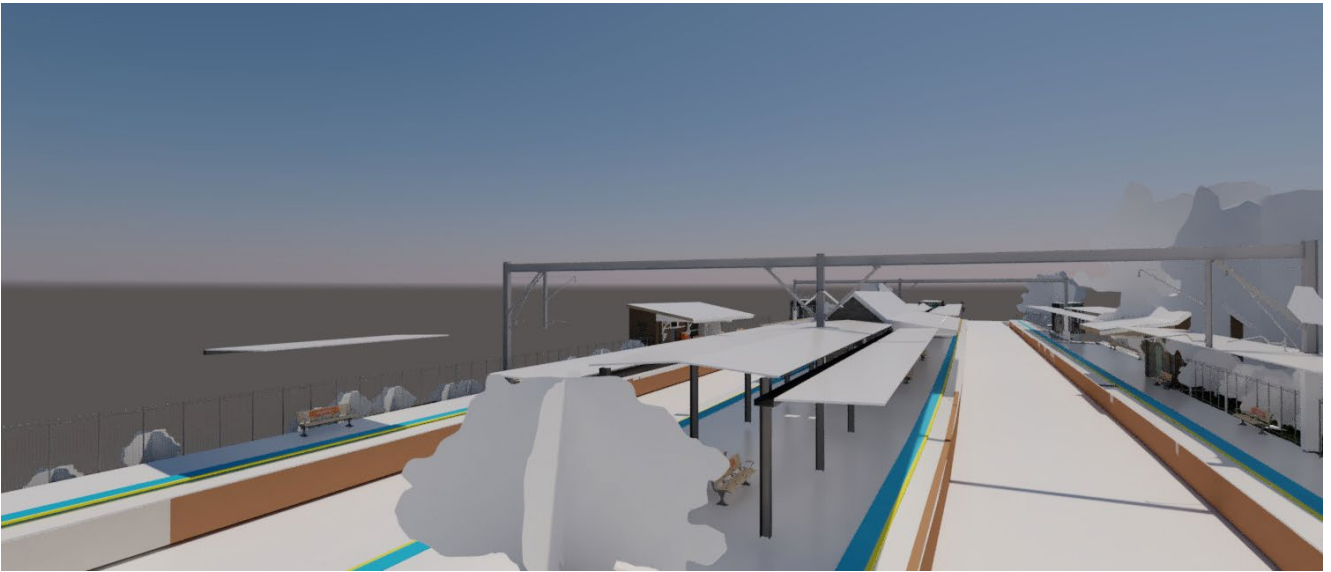
Figure 8.8: Platform 2/3 canopies; facing north

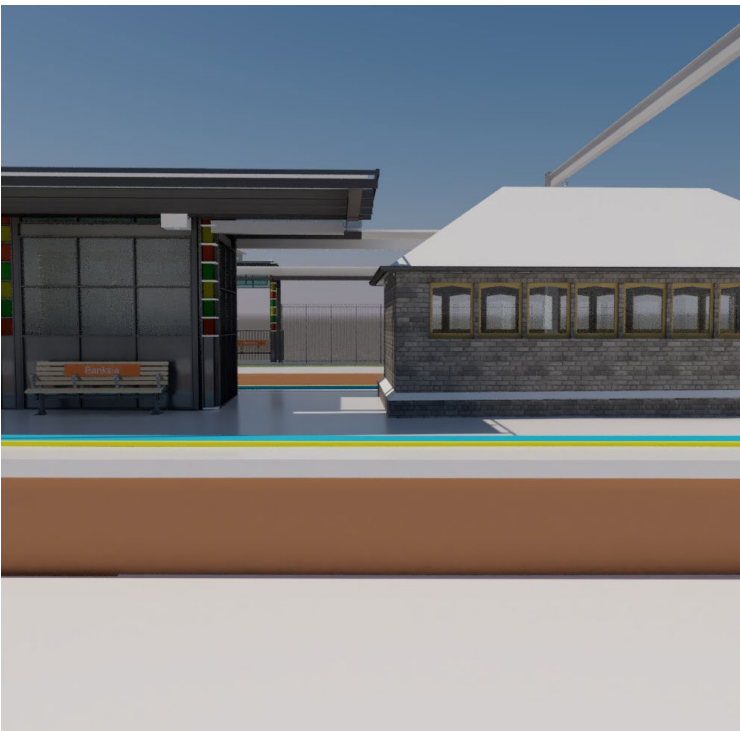
Figure 8.9: Lift 2 structure and canopy on Platform 2/3; facing west

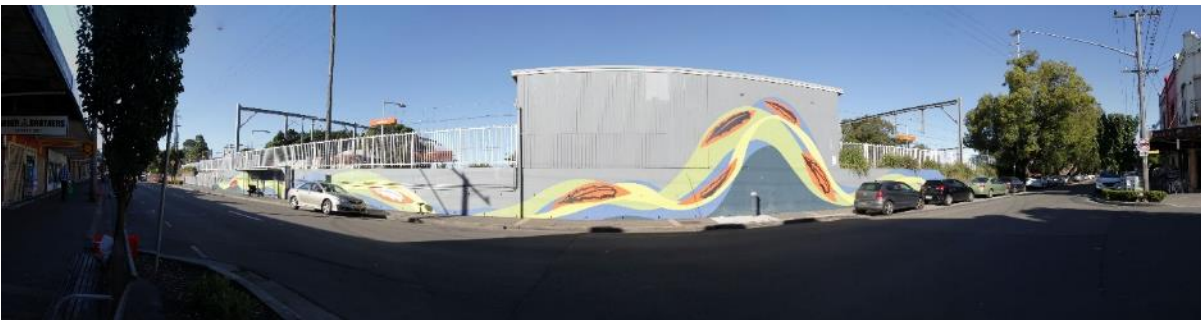
Figure 9.2: Current view from Railway Street towards the platform buildings and subway entrance from west of Banksia Station adjacent to the shopping centre (Source: Jacobs 2019)

Due to the elevated nature of the rail line at Banksia Station, a majority of the public viewpoints from the surrounding streets are screened by a combination of brick retaining walls, native shrub plantings and mature Camphor laurel trees (primarily the southern half of the station), particularly from the east along Hattersley Street (Figure 9.2).
