Timber Beam Bridges

Study of Relative Heritage Significance of RTA
Controlled Timber Beam Road Bridges in NSW

2000

HISTORY OF TIMBER BEAM BRIDGES IN NSW

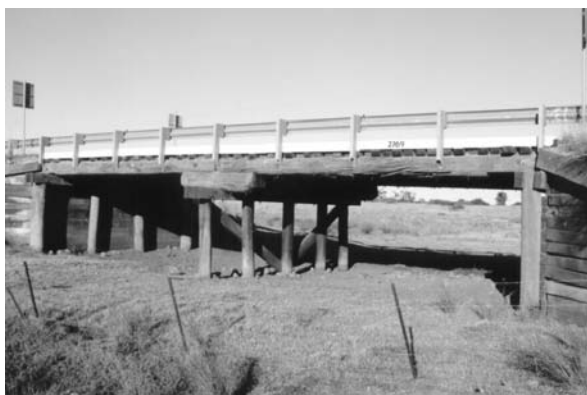
Typical timber beam road bridge, Br No 2769

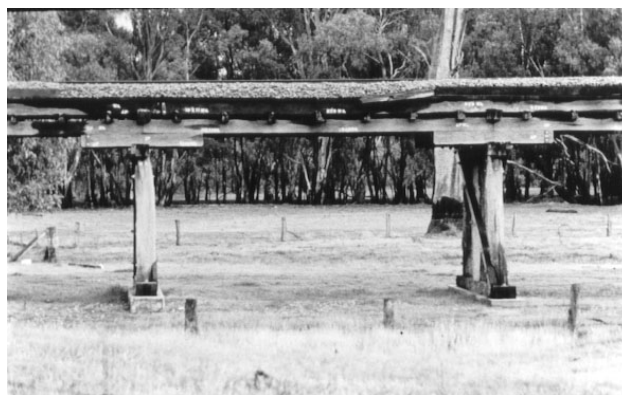
Typical timber beam railway bridge

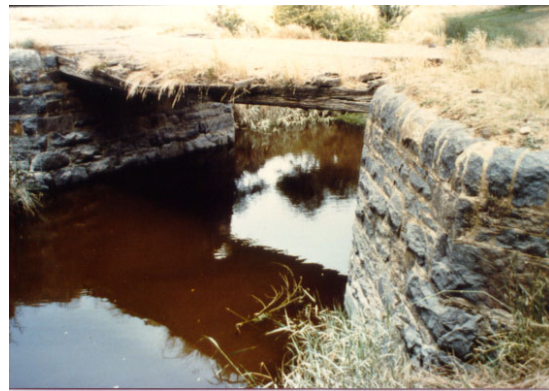
A turf covered beam bridge

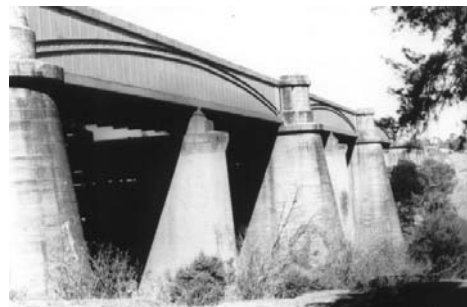
*The 1863 Menangle railway bridge,
extra piers 1905*

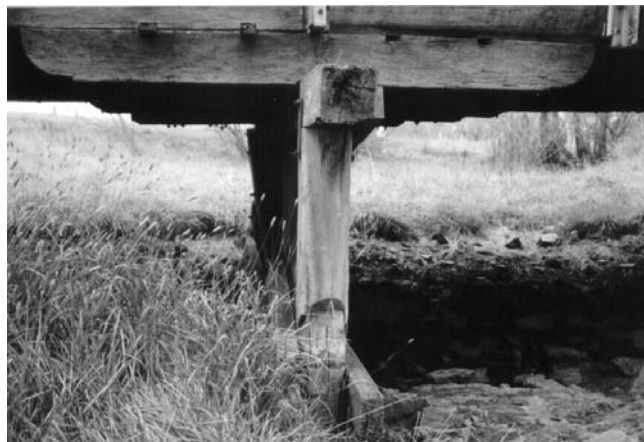
Pre-1894 detail at top of trestle

The construction details from the period of 1840 to 1894 consisted of a series of timber trestles each with 3 to 5 piles of 14-18 inch (360-460mm) diameter driven into the bed of the waterway. The piles were capped directly over their tops by a 12 inch x 12 inch (300 x 300mm) headstock. A headstock is a single piece of timber sitting over the tops of the piles. To replace it required raising the whole superstructure to obtain clearance. The piles were then braced on the outsides by opposite inclined 10 inch x 4 inch (250mm x 100mm) planks to form cross bracing.

Supported on the headstock, and at right angles to it, would be a set of short (8-12 foot) 12 inch x 12 inch timbers, called corbels. Their number and location would be the same as the main longitudinal beams that were usually 12 inch x 12 inch dressed or 15 inch (380mm) logs dressed only at their ends to sit flat on the corbels. Both 12 inch x 12 inch beams and 15 inch round beams were used in timber beam road bridges. The most common arrangement was for the dressed or squared timbers to be on the outside for appearance sake and the round logs with their bark attached "hidden" in the interior. The lengths of these beams would be either equal to the distance centre to centre of the trestles when cut square or longer if overlapping scarfing was used over each support. On top of the main beams were the 3 inch (75mm) thick transverse deck planks.

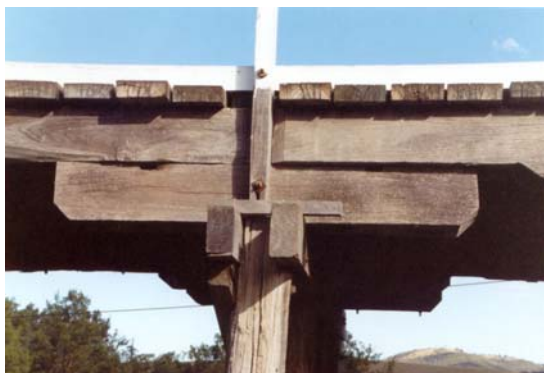
Improved detail at top of trestle

Allan's solution to this problem was simple. A pair of half-headstocks or capwales was checked into the piles at their tops, one on each side, and cross-bolted. They could be replaced without raising the superstructure. The time consuming carpentry required to make the mortise and tenons, and the use of the strap bolts were eliminated.

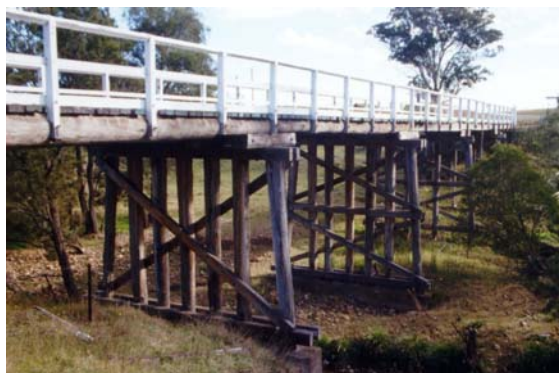
The 1894 timber beam road bridge

Furthermore, the lengths of the corbels were reduced, scarfing of the main beams over the trestles was eliminated and simple squared butt ends introduced and the number of shear keys for compound beams was reduced. Full-length piles were eliminated and were cut off just below ground and covered by a concrete sill or capping beam, then an independent trestle structure was built on top of the sill. This system could not be applied to the abutments due to the effects of lateral earth pressure, so full height piles were retained at the abutments. The deck was changed from a single layer of 3 inch (75mm) cross planks, to two layers of 2 inch (50mm) planks, one cross layer with a longitudinal layer over the top. This practice continued as circumstances dictated until formalised in the 1950s as standard for all timber decks.

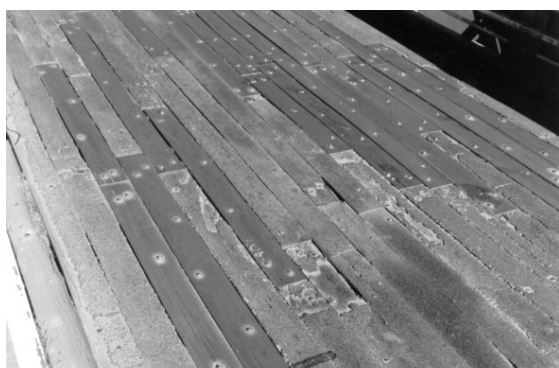
Second layer of longitudinal planks

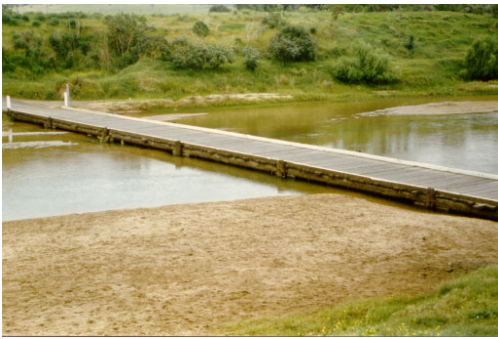
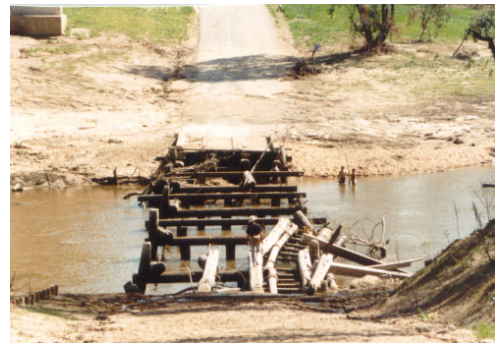
There is always a large risk with the height of a low-level bridge. These bridges need to be placed at a certain height above normal water level. This height was determined such that the bridge was available for traffic in times of small floods, yet was low enough to be submerged to a sufficient depth to allow drift timber to pass safely over in a major flood. The deck of such bridges seldom exceeds 2 metres above normal water level.

Some low level bridges were built at higher levels than designed due to an agitation being started by locals to raise the deck following the authorisation of the bridge. Many failures have occurred in the State with low level bridges due to their being built at a higher level than originally contemplated by the engineer with consequent exposure to damage by drift timber which was not allowed for in the original design.

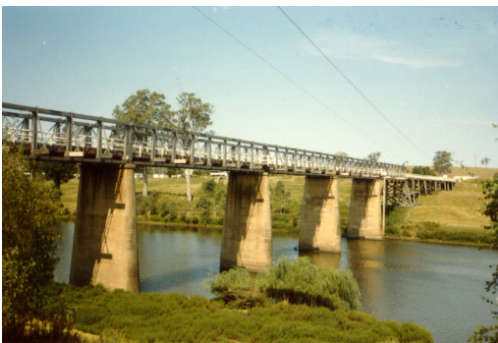
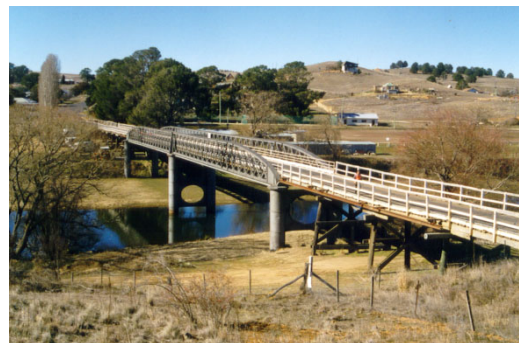
*Solutions beyond the limits of timber beam bridges,
left, timber trusses on concrete piers over the Clarence River at Tabulam,
right, iron lattice trusses on cylindrical iron piers over the Snowy River at Dalgetty.*

For high level bridges, the criterion is to maintain traffic flow over all likely levels of flooding. The decks were usually placed 0.6 metres clear of the highest known flood. However, there is a limit to this ideal when the trestles become as tall as the spans are long, and where the whole structure is quite long. With excessively tall trestles the larger proportion of costs is in the substructure and the forest of relatively closely spaced trestles can present a serious obstacle to drift timber during flooding. The conventional solution was to increase the spans of the superstructure using timber trusses, steel beams or iron lattice spans, with fewer but sturdier timber trestles, masonry or cylindrical iron piers.
