Pacific Highway Upgrade ~ Cooperook to Herons Creek

Operational Phase Fauna Crossing Structure Monitoring Program

Final Report ~ Version 2

15 June 2015

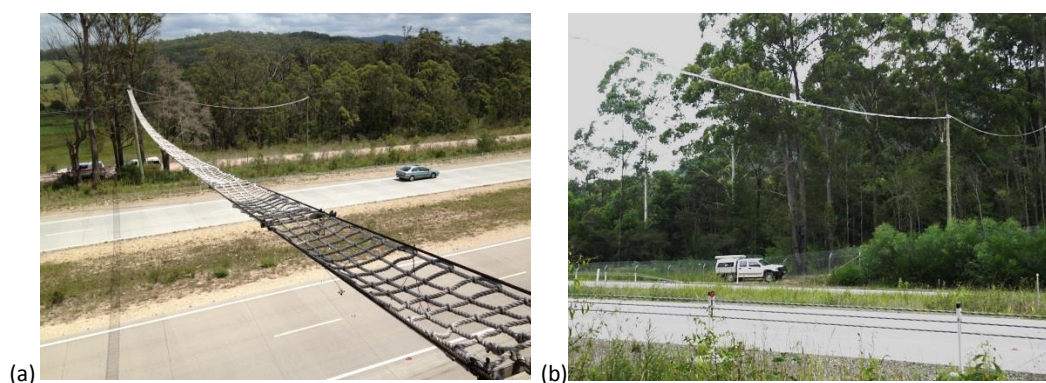
Plate 1: The rope bridge at Kew features two spans – one over the dual carriageway and a second over a service road to the west (a). The single-span John's River rope bridge connects directly to forest on the west (b) and east sides of the highway.

The rope bridge sites are located near large blocks of dry coastal forest. The forest is contiguous with the rope bridge on both sides of the highway at John's River and on the east side of the highway at Kew (Figure 1 & Plate 1). On the west side of the highway at Kew, the rope bridge terminates at a cluster of tall trees and is connected to the nearby forest block (~45m away) by a second rope bridge span over a service road and easement (Plate 1a).

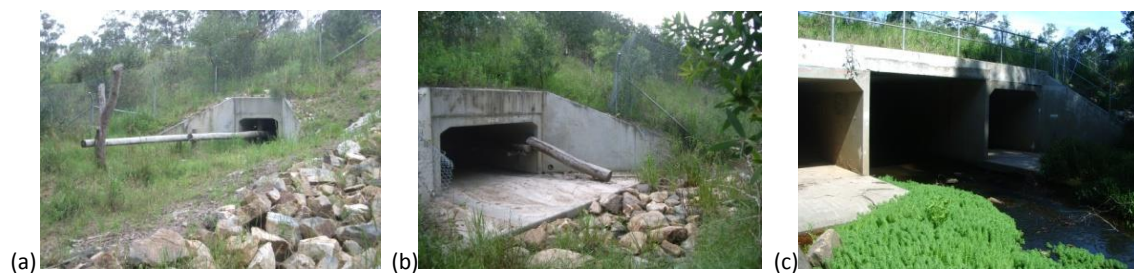
Plate 2: Monitored fauna culverts along the C2HC upgrade at Kew (a), John’s River (b) and Moorland (c).

The three fauna culvert sites are each located within drainage lines, although Moorland is the only site featuring permanently flowing water (Plate 2). Moorland culverts connect a riparian rainforest corridor. The John’s River culvert links dry forest and heathland on either side of the highway. Vegetation surrounding the Kew culvert is largely dry open forest though it is highly fragmented on the east side of the highway.

Fauna culverts are reinforced concrete (RC) box design of varying dimensions (Plate 2). Kew and John’s River culverts are single-cell design and each feature a timber rail running the entirety of their length. The Moorland culvert is triple-cell design featuring outer cells raised above creek low-flow level and central cell set into the creek bed. Moorland culverts do not feature timber rails. Culvert design and context features are detailed in Table 1.

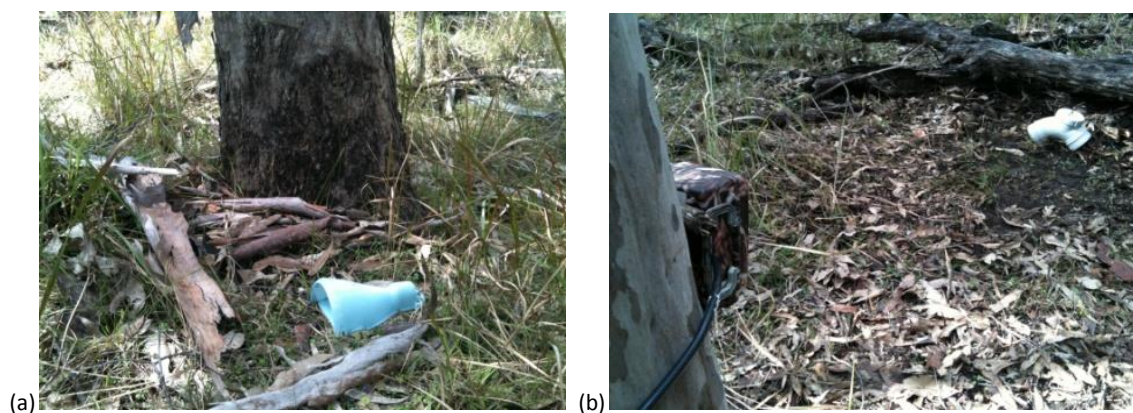
Plate 5: Hair funnels (a) and IR cameras aimed at bait stations (b) were used during baseline surveys of habitat surrounding the three monitored fauna culverts.

Ten hair funnels containing standard bait were distributed along each sampling transect at 40-50m intervals. Funnels were fixed to the ground with tent pegs and remained active for nine days (Plate 5a). Retrieved hair samples were sent to B.Triggs for identification. A Reconyx IR camera was positioned along each sampling transect. Cameras were strapped to a tree at approximately 1m height and directed at a bait station ~3m away (Plate 5b). Bait stations were constructed from ~300mm-long PVC pipe elbows (100mm diam) with a bait chamber in the centre and grated covers on each end. Bait stations were baited with chicken necks and secured to the ground with a tent peg. Fish sauce was dripped around the secured bait chamber as an additional attractant.

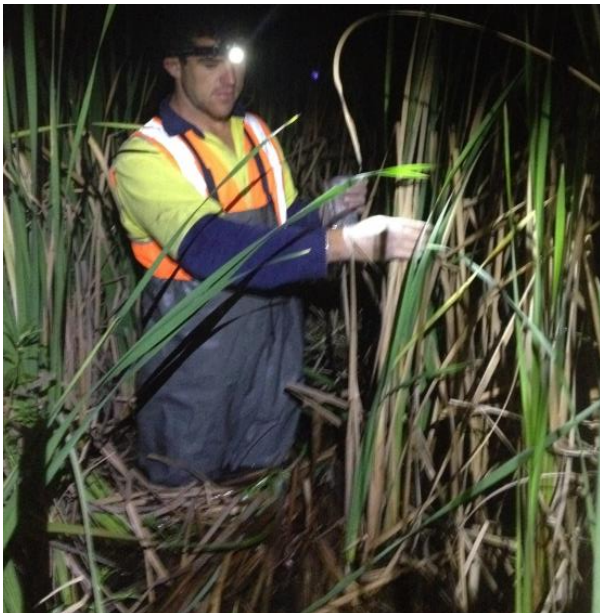
Plate 6: An ecologist searches for frogs to capture/mark/release on the downstream/eastern side of the frog pipes. The drainage pond is dominated by *Typha orientalis*.

The drainage pond and adjoining sediment pond on the eastern/downstream side of the frog pipes was searched for frogs for 3-4 hours by two ecologists on each evening of 29 and 30/1/14 (Plate 6). Captured frogs were toe-tipped according to which pond they were captured at. Frogs captured on the first night were retained in an aquarium until the following night. All frogs were subsequently released at point of capture on completion of the second nights' search. No rain occurred during the two survey nights though 25.8mm of rain had fallen during the previous seven days (BOM, Laurieton weather station). Below average rainfall in December 2013 and January 2014 meant the frog survey was delayed until late January. Sampling during a wet period when frog activity, particularly movement, is greatest was preferable.

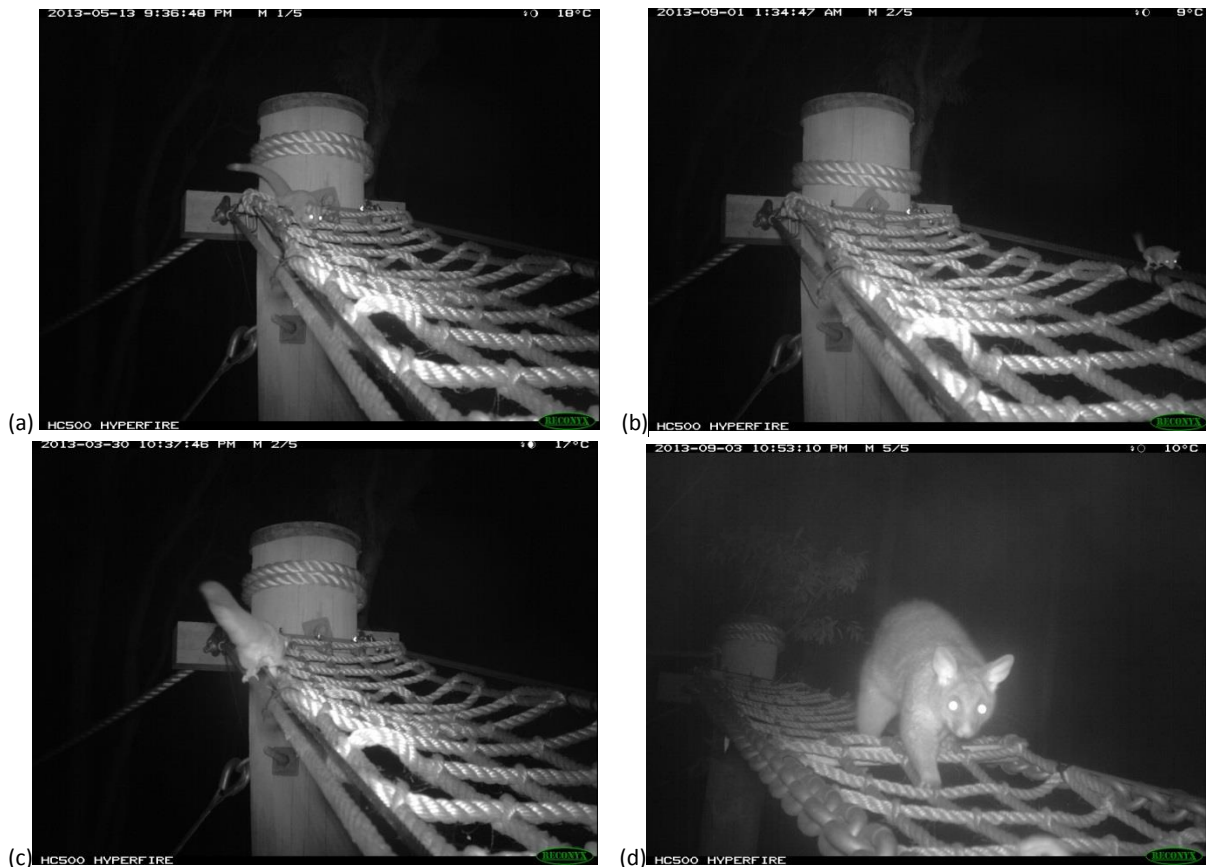
Plate 7: Sugar gliders (a) and feathertail gliders (b) were detected at each end of the John’s River rope bridge. What is probably a squirrel glider was photographed exploring the east end of the John’s River rope bridge (Plate 7c). A common brushtail possum was detected on two occasions at the east end of Kew rope bridge. No crossings of the highway were confirmed during the monitoring period.

Three, probably four, species of arboreal mammal were detected accessing rope bridges during the two monitoring periods (Table 4). Sugar gliders were detected at both ends of the John’s River rope bridge, including on at least eight occasions by the east camera (Plate 7a). A sugar glider was also detected on one occasion (26/7/13 at 8:49pm) by the Kew-mid camera which requires crossing of either the service road to the west or the highway to the east to access. The east camera did not register any concurrent detections and the west cam was not deployed at that time. It is likely the individual came across the service road.

Feathertail gliders were photographed exploring each end of the John’s River rope bridge on numerous occasions (Plate 7b) and were detected on at least one occasion by the Kew-west camera. What is probably a squirrel glider (Plate 7c) was detected exploring the east end of the Johns River rope bridge on one occasion (30/3/13 at 10:36pm). A common brushtail possum was photographed at the east end of the Kew rope bridge

moving west (Plate 7d) and on another occasion moving west and returning. Full details of fauna detections are provided in Table C1, Appendix C.

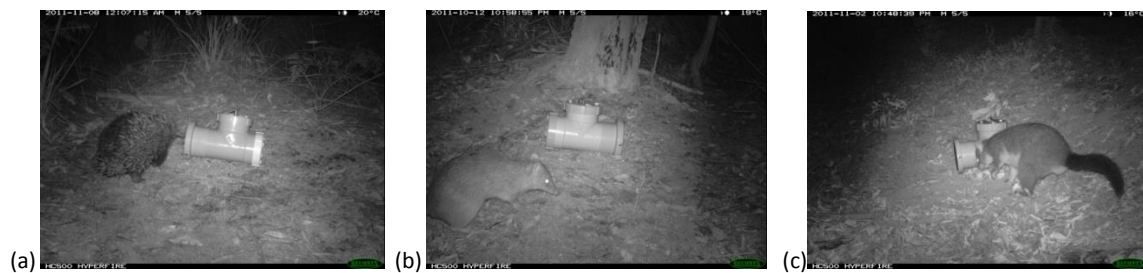
Plate 8: Remote cameras within habitat surrounding fauna culverts detected a range of species, including echidna (John's River east) (a), northern brown bandicoot (Kew west) (b) and short-eared brushtail possum (Moorland west) (c).

Most species detected in surrounding habitat are recognised as being widespread and relatively common in north-east NSW (Plate 8a-c). A number of less common species were also detected during surveys. The dusky antechinus (*Antechinus swainsonii*) was captured in dry forest on the west side of John's River ~300m from the culvert (Plate 9a). The eastern water skink (*Eulamprus quoyii*) was captured in riparian rainforest ~100m to the west of the Moorland fauna culvert (Plate 9b). Two threatened species were detected during surveys. Both records occurred on the east side of John's River. A koala was detected ~150m east of the culvert and a powerful owl, which responded to call playback, was detected ~200m east of the culvert.

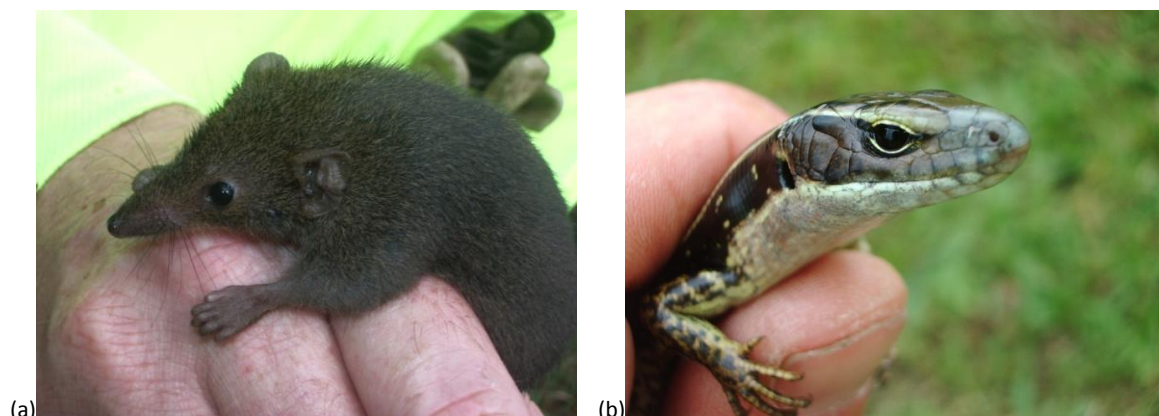
Plate 9: A male dusky antechinus (*Antechinus swainsonii*) (a) was captured in an Elliott trap ~300m east of the John's River culvert and an eastern water skink (*Eulamprus quoyii*) (b) was detected during active searches to the west of the Moorland culverts. Photos: B.Taylor.

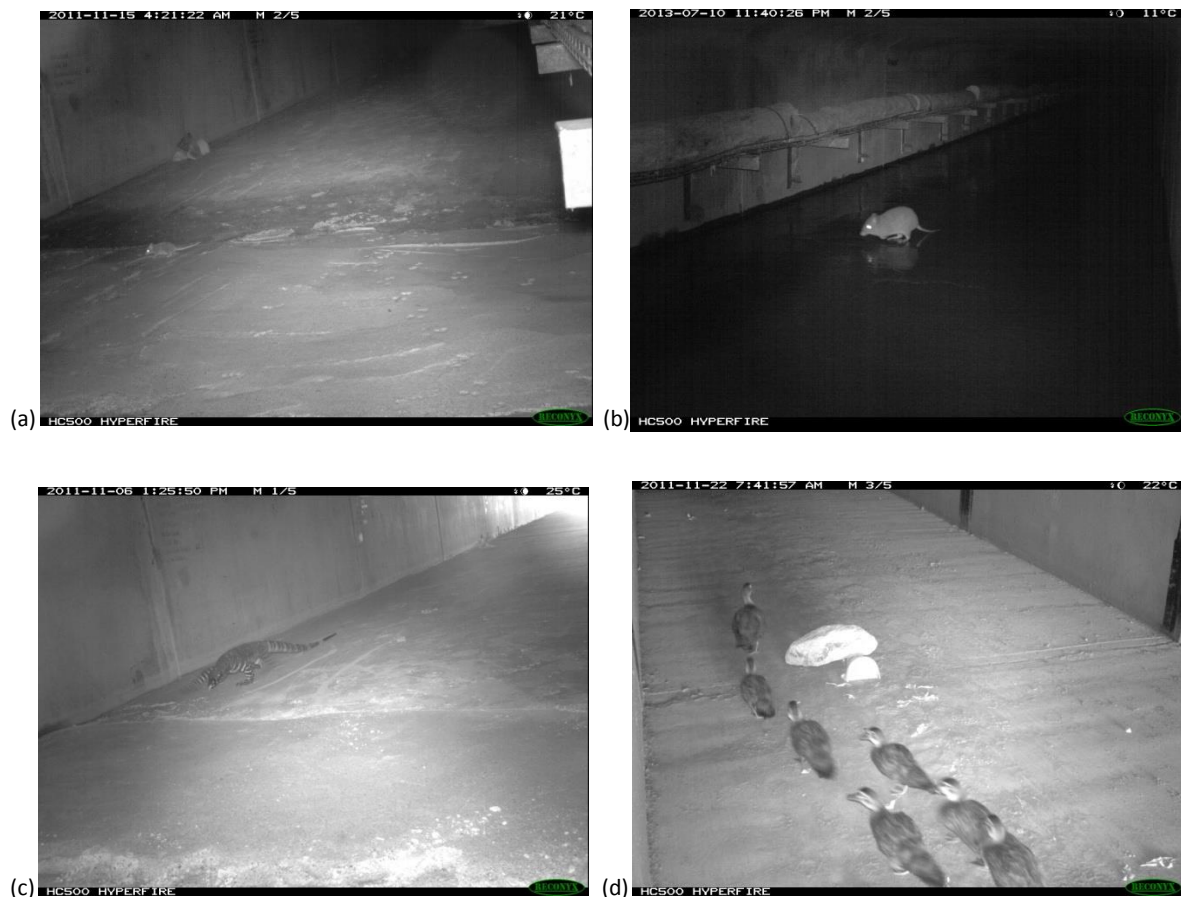
Plate 10: A variety of fauna were detected using C2HC culverts, including brown antechinus (a), long-nosed potoroo (b) and lace monitor (c). A procession of pacific black ducks were photographed moving through one of the twin-cells at Moorland (d).

Twenty two species/groups of vertebrate were recorded using the three monitored fauna culverts. John's River and Moorland were the most diverse (17 spp.) and Kew the least diverse (10 spp.). The combination of sand pads and cameras enabled a relatively high level of confidence in identifying culvert users. For example, a brown antechinus was photographed at John's River (Plate 10a) concurrent with sand pad tracks attributed to a small dasyurid (Plate 11a). Other species identified with a high level of confidence included: long-nosed potoroo (Plate 10b), lace monitor (Plate 10c), northern brown and long-nosed bandicoot, pacific black duck (plate 10d), fox, black rat, bush rat, water dragon, echidna, water rat, cat and dog. The only species/groups not confidently determined to species level were brushtail possum (probably short-eared possum), wallaby (probably swamp wallaby or red-neck wallaby), heron/egret (probably white faced heron or egret sp.) and small lizard/skink (probably *Eulamprus* sp.). Full details of camera and sand detections are provided in Table D1, Appendix D and Table E1 & E2, Appendix E.

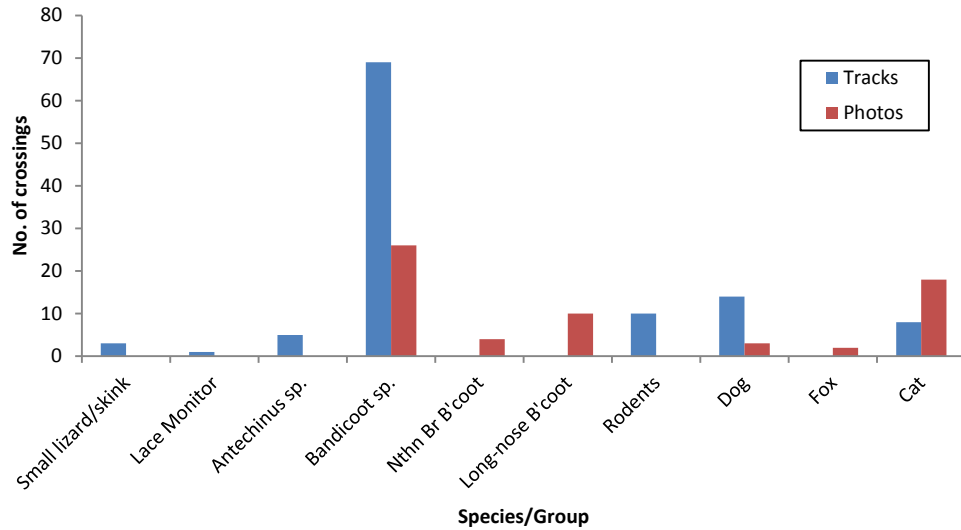
Figure 2: Complete crossings of the Kew culvert (1.5m H x 1.5m W x 53m L) pooled for the two monitoring periods.
