Oxley Highway Upgrade – Port Macquarie
Monitoring of Wildlife Road Crossing Structures
June 2013 – September 2016

Final Report

Report Prepared for the NSW Roads & Maritime Service

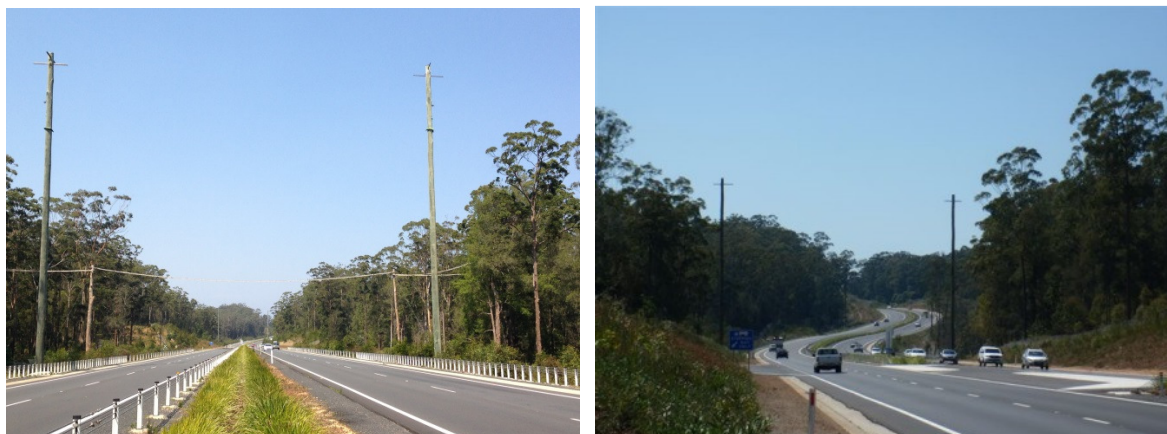
Two pairs of wooden glide poles (25-26 m high) were installed along the highway adjacent to the large block of open forest (Figure 2). The two pairs are located 460 m apart (Figure 3). The western pair is located 40 m from a rope-bridge.

Figure 2. Glide poles on the Oxley Highway. At left the western pole pair and at right the eastern pole pair.

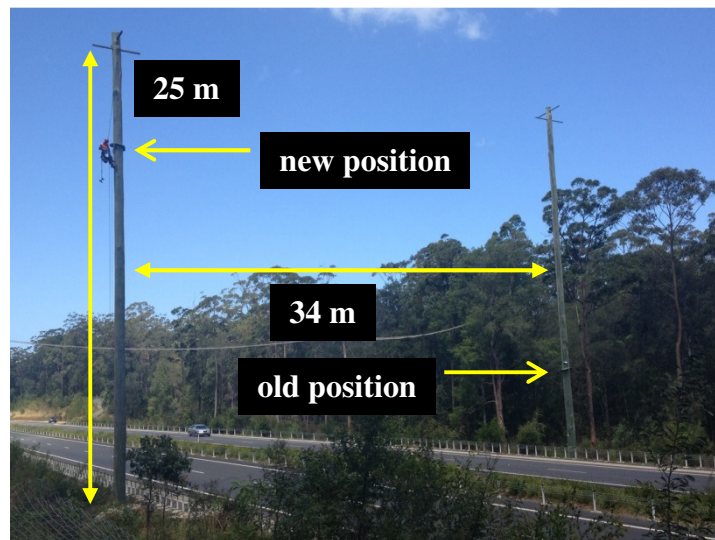
When first installed on 19 June 2013, the collars were placed at 5 m above ground and the cameras at 7 m above ground and could be accessed via a ladder. In November 2013, the cameras and collars were raised to 21 m and 19 m, respectively, by a qualified tree-climber

(Figure 5). This was due to concern that animals may evade detection by gliding to a pole and landing above the cameras. The cameras were raised a further 1 m above the collars on 17 November 2015 to create a 3 m collar to camera spacing. An increase in the number of night images with no obvious cause of triggering suggested that gliders were triggering the cameras and ascending a pole faster than the reaction time of the camera and were not being photographed. Providing an additional metre above the collar should give a camera a slightly longer period in which to capture an image.

Figure 5. A close-up of the western pole array showing the initial position of the camera and collar and the new position used from November 2013 onwards.

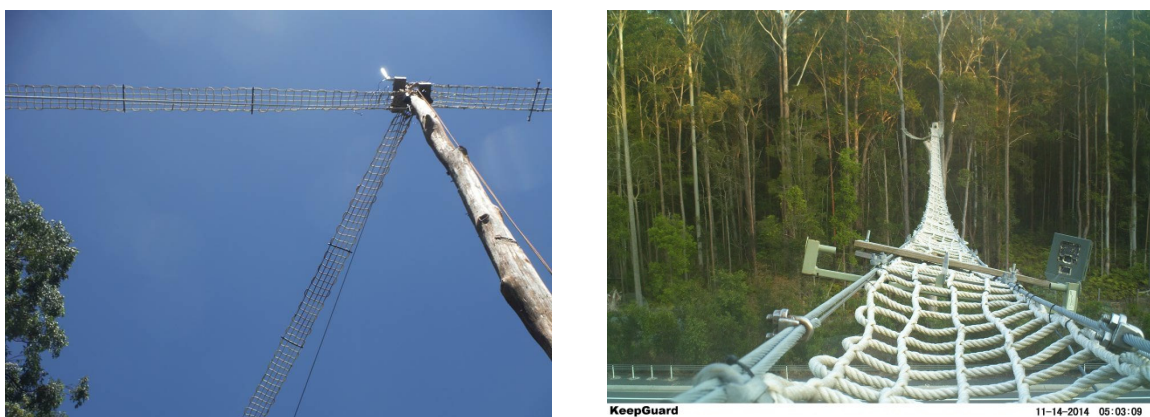
The rope-bridge is positioned approximately 12 m above the road-way and is held in position by two wooden poles (Figure 6). The pole to pole distance along the rope-bridge is 41 m. A single Reconyx camera mounted on a board was installed near each end of the rope-bridge on 18 June 2013 pointing back to the pole supporting the rope-bridge (Figure 6). Buckeye cameras that we intended to monitor the rope-bridge with did not become available from Faunatech until February 2014.

Figure 6. Attachment of the rope-bridge to a supporting pole. There are two sections of the rope-bridge that allow access from trees in the forest (*Left*). Photograph taken at the south end of the rope-bridge. The Reconyx camera can be seen to the right of the rope-bridge (*Right*).

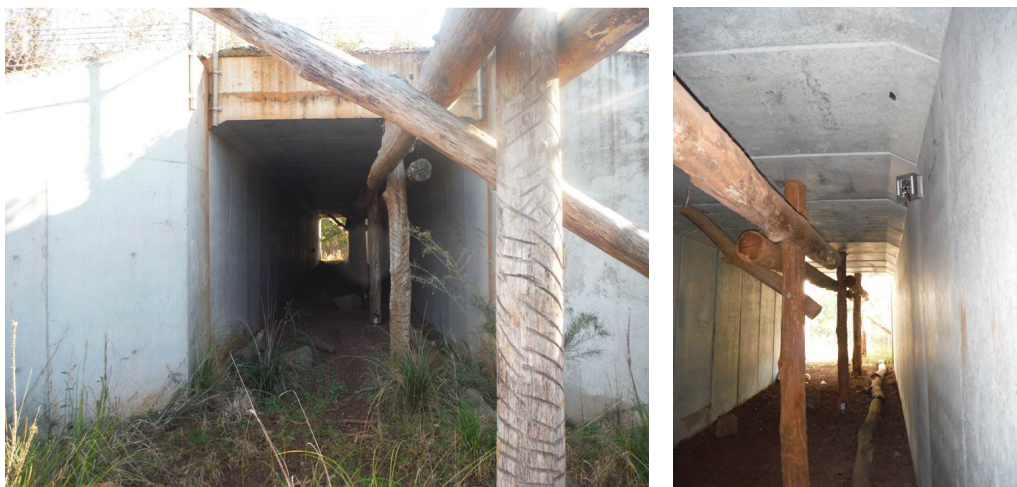
Two Reconyx cameras were installed in the western fauna underpass and the combined underpass, ~5 m inside each end, mounted 1-1.5 m high and positioned to view the entrance. Two Reconyx cameras (both facing south) were mounted in the middle of the eastern fauna underpass at 1 m high and at 2.5 m high (to view along the fauna railing) (Figure 8). Cameras were set to take 5 images 1 second apart when triggered and with no delay between triggers.

Figure 8. (Left) Entrance to the eastern fauna underpass. (Right) This underpass had a camera installed 2.5 m high to record any animals using the fauna furniture.

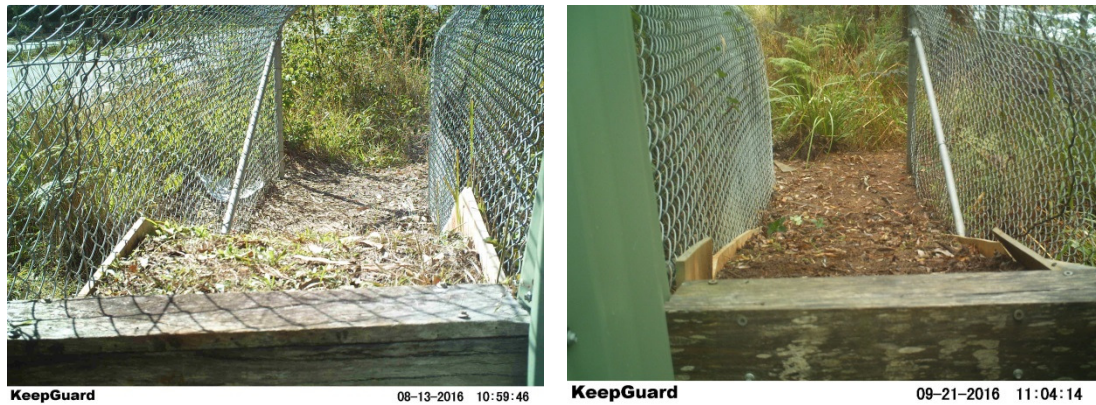
Koala drop-downs are basically road-escape ramps that allow animals that might become trapped on the roadway to discover a break in the wildlife exclusion fence through which they can pass and exit the roadway. These escape ramps are designed for one-way passage and have been installed primarily to minimise koala road mortality. The entrance to the ramp is at ground level on the road side of the exclusion fence (Figure 10). The ground in the ramp is angled up so at the opening in the fence it is approximately 60-80 cm above ground level (Figure 11). This is intended to create a one-way passage. Any animals that somehow find their way onto the road side of the exclusion fence (e.g. by climbing over the floppy top fence) would not be trapped near the road but would eventually encounter an escape ramp and leave the road side. The ledge on the drop-down ramp is intended to be high enough that animals on the forest side of the exclusion fence should be prevented from gaining entry because they would need to jump up onto the ramp.

Figure 10. View looking down a drop-down ramp into the road-side vegetation for drop-downs 5S (left) and 7N (right). This shows the substantial amount of road-side vegetation that may be attractive to animals for foraging.

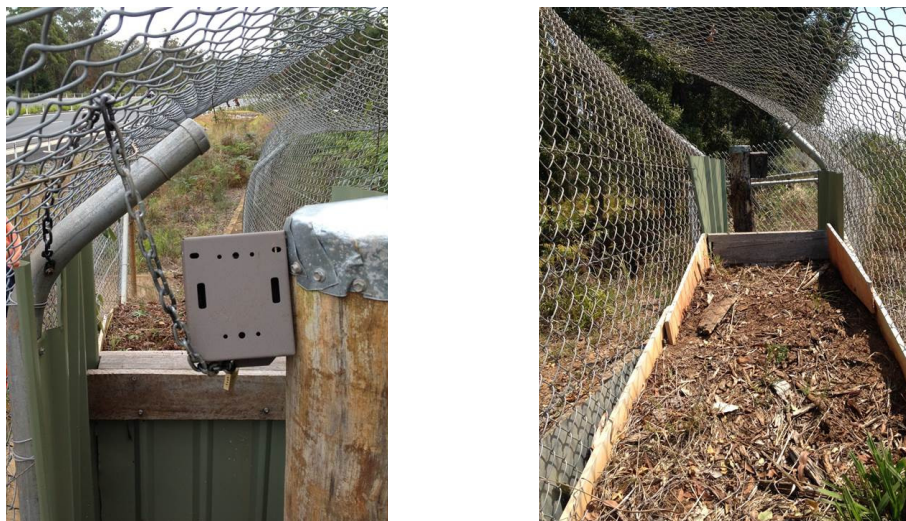
Figure 11. Motion-activated camera directed down the drop-down ramp.

Five to seven drop-downs were monitored using a Keepguard KG680v camera positioned on the refuge pole near the top end of the ramp and directed down the ramp (Figure 11). Cameras were set to take 3 images 1 second apart when triggered and with a 1 minute delay between triggers. Monitoring locations were spread along the road alignment and included five drop-downs in year 1 (Figure 1). The number of drop-downs monitored was seven in year 2 and six in year 3 due to the theft of several cameras and a reluctance to reinstall where theft had occurred. One drop-down at the eastern end of the study area became in close proximity to a new housing development and was considered vulnerable to further theft.

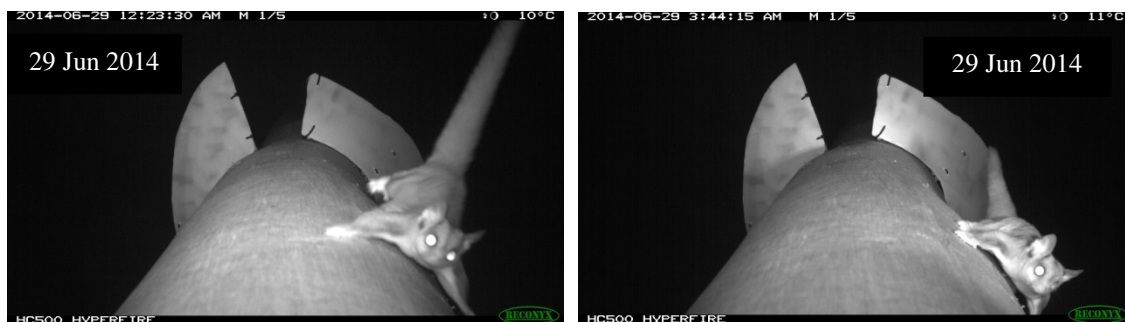
Figure 13. A female (*left*) and male (*right*) sugar glider detected on the south-west pole within 4 hours of each other (2423 h & 0344 h) on 29 June 2014. The male has a scent gland on the head that can be seen when this image is enlarged.

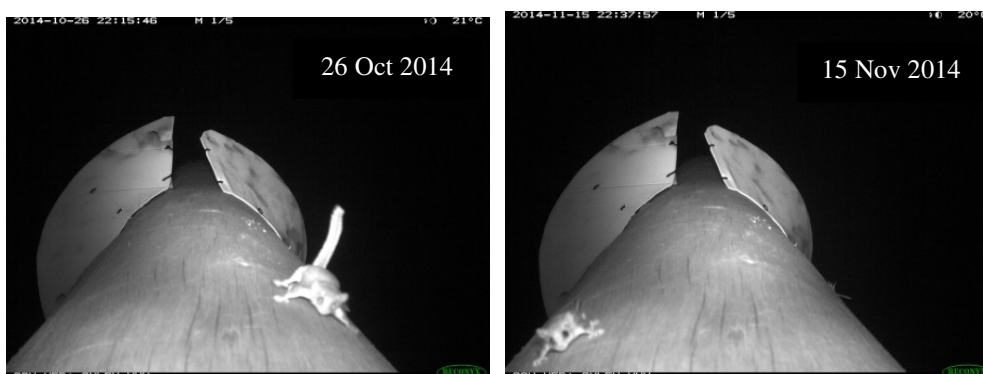
Figure 16. Feathertail gliders were detected on 60 different nights during the study.

Across the three years of the study there were 419 records of sugar gliders (including an unknown number of squirrel gliders) and 71 records of feathertail gliders (Figure 16). These amount to 318 records of sugar gliders (including an unknown number of squirrel gliders) on different nights and 65 records of feathertail gliders on different nights. The yellow-bellied glider was recorded on two occasions: on 17 Jan 2014 and 10 May 2015 (Figure 17). Surprisingly most records of individual species were on different nights for opposing poles. There was only a single instance when an image on one pole could be matched to an image on the opposing pole (Figure 18). Both images showed the same time suggesting the squirrel glider had landed on one pole, ascended and glided across the road to the other pole, and quickly ascended that pole. Presumably it then glided from that pole to the adjoining forest.

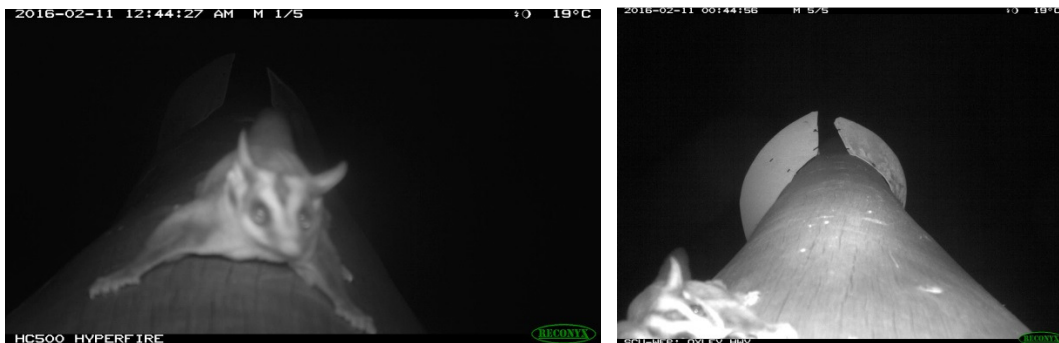
Figure 18. A male squirrel glider photographed at 0044 h on 11 Feb 2016 on each of the poles of the east pole pair.

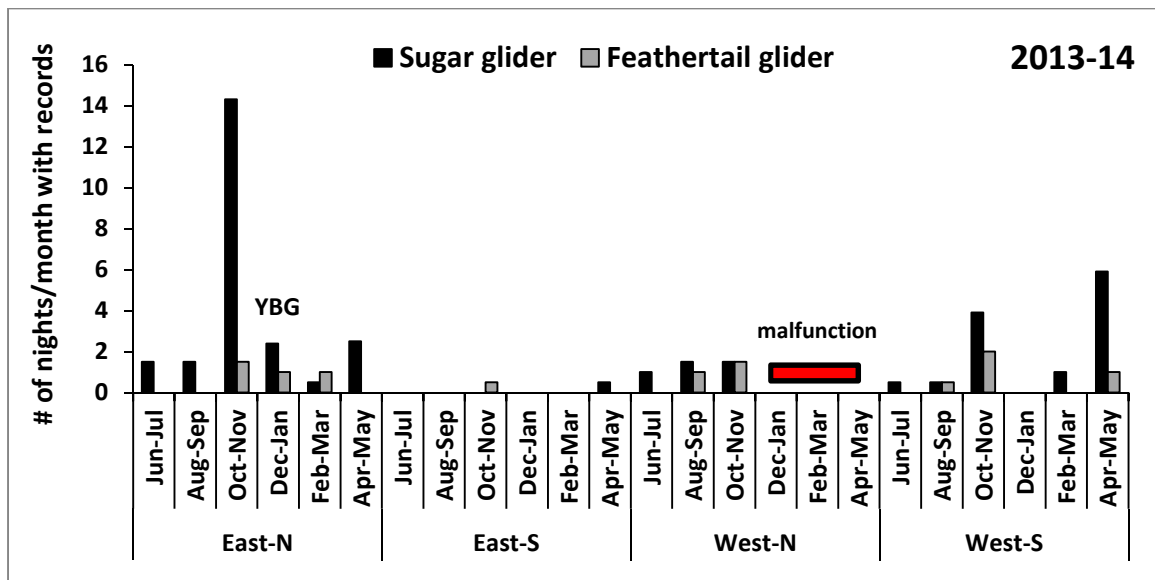
Sugar gliders were detected relatively frequently on different poles across the 3 years (Figure 19). The number of nights with records varied from 0 to 20 nights per month. Feathertail gliders showed a consistent but low number of nights (0-2) with records across the 3 years (Figure 19). The south eastern pole showed a high number of records of feathertail gliders in Oct-Nov 2014 (Figure 19).

Figure 19. The number of nights per month in which sugar gliders and feathertail gliders were detected on the two glide pole pairs. The cameras were raised from 7 m above the ground to 21 m above the ground in November 2013. Cameras were raised 1 m, to be 3 m above the collar in November 2015.

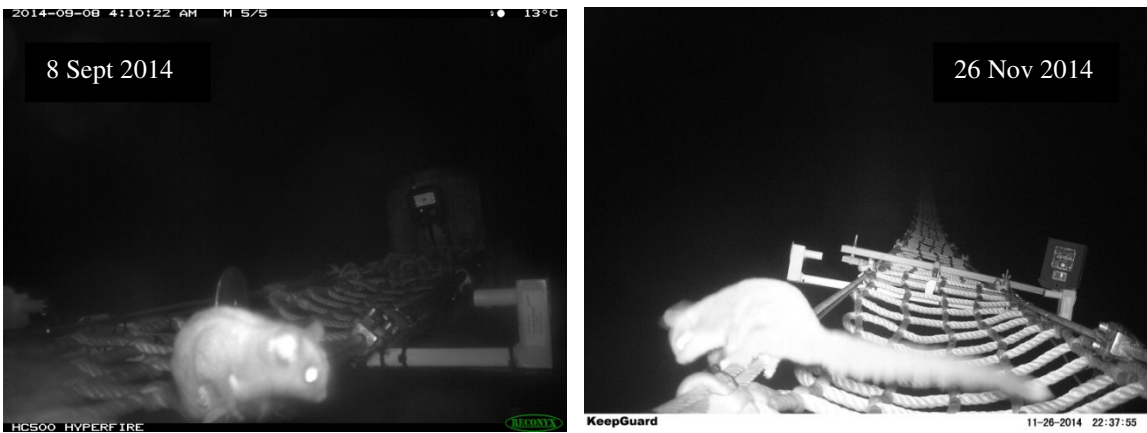
Figure 21. A sugar glider detected by the Reconyx camera on the rope-bridge in September 2014 (*left*) and by the KeepGuard camera in November 2014 (*right*).

None of these records over the three years were obtained at both ends of the rope bridge on the same night. Some images were of sugar gliders that appeared to be preparing to glide from the bridge (Figure 21). Three records of sugar gliders (Figures 20 *left*, 22 *right*, 23 *left*) and the one of a squirrel glider (Figure 23 *right*) suggested movement towards the other end of the rope-bridge and may represent crossings. The two records of the feathertail glider showed movement in a single direction away from the camera that suggested a crossing.

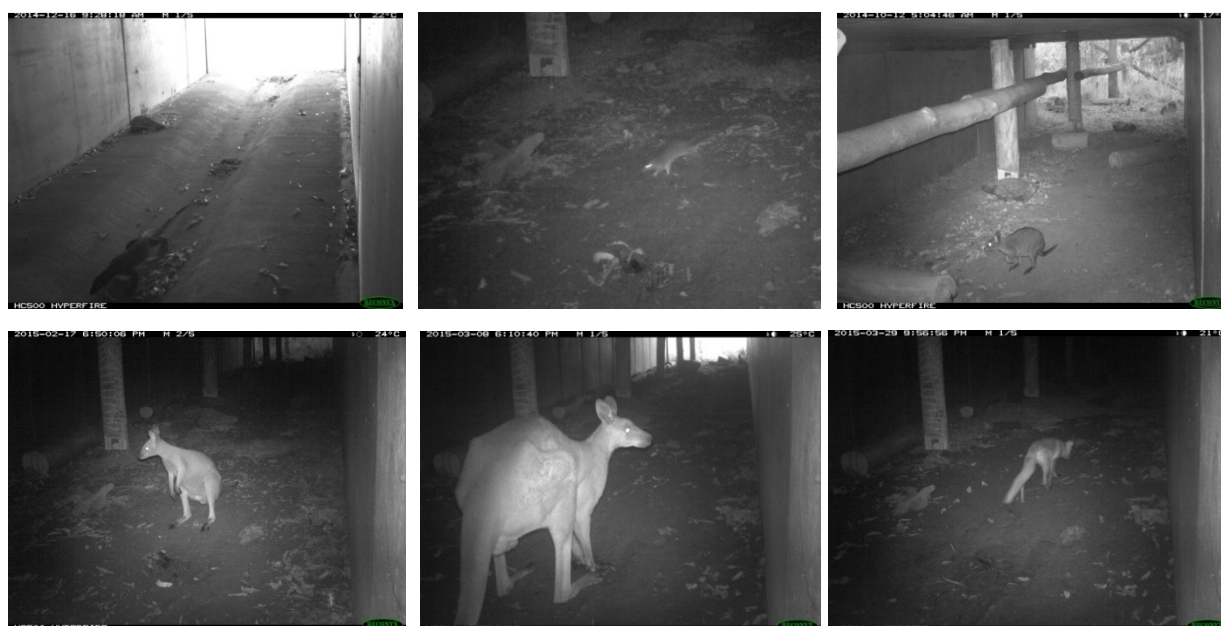
Figure 24. The species commonly recorded in the underpasses. *Upper row:* lace monitor (*Left*), northern brown bandicoot (*Middle – close-up*), and red-necked pademelon (*Right*). *Lower row:* red-necked wallaby (*Left*), eastern grey kangaroo (*Middle*), and red fox (*Right*).

The cameras in the three underpasses achieved the monitoring targets for each of the three years (Table 3). The species commonly recorded in the underpasses were the swamp wallaby, the lace monitor, northern brown bandicoot, red-necked pademelon, red-necked wallaby, eastern grey kangaroo, red fox (Figure 24) and long-nosed bandicoot. There were four koala traverses detected in year 1, none in year 2 and 5 in year 3 (Table 3) (Figure 25).

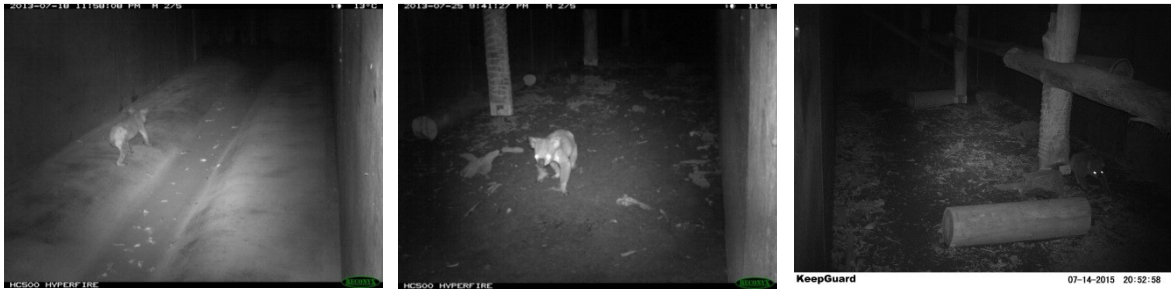
Figure 25. Koalas were detected in all underpasses: combined (*left*), east fauna (*middle*) and west fauna (*right*).

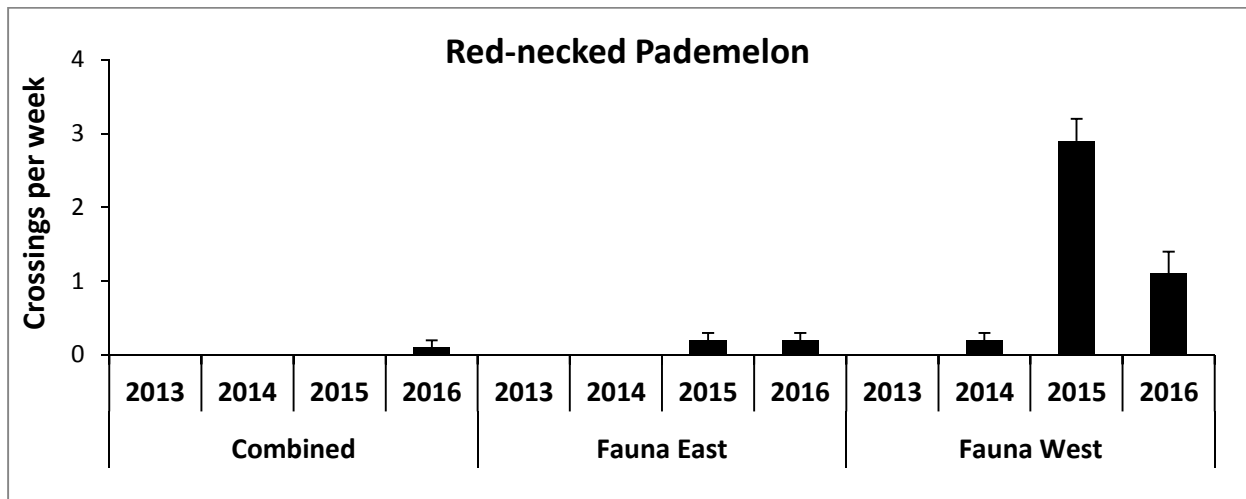
Figure 28. The mean number of passes per week (+SE) by the red-necked pademelon.

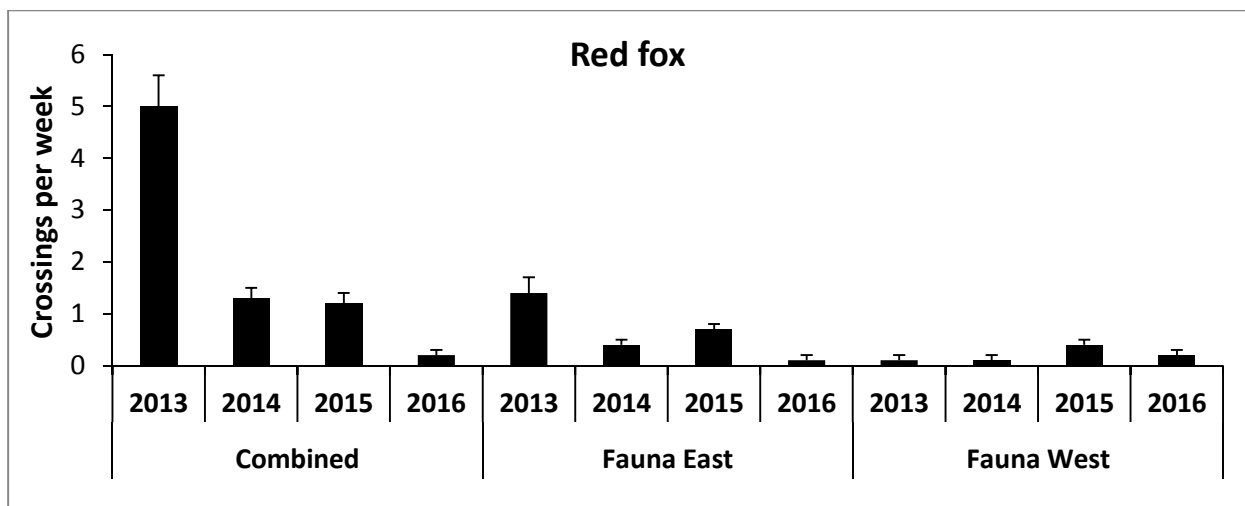
Figure 31. The mean number of passes per week (+SE) by the red fox.

The crossing data have been collated on a weekly basis and averages determined for each of the years in which monitoring has taken place (from 18 June 2013 to 6 May 2016). This has revealed some patterns in the data for the six most commonly detected species. The swamp wallaby traversed all three underpasses at a rate of at least 1-2 crossings per week (Figure 26). Traverses of the east underpass were consistently higher than in the other two underpasses. The eastern grey kangaroo showed high crossing frequency in the eastern underpass in three of the years but there was an obvious decreasing trend (Figure 27). The red-necked pademelon was rare in all three underpasses in the first 18 months of the study but then started using the west fauna underpass frequently in 2015 and 2016 (Figure 28). The lace monitor showed a high frequency of crossing in all three underpasses (Figure 29). Its activity was mostly confined to the period of September through to April. The two species of bandicoot were not particularly abundant individually so they have been pooled. They crossed in the east fauna underpass more than once per week in 2014 and 2015 (Figure 30). The red fox showed a very high crossing frequency in 2013 in the combined underpass but the rate declined to a very low level in that underpass in 2016 which matched the low levels in the other two underpasses (Figure 31).

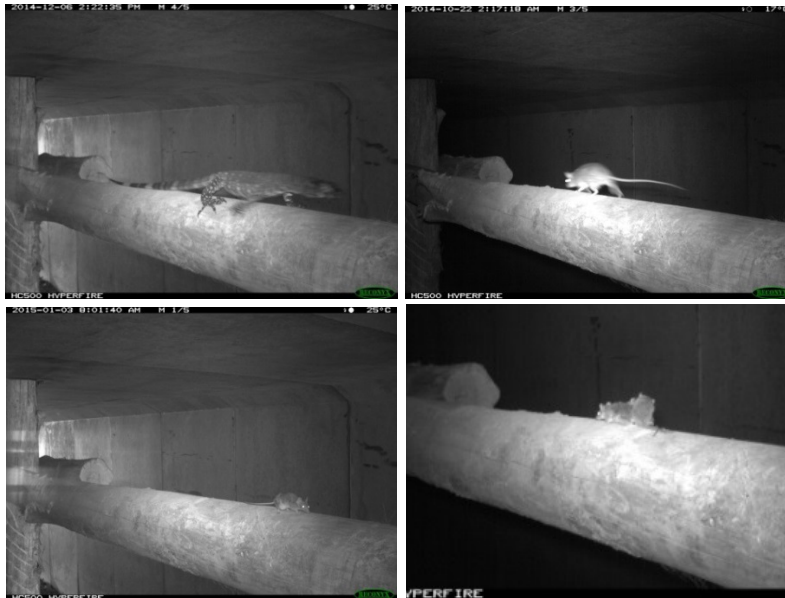
One interesting observation was made on 6 January 2015 (Figure 32, lower right) when an antechinus mother was recorded carrying 4 large nestlings (two, then one, then another) across the railing over a 48 min period; each crossing past the camera with back-young taking approximately 3-8 sec.

Figure 32. Three species were detected on the fauna railing in the eastern fauna underpass. The lace monitor (*upper left*), black rat (*upper right*), and antechinus (*lower left*). One antechinus carried back young across on 6 Jan 2015 in one direction only (*lower right*).

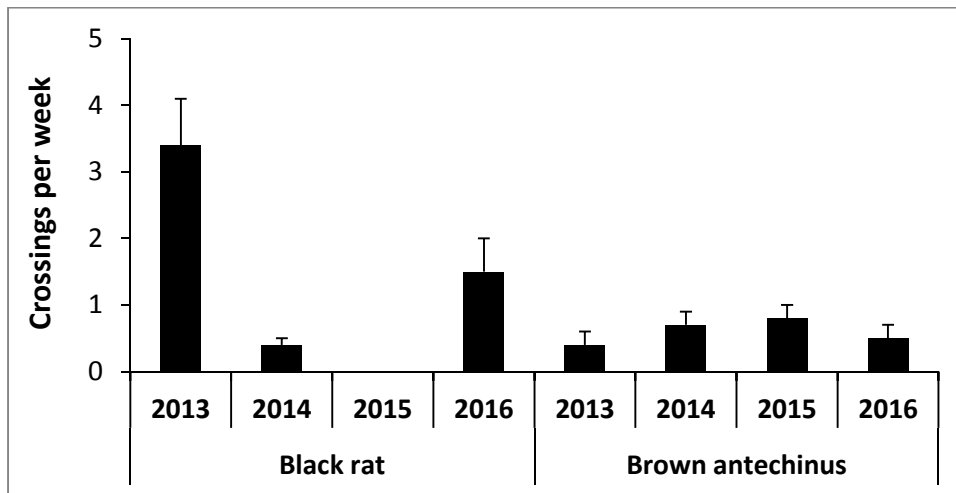
Figure 33. The number of passes per week (+SE) by rats and antechinuses on the fauna railing in the eastern fauna underpass.

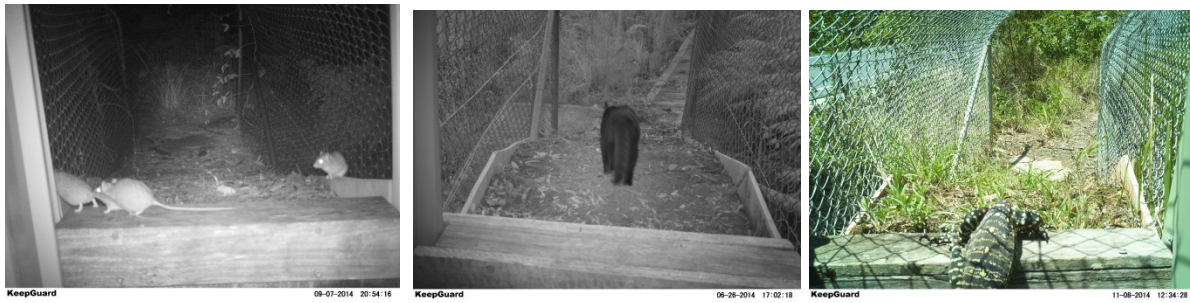
Figure 34. Black rats (*left*) were present at all of the drop-downs and produced records almost every night. A cat was detected on two occasions (*middle*). Lace monitors used the drop-downs in both directions (*right*).

A black cat was recorded twice (12 days apart) moving through drop-down 2N (Figure 34), whilst lace monitors (Figure 34) were detected occasionally at most drop-downs. Long-nosed and northern brown bandicoots (Figure 35) were detected at most drop-downs whereas two species of brushtailed possum, the common ringtailed possum and the eastern grey kangaroo (Figure 36) were detected infrequently. The red fox was a frequent user of some drop-downs (Figure 37; Table 6).

Those species detected frequently were observed to move up and down, through the drop-down in both directions. Images showed animals stretching out (Figures 35 and 37, *middle*) and disappearing over the edge of the drop-down ledge (Figures 34 and 37, *right*) as well as appearing at the edge with their back to the camera (Figure 36, *left*) before moving away from the camera (Figure 34, *middle*; Figure 37, *left*).

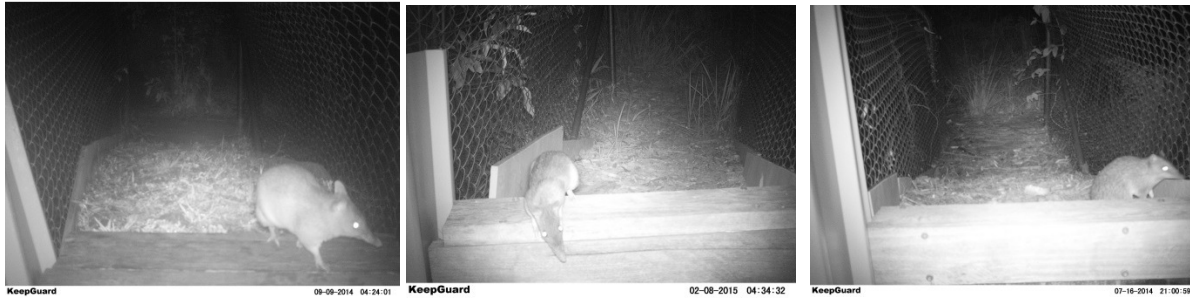
Figure 35. Bandicoots were frequently detected on the drop-downs and going up and down the drop. This included long-nosed bandicoots (*left*) and (*middle*), and the northern brown bandicoot (*right*).

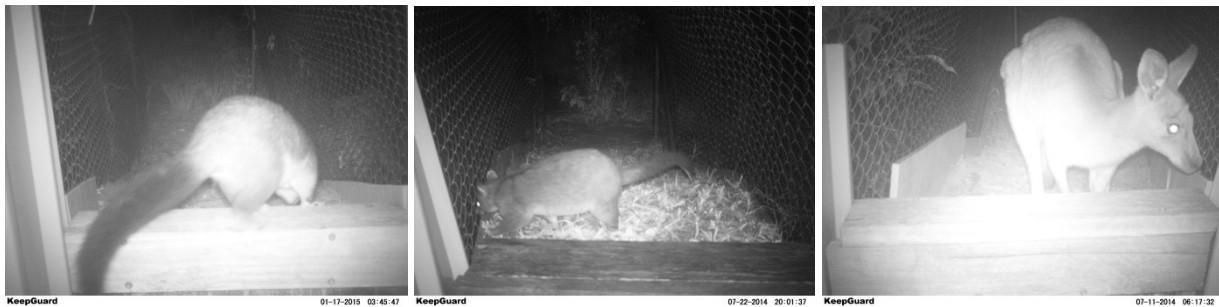
Figure 36. Occasionally detected at the drop-downs were the common brushtail possum (*left*), the northern mountain brushtail possum (*middle*), and the eastern grey kangaroo (*right*).

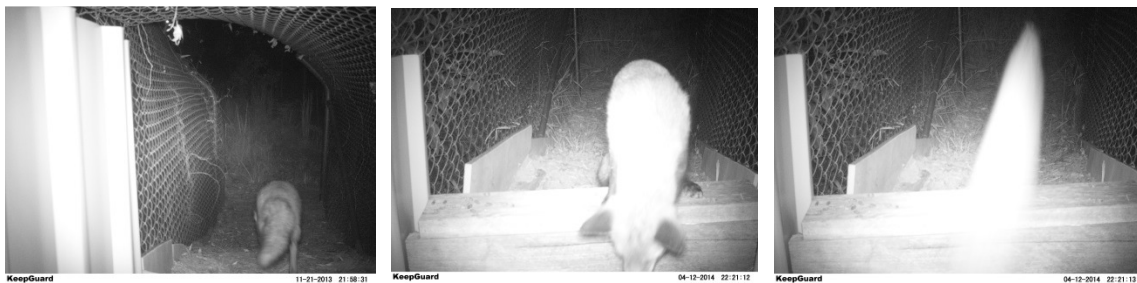
Figure 37. A red fox moving through a drop-down towards the road-way (*left*). A red fox using a drop-down (*middle and right*) to exit the road-side.

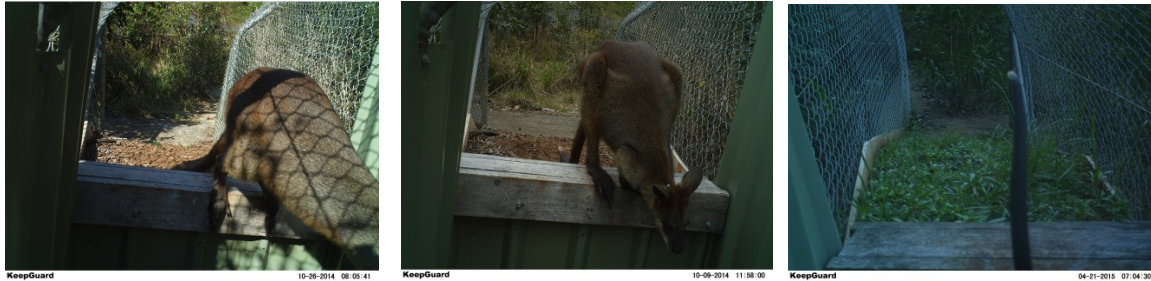
Figure 38. Swamp wallabies are frequent users of the drop-downs. These three images show individuals departing the road-side of the drop-down.

The swamp wallaby was the most frequently detected species commuting through the drop-downs, with images showing definitively that wallabies moved in both directions. Swamp wallabies could be seen leaping from the ledge of the drop-down in one image and then they

were gone or only their tail was visible (Figure 38). When moving in the other direction they appeared at the top of the drop-down ledge and then were photographed moving down the ramp and in some cases bounding away.

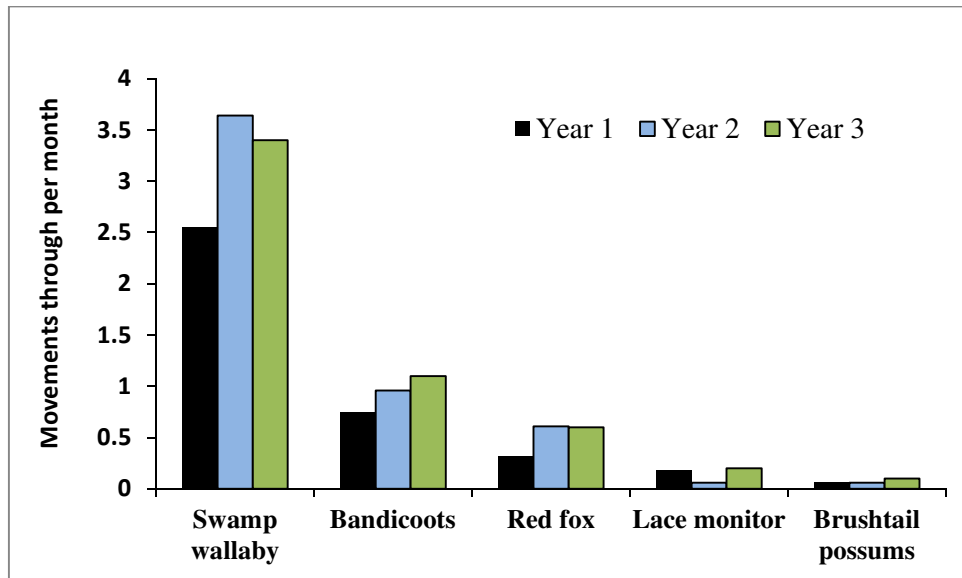
Overall, there were 814 movements by animals recorded through the drop-downs over the 3-year monitoring period (Table 6). The swamp wallaby accounted for 62% of these records while the two species of bandicoots accounted for 18% of records. Because different drop-downs were monitored in different years it is not practical to examine variation in the use of individual drop-downs over the three years. However, the totals for each year have been summed across individual drop-downs and standardised by the monitoring periods in a given year. This shows an increase in the movement of swamp wallabies through the drop-downs in year 2 (Figure 39). Swamp wallabies showed variable use across different drop-downs (Table 6). Drop-down 5N was the most frequently used of all drop-downs by swamp wallabies. Movement per 30 days through this drop-down was consistently high over the three years (yr1: 11.9; yr 2: 10.6; yr 3: 11.3). The monthly rate for bandicoots and the red fox showed an increase after year 1. Lace monitors and possums showed low rates.

Figure 39. Movements per month (30-day period) through the drop-downs by the species most commonly recorded using the drop-downs.
