**ARCHAEOLOGICAL TEST
EXCAVATIONS AT THE
SOUTH GRAFTON BRIDGE
CONSTRUCTION SITE**

REPORT BY JCIS CONSULTANTS

JCIS Consultants Report 13-036

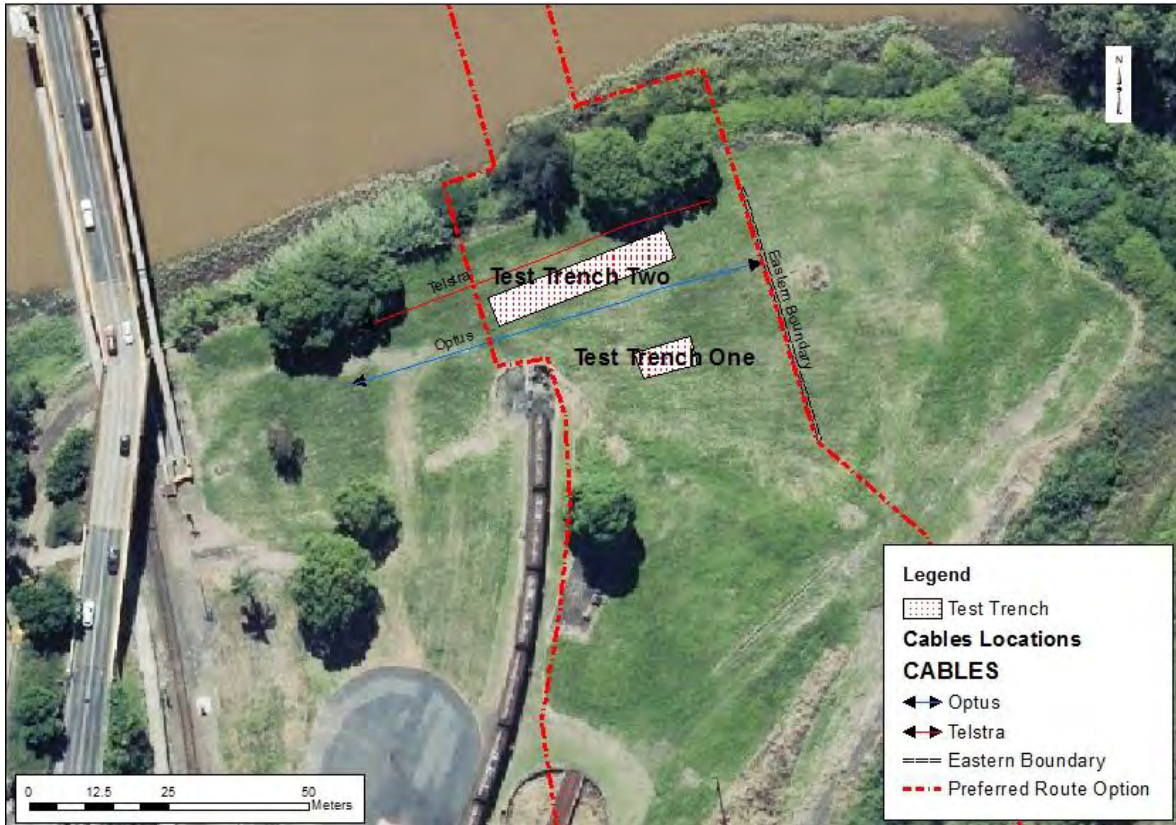
Figure 7: Locations of the Test Trenches at South Grafton.

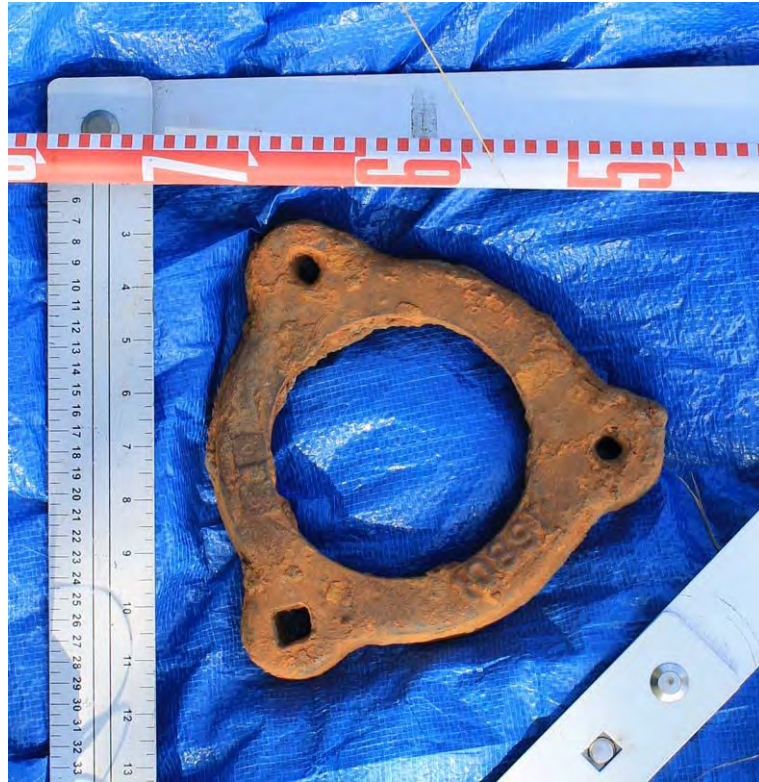
Figure 13: Artefacts from Test Trench 1.

Number	Fabric	Description
1	Steel	Flat bottom rail section, 34cm long.
2	Iron	Two links of a large chain, most likely from a coupling.
3	Iron	40cm length of 7.7cm diameter pipe.
4	Composite	Square lead washer; iron bolt with a square head; square keeper plate; and other corroded iron items.
5	Composite	Rectangular iron plate, with a bolt through it, plus another hole; remnant timber.
6	Composite	Rectangular iron plate, with a bolt through it, and remnants of timber.
7	Iron	Iron rail joining plate.
8	Composite	Four iron bolts with square washers and threaded end through a remnant timber.
9	Iron	Iron strap.
10	Steel	Circular metal piston ring stamped with the number 16001.
11	Iron	84 miscellaneous iron pieces.
12	Steel	Flat bottom rail 91cm long.
13	Wood	Timber sleeper.

Overall, the collection is not unexpected given the general area was the site of a locomotive depot in which all these items could have been found and discarded in situ. There is nothing in the artefact collection that specifically points to the construction of the bridge.

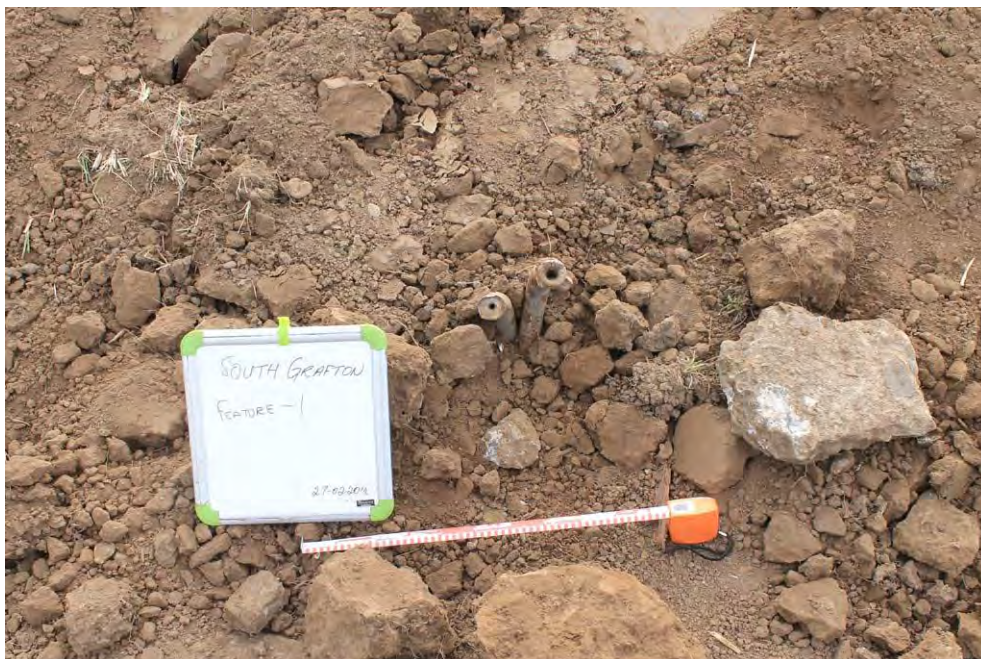
Figure 16: Test Trench 2, Feature 1.

Feature	Description
Feature 2	A 34m diameter pipe bent over; no sign of a foundation trench but the pipe is clearly in Context 3.
Feature 3	A 35m diameter pipe bent over; no sign of a foundation trench but the pipe is clearly in Context 3.
Feature 4	A 35m diameter pipe bent over. The pipe seems to be associated with a concrete deposit consisting of large river pebbles loosely cemented together.
Feature 5	A drain consisting of 21cm terracotta agricultural pipes running across the trench.
Feature 6	A metal pipe, 52mm in diameter, running roughly parallel to the trench, 6m long. The pipe was resting in Context 1 and sealed by Context 2.
Post Hole 1	Was a roughly circular hole 82cm in diameter. The cut was square and 80cm deep and cut into Context 3, and sealed by Context 1. No post was in situ but the cut was backfilled with a dark brown/black silt containing abundant wood fragments.
Post Hole 2	Steep sided, flat bottomed post hole with post in situ. Post hole was 70cm deep and 33cm in diameter, cut into Context 3 and sealed by Context 1. Part of the post was in situ; the timber being a bush timber (i.e. not sawn).

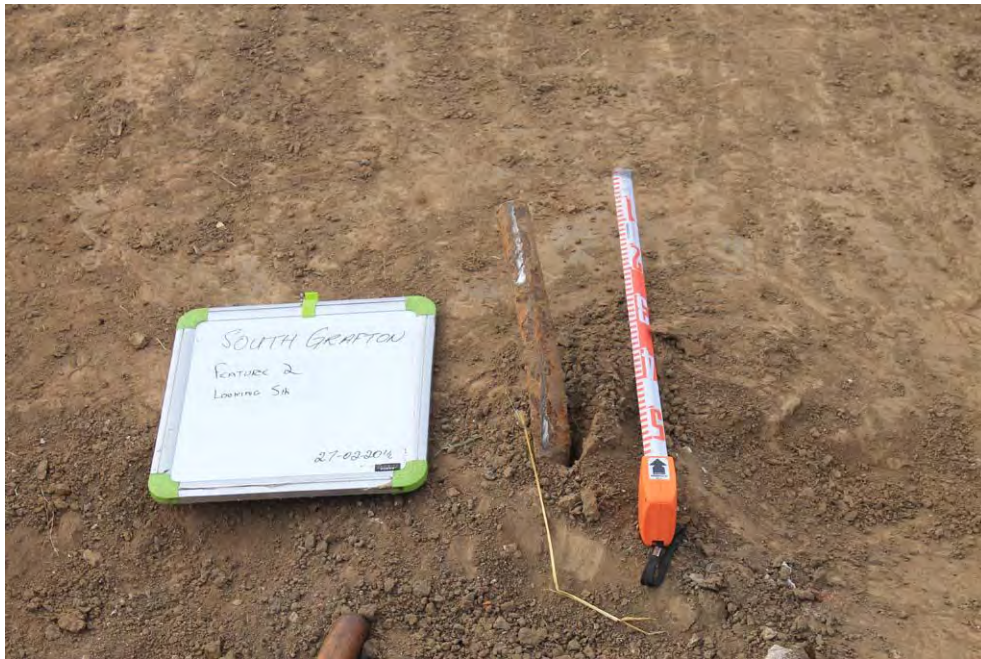
Figure 17: Test Trench 2, Feature 2.

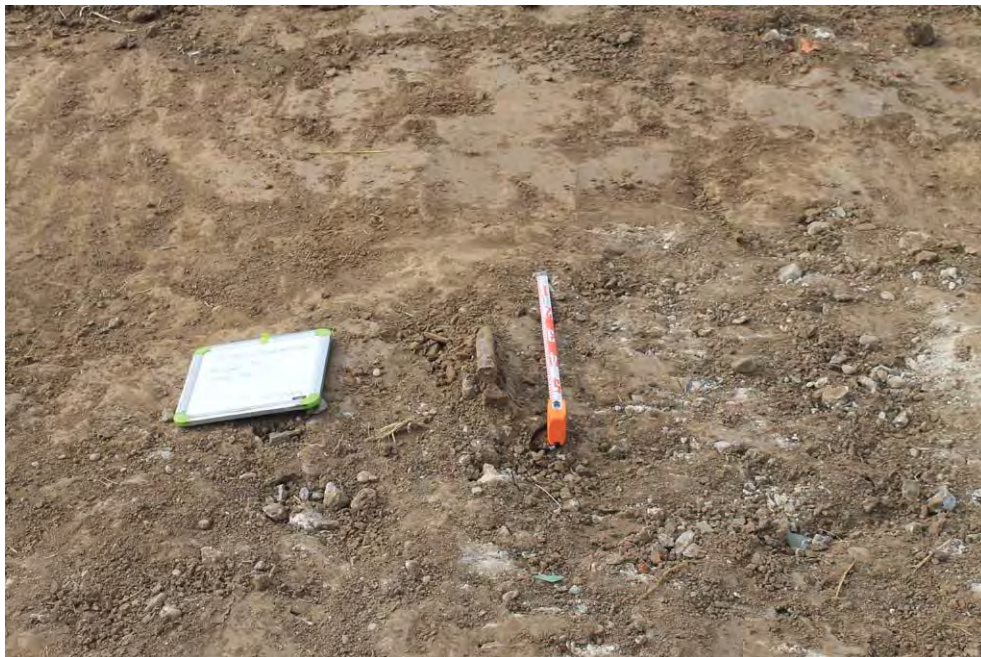
Figure 18: Test Trench 2, Feature 3.

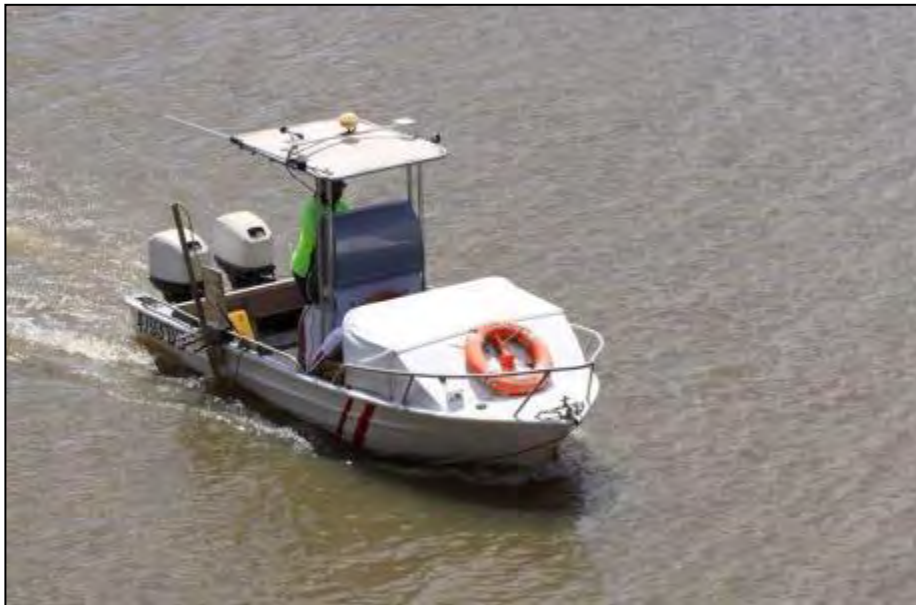
Photograph 1: Mapping & Hydrographic Surveys from aboard its 4.9 metre survey vessel *Delta Tauri*

The remote sensing surveys were conducted from 17-19 December 2013 under the supervision of Comber Consultants' archaeologist, David Nutley. The hydrographic and marine geophysical surveys were conducted by Mapping & Hydrographic Surveys from aboard its 4.9 metre survey vessel *Delta Tauri* (Photograph 1). An area of approximately 22ha of the Clarence River between North and South Grafton was defined in which to identify any potential features. The survey area extended 100m upstream (west) of the historic shipwreck ss *Induna*. To the east, the survey area extended about 375-400 metres downstream of Alipou Creek. (See details of methodology in attached Hydrographic and Marine Geophysical report – Appendix 1).

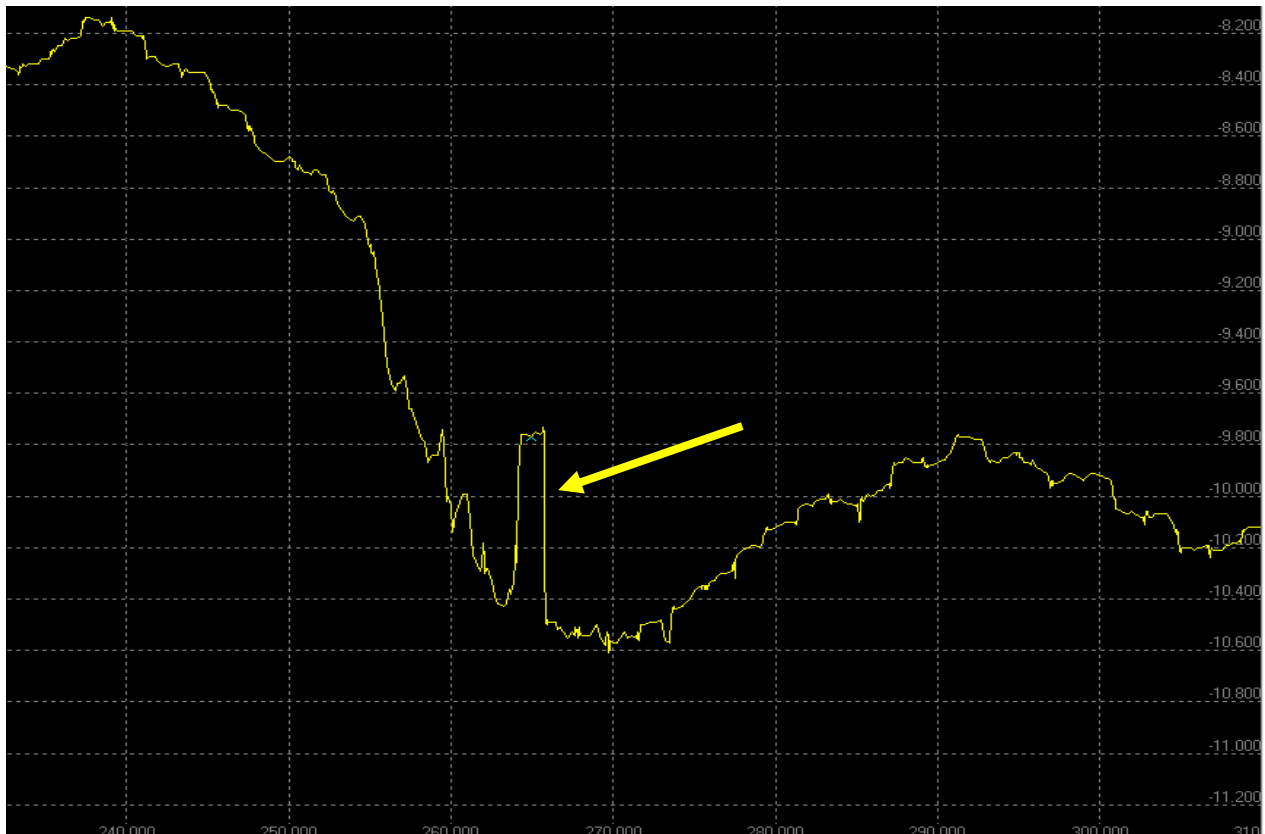
Figure 4:– Feature 1 -Clear bathymetric anomaly in the SBES data (yellow arrow), 1-2m length 0.8m height above the riverbed.

Feature 1 appears as a bathymetric 1-2m length 0.8m high anomaly (Figure 4) and also as a feature in the side scan data (Figure 5). Its absence from the pinger survey (sub-bottom profile – Figure 6) suggested that it did not have any substantial presence below the seabed.

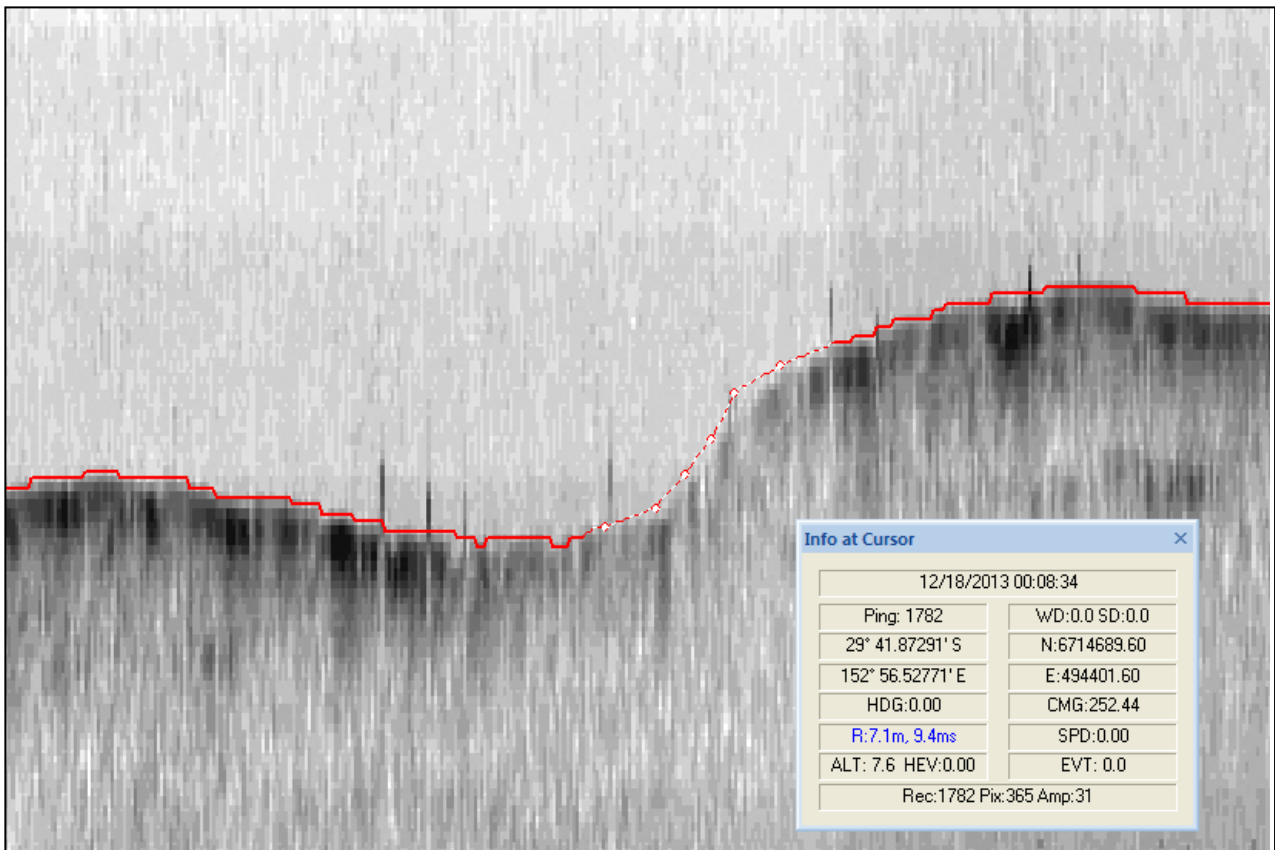
Figure 6: Feature 1 does not appear to be visible in SBP Pinger data at the same location.

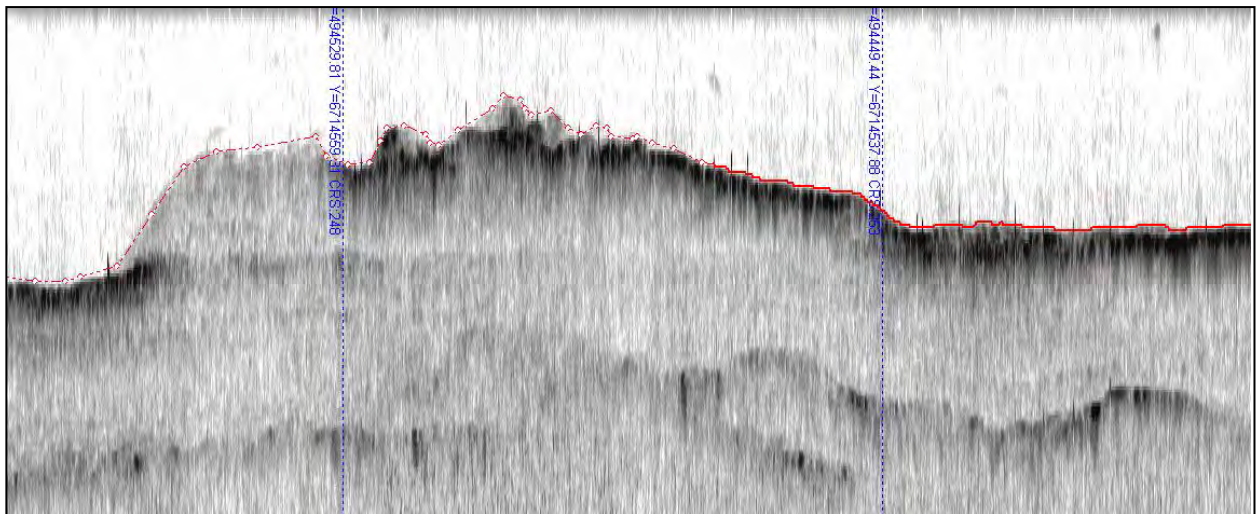
Figure 8: Pinger data showing rocky outcrop around derelict wharf on eastern side of bridge.

Feature 2 (Figure 7) appears in a rocky section of the southern bank in the vicinity of the derelict wharf (adjacent to AS01 Figure 21) (Figure 8 and Photograph 10). There is a high concentration of debris.

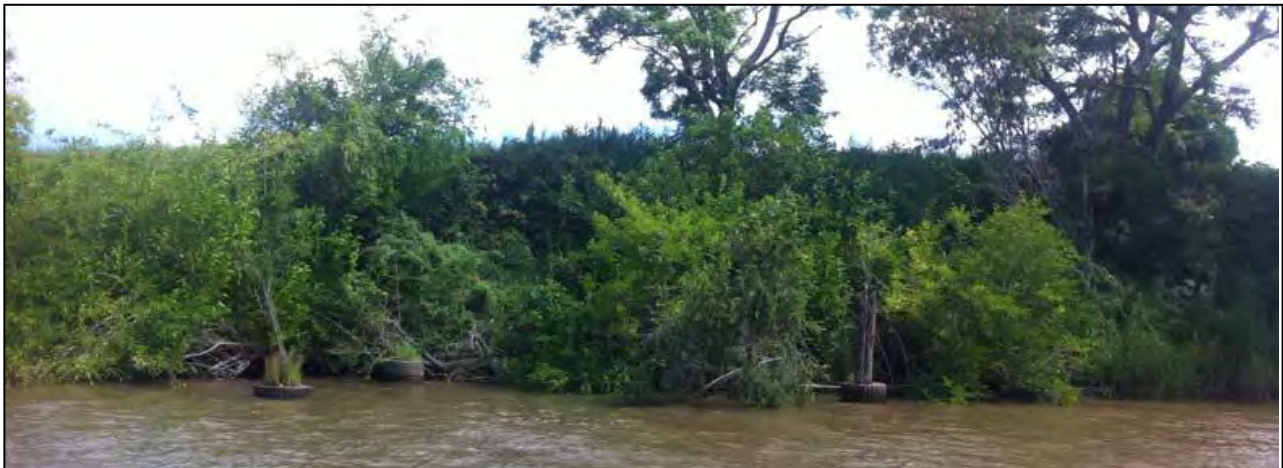
Photograph 10: Derelict wharf from aboard *Delta Tauril*. (Photo: Mapping & Hydrographic Surveys)

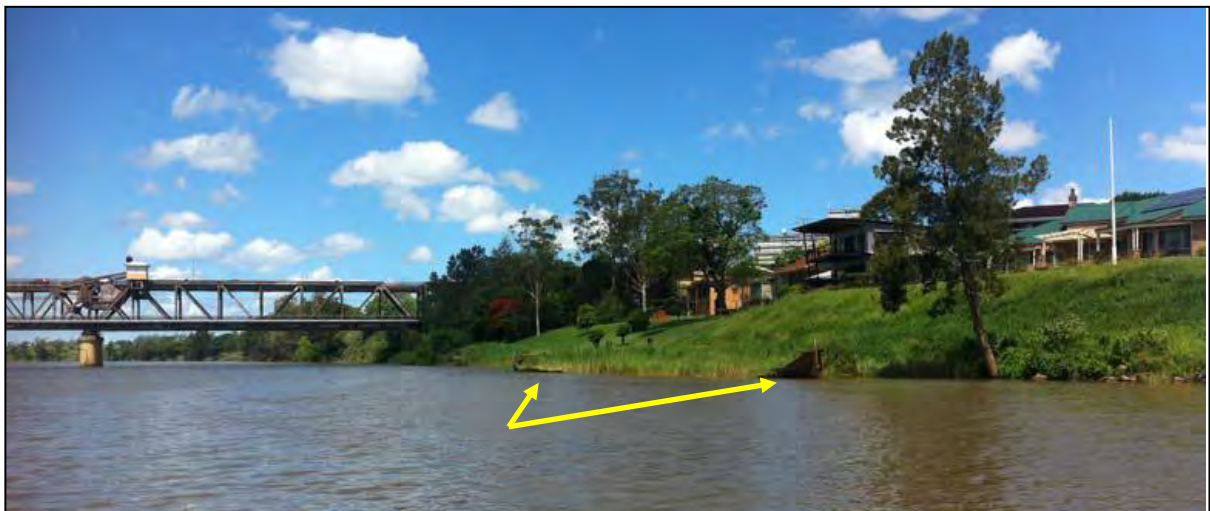
Photograph 11: Wreck of the *Induna* between yellow arrows.

Feature 4 (Figures 10, 11, and Photograph 11) is adjacent to the site of the historic shipwreck ss *Induna* on the south bank, west of the present bridge. An adjacent debris field may contain debris from the shipwreck or associated wharf.

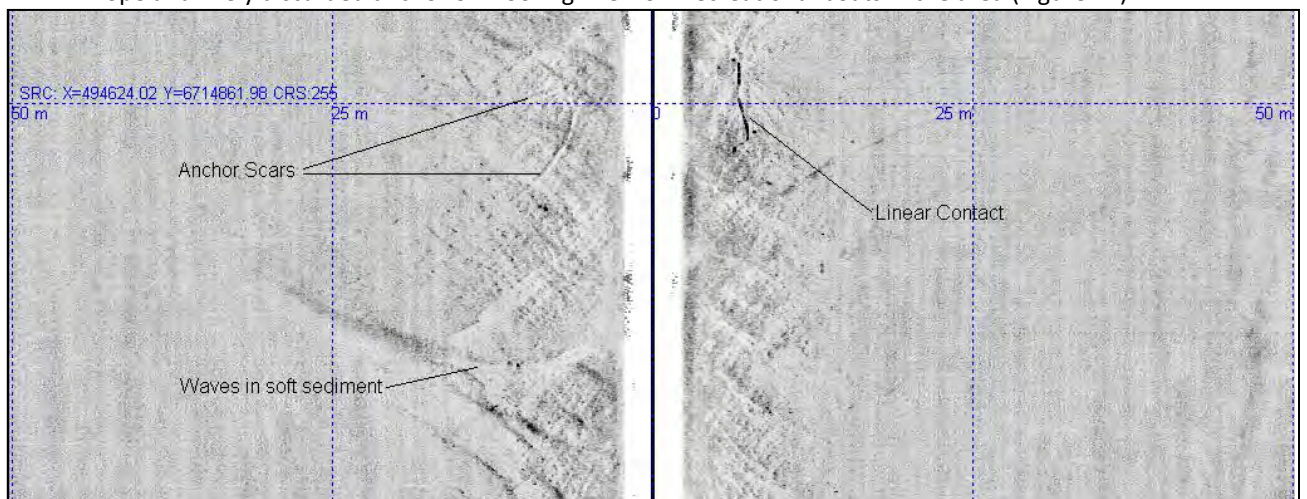
Figure 14: Linear contact 9m length

Feature 7, near the north shore and on the eastern side of the existing bridge is a 9 metre object consistent with rope and likely discarded anchor or mooring line from recreational boats in the area (Figure 14).

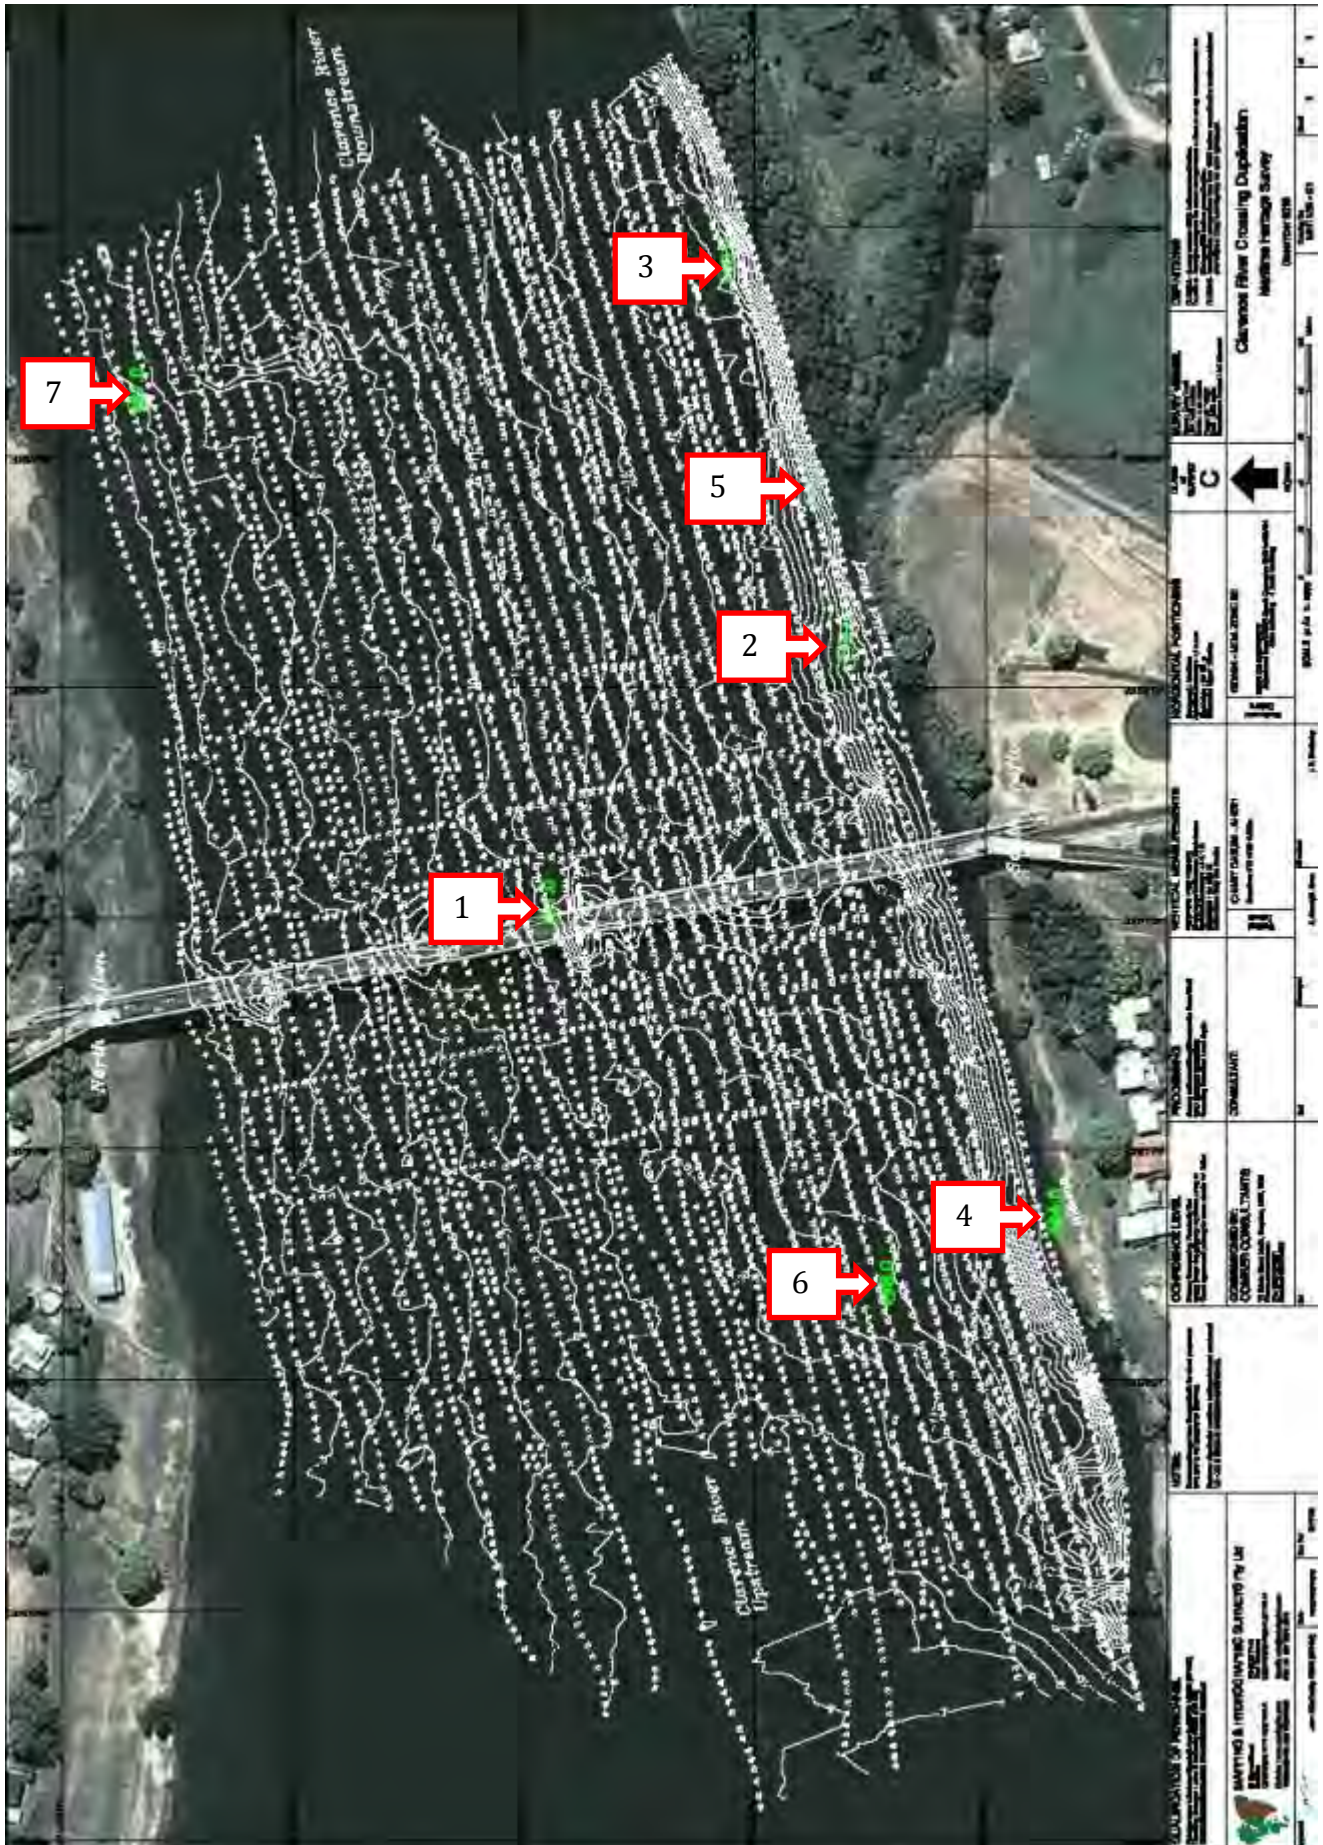
Figure 17: Areas of potential underwater cultural heritage interest

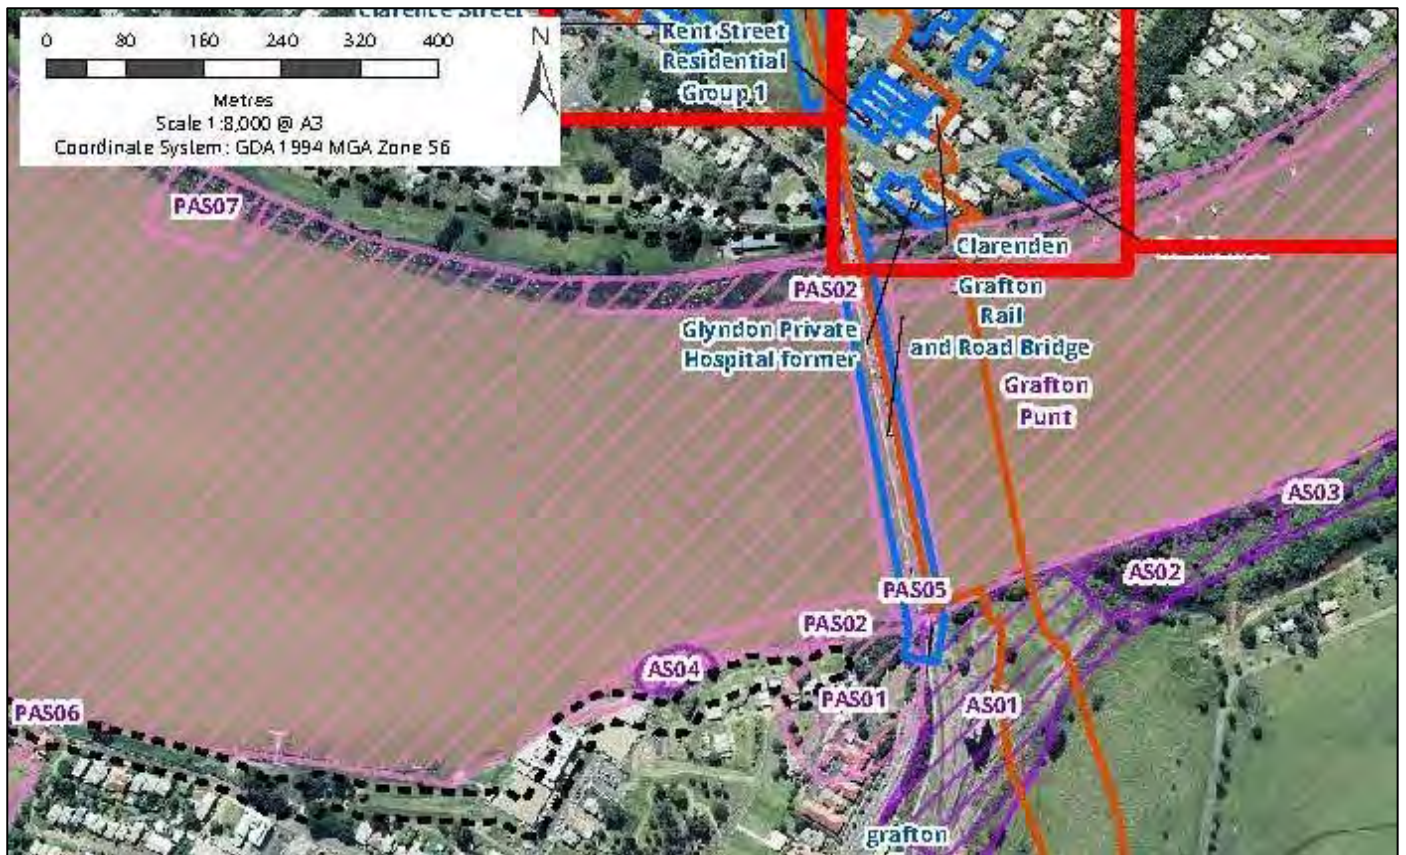
Figure 19: Map showing terrestrial archaeological sites (AS) and potential archaeological sites (PAS) and relationship to the route options for the bridge duplication (adapted from Biosis map)

The majority of anomalies detected during the remote sensing surveys are located near the southern bank of the river. This is consistent with this area being an active wharfage zone (PAS02, AS01 and AS02 in Figure 21) prior to the building of the bridge crossing. The north side of the river is the inner curve of the river bend and therefore subject to more sedimentation than the southern bank. The shallow water in this area would have been less amenable to shipping and ferry connections.

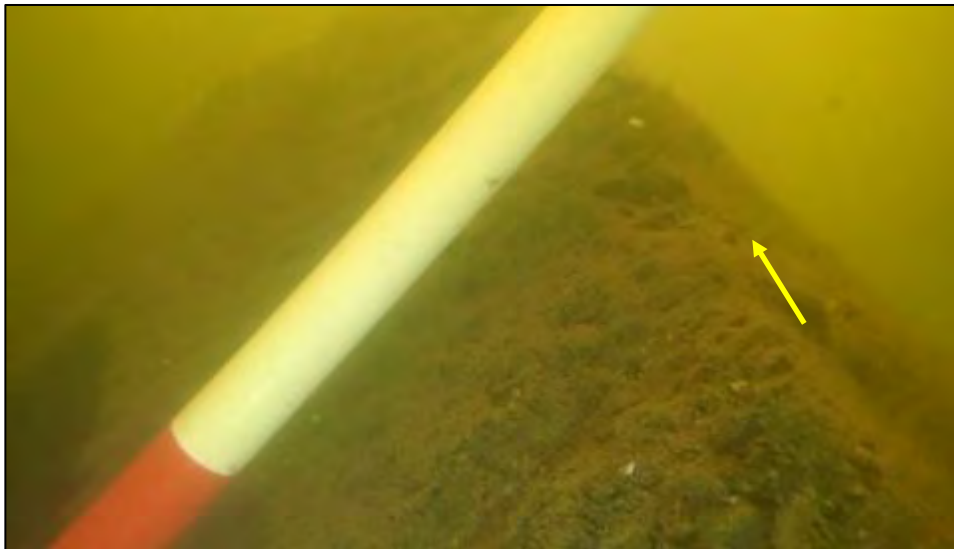
Photograph 12: Concrete pillar sleeve with corrugated at remote sensing feature 2 (yellow arrow)

The wharf remains include two hollow concrete pylon sleeves (Photographs 12 & 13) with a corrugated outer surface lying end to end. Half of a third concrete sleeve, split open longitudinally, was also observed. Each concrete sleeve is about 3.15m in length. They are identical in construction to the pylons that are visible above water at the edge of the river (Photograph 14). The concrete formed a sleeve around a central timber pole. This timber has rotted away leaving the hollow centre. An upright piece of one timber post of similar dimension (0.3 metres) was visible on the riverbed (Photograph 14).

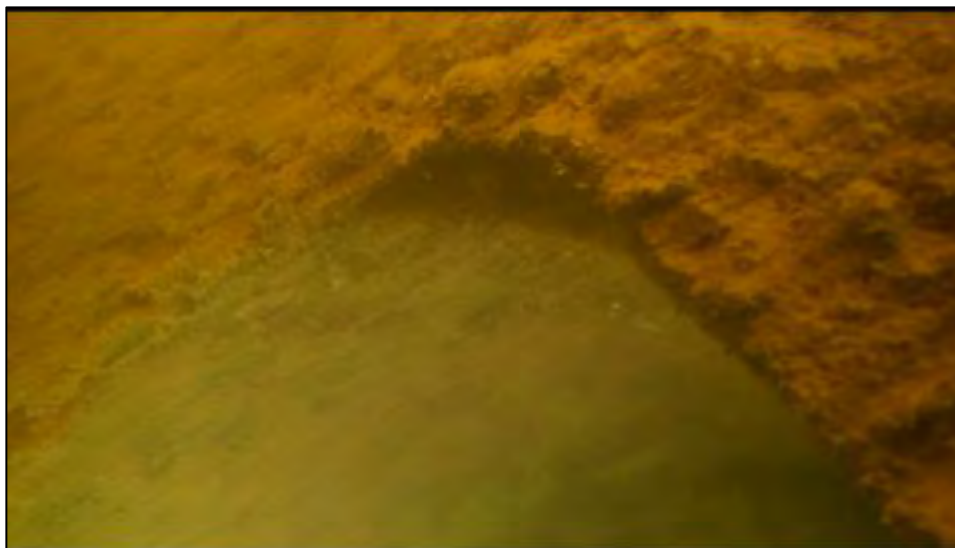
Photograph 13: End of concrete pillar sleeve – hollow centre - at remote sensing feature 2

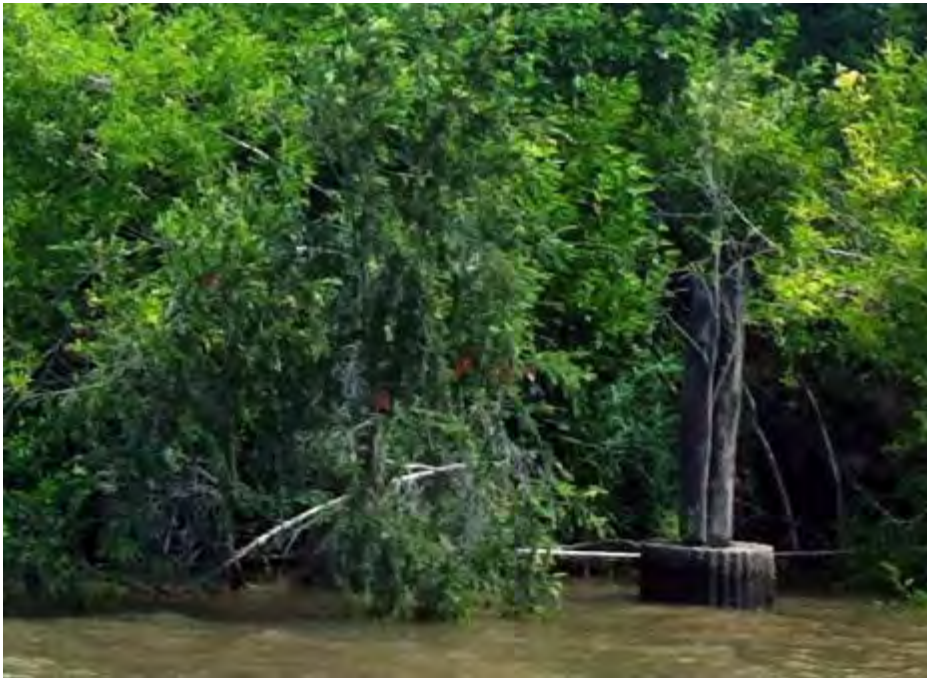
Photograph 15: Exposed remains of timber post with concrete sleeve at base near river bank – showing corrugated outer surface of the sleeve

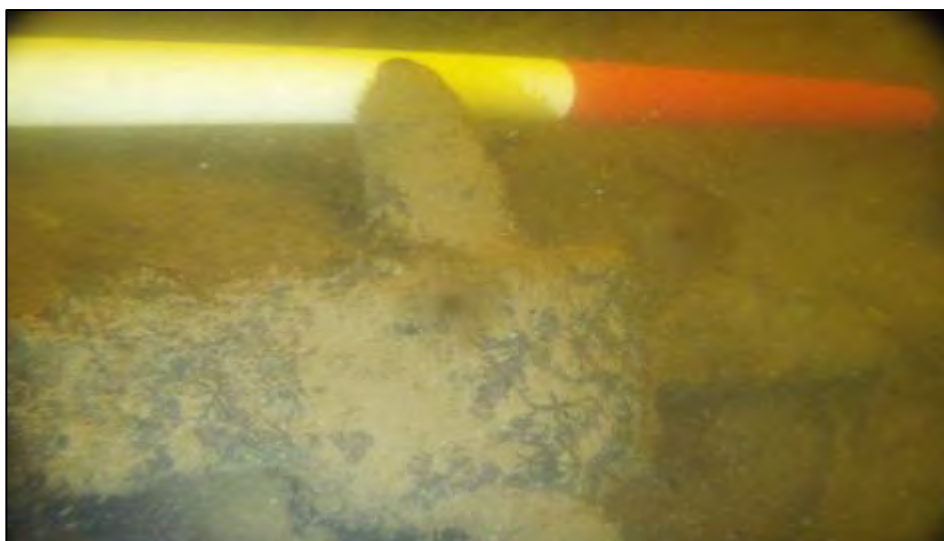
Photograph 18: Mattock head with remnant timber handle

Mattocks and picks (Photographs 16, 17, 18) lie west of the concrete pylons and are massed together in heaps of six or more. The timber handles were occasionally present (Photograph 18). The tools appear to have been dumped as a group.

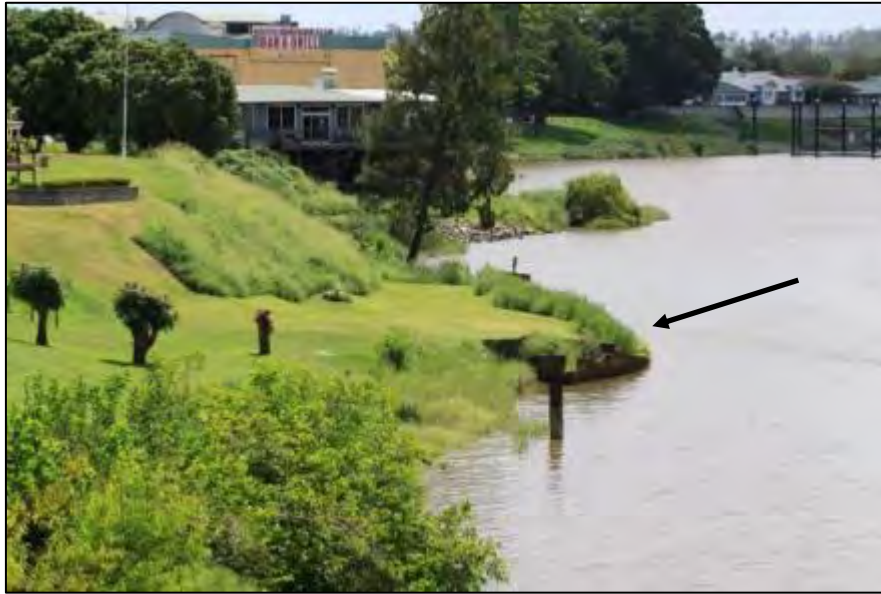
Photograph 20: ss Induna (arrow) on southern bank of river. View west from Grafton Bridge with embankment extending over Induna hull.

The remains of the *Induna* lie 156 metres west of the Grafton Bridge on the southern bank of the Clarence River (Photograph 19).

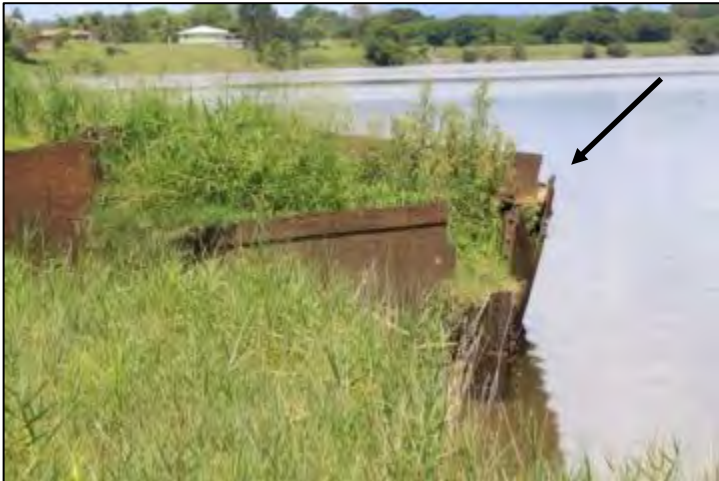
Photograph 21: Bow area with arrow to where bow was removed for nearby memorial

The bow (Photograph 21) and stern (Photograph 21, 22) are both visible as is most of the upper edge of the port side hull. The majority of the starboard side of the vessel has been claimed by the riverbank and is covered with mown grass. Along the northern side of the vessel (port side), reed growth has become established inside of the hull (Photographs 21 & 24) except for a couple of metres near the port starboard quarter. Weeds entirely fill the space from the tip of the bow to the first bulk head which is 4.1 metres from the bow (Figure 21).

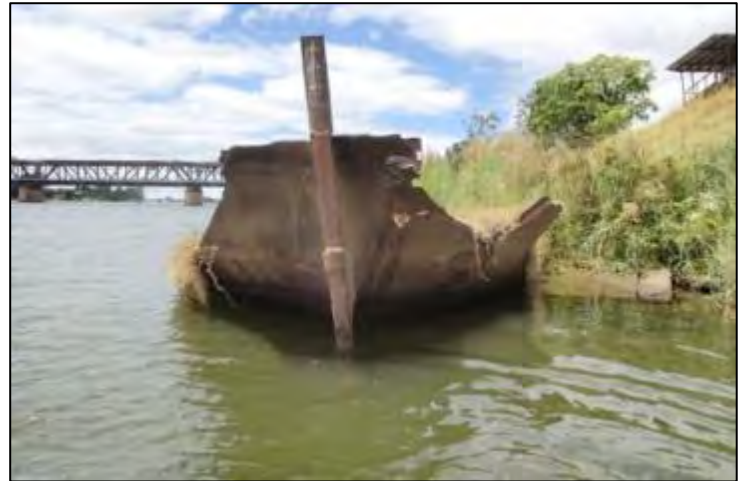
Photograph 22: Stern of *Induna* – view to east

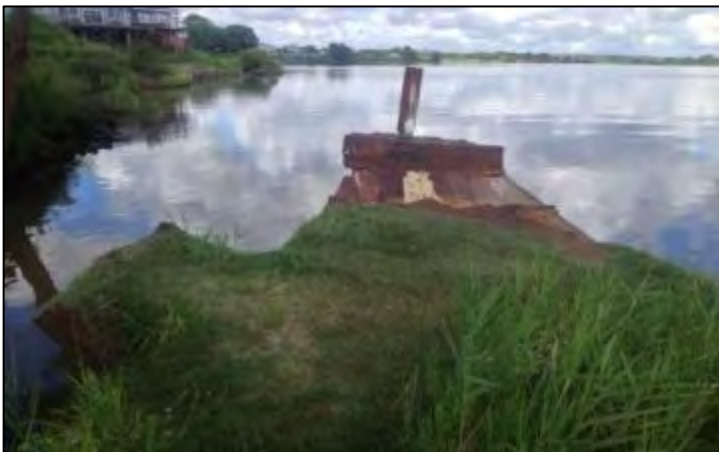
Photograph 23: Stern of *Induna* – view to west

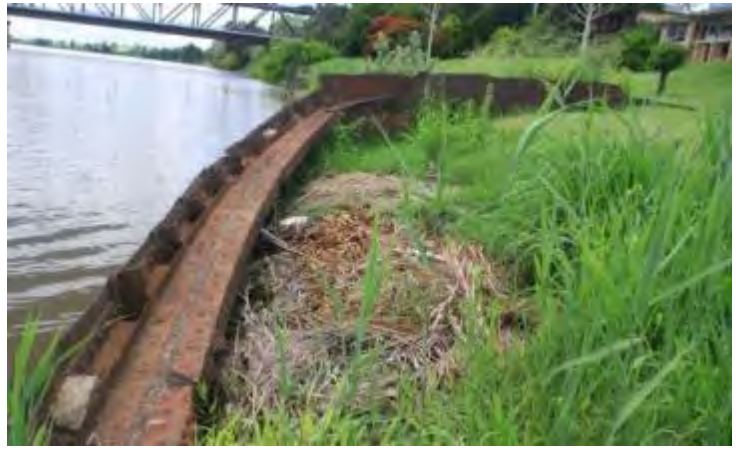
Photograph 24: View east along port quarter to bulk head behind bow with intact topside of hull and reed growth inside hull

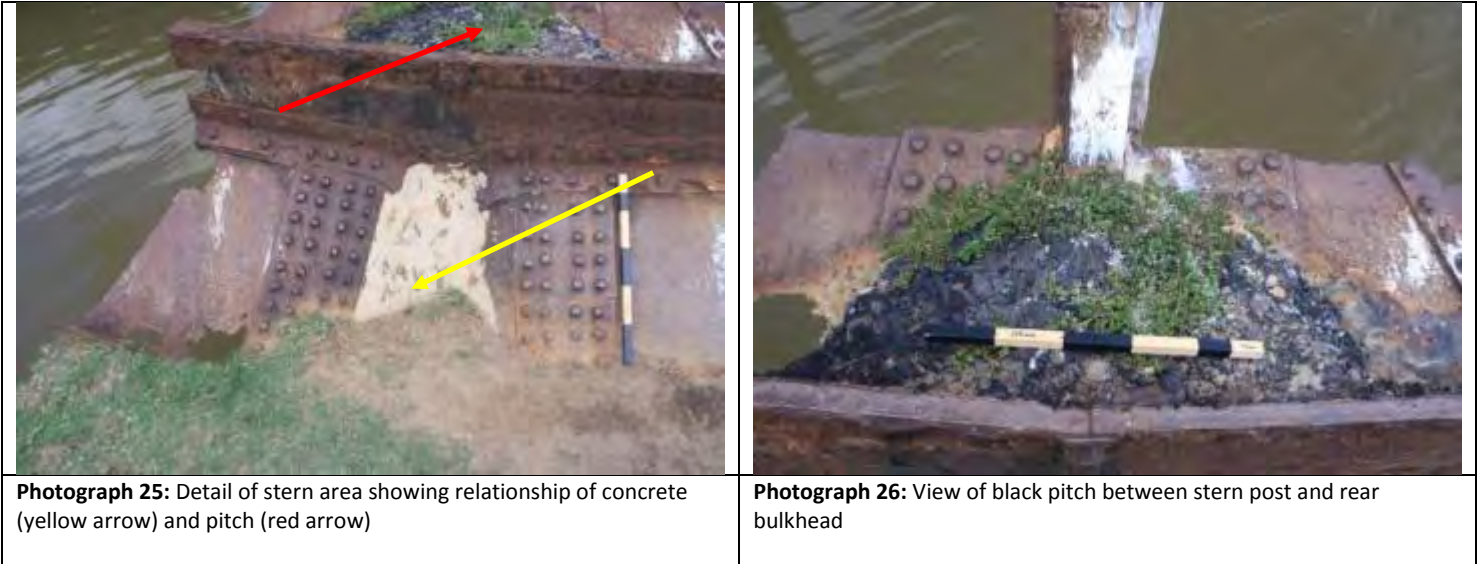
Figure 20: ss Induna site plan (Plan by D Nutley 18-12-2013)

Immediately in front of the stern post is remnant tar/pitch which lies between the stern post and a 1650mm frame (Figure 20 and photographs 25 & 26). In front of this frame can be seen the rear extremity of the concrete ballast that was introduced for the vessel's rail ferry work (Figure 21 & photograph 25).

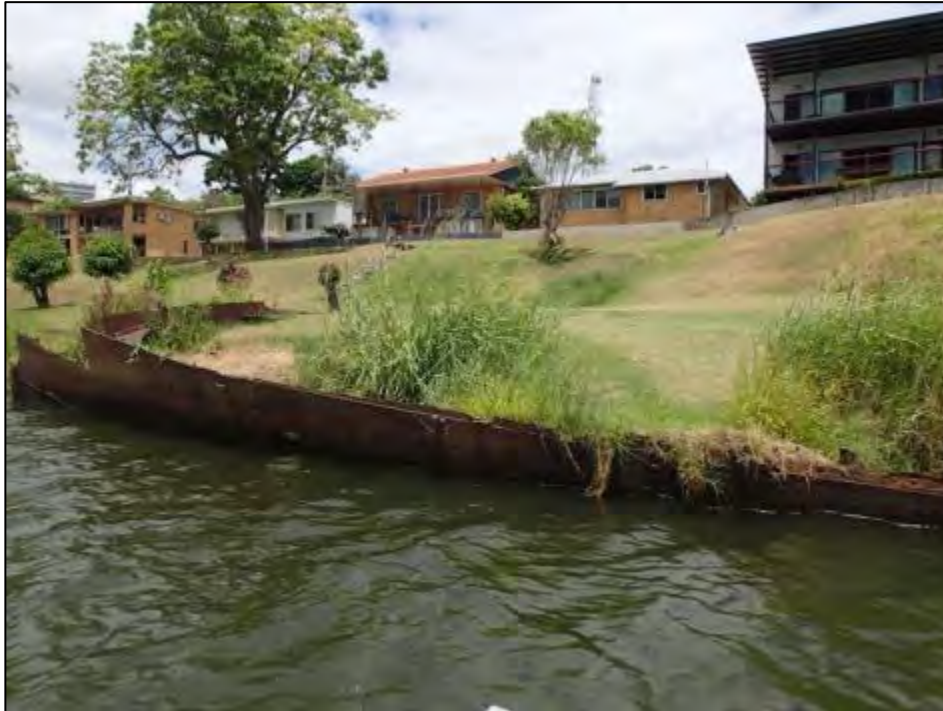
Photograph 27: View to the port side of *Induna* from across the debris field

Underwater, the debris field is restricted to the length of the ship (about 58 metres) and about 6 metres northwards from the port side of the hull (Photograph 27). Most of the debris was within 3 metres of the hull. With the exception of one and a half house bricks the debris field consisted entirely of ferrous metal associated with the *Induna* which fell into the river prior to or

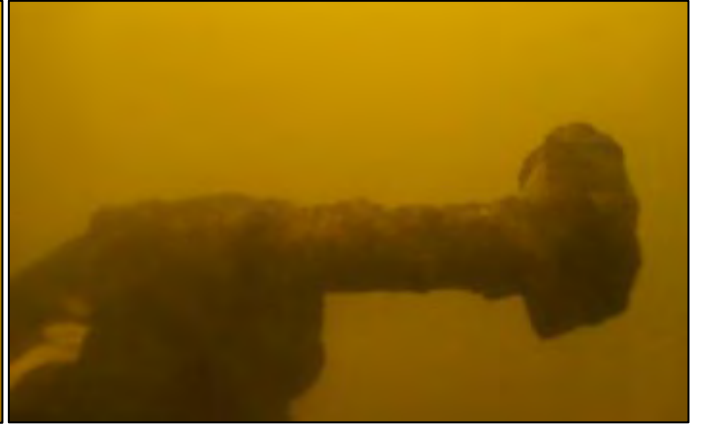
Photograph 31: Bolt or railway spike

In addition to various small, decomposing tree branches, a debris field of small ferrous objects was identified. These included numerous steel bolts of various lengths and railway sleeper spikes (Photographs 30-33), metal rings (Photograph 34) and 100 x 100mm squares of steel plate with 35-40mm holes in the centre (Photograph 35). The site also included the remains of a ferrous pole, approximately 1.5 metres in length and with metal plate (about 150mm x 200mm) at one end (Photograph 36).

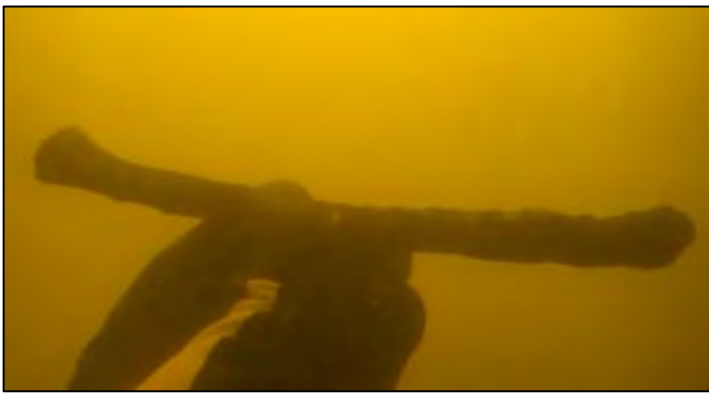
Photograph 32: Ferrous pin

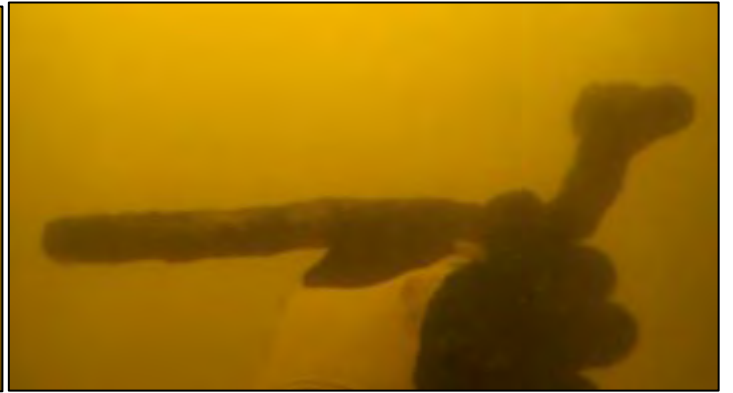
Photograph 33: Ferrous pin
